**CAMBRIDGE WATER, SEWER, AND STORMWATER COMMITTEE  
AMUNDSON COMMUNITY CENTER  
200 SPRING STREET - COMMUNITY ROOM  
NOVEMBER 19, 2024  
6:30PM  
AGENDA**

**To:** Village of Cambridge  
**From:** MSA Professional Services  
**Subject:** Vineyards Pond Inspections and Maintenance Recommendations  
**Date:** November 11<sup>th</sup>, 2024

On September 17<sup>th</sup>, 2024, MSA Professional Services performed visual inspections of four stormwater ponds in the Village of Cambridge, Dane County, WI. The purpose of the inspections was to address Village and resident concerns regarding performance, visual observations, modifications made by the previous developer and sump backup issues. Inspections included visual checks of detention basins, infiltration basins, inlet and outfall structures, bank erosion, berms, erosion control such as rip rap and erosion fabrics, as well as checking pond footprints to construction plans. Observations and recommended maintenance are included in this memo to maintain pond function in the Vineyards Development.

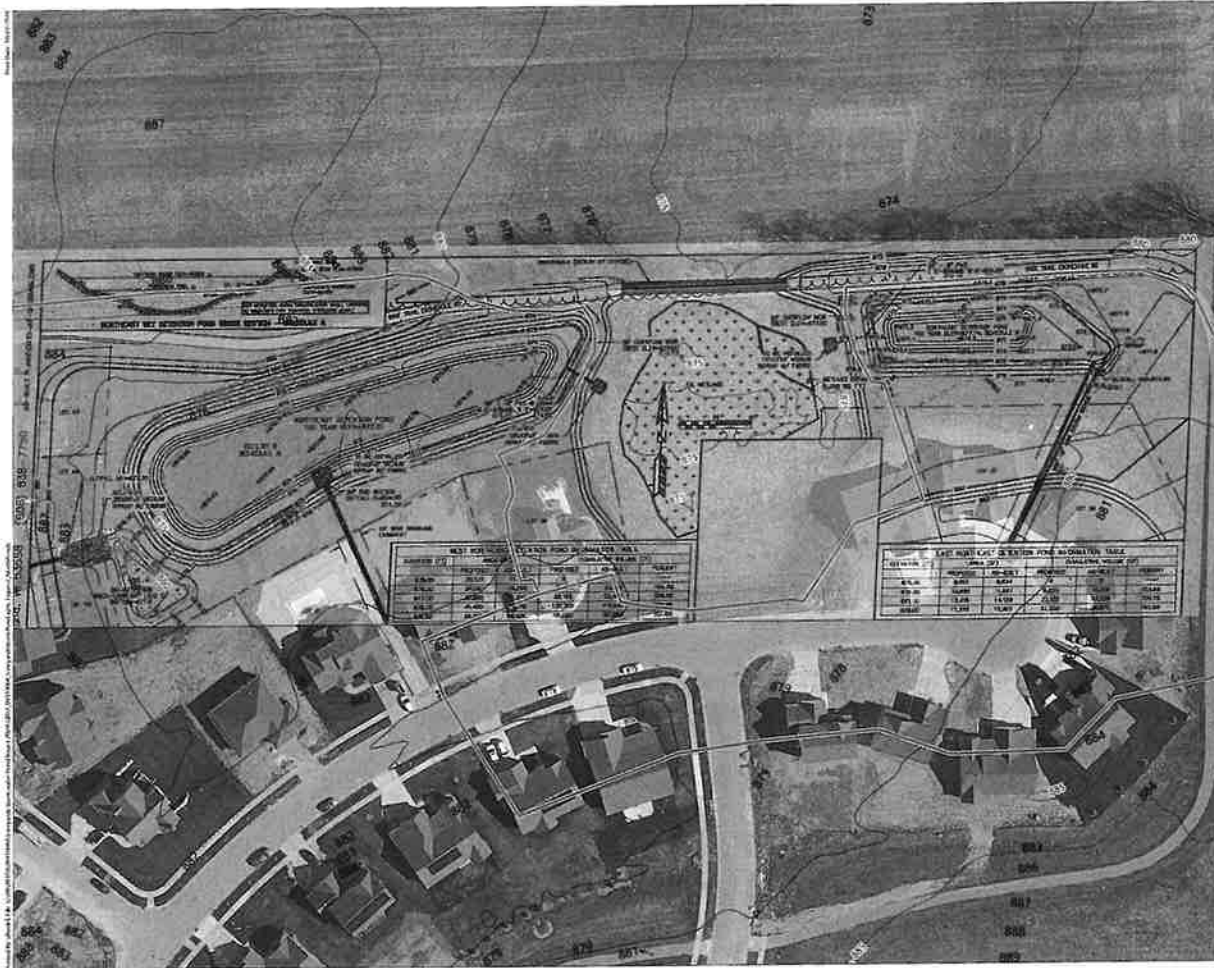
As shown in Figure 2, the North Vineyards Ponds consist of two wet detention basins and an infiltration basin located north of Kenseth Way. The following observations were identified as a result of MSA's inspection

1. The infiltration basin located adjacent to the west pond has been filled in and is no longer functioning as designed. Rip rap has been installed between the infiltration basin and the detention basin that is not included in the original design.
2. The infiltration basin is lacking bio-retention vegetation called out in design plan.
3. The erosion socks located in the filled-in infiltration basin are insufficient for a permanent solution of directing water to the pond.
4. Excessive vegetation is present throughout the western inlet structure and rip rap.
5. Trash was observed at the southern inlet rip rap.

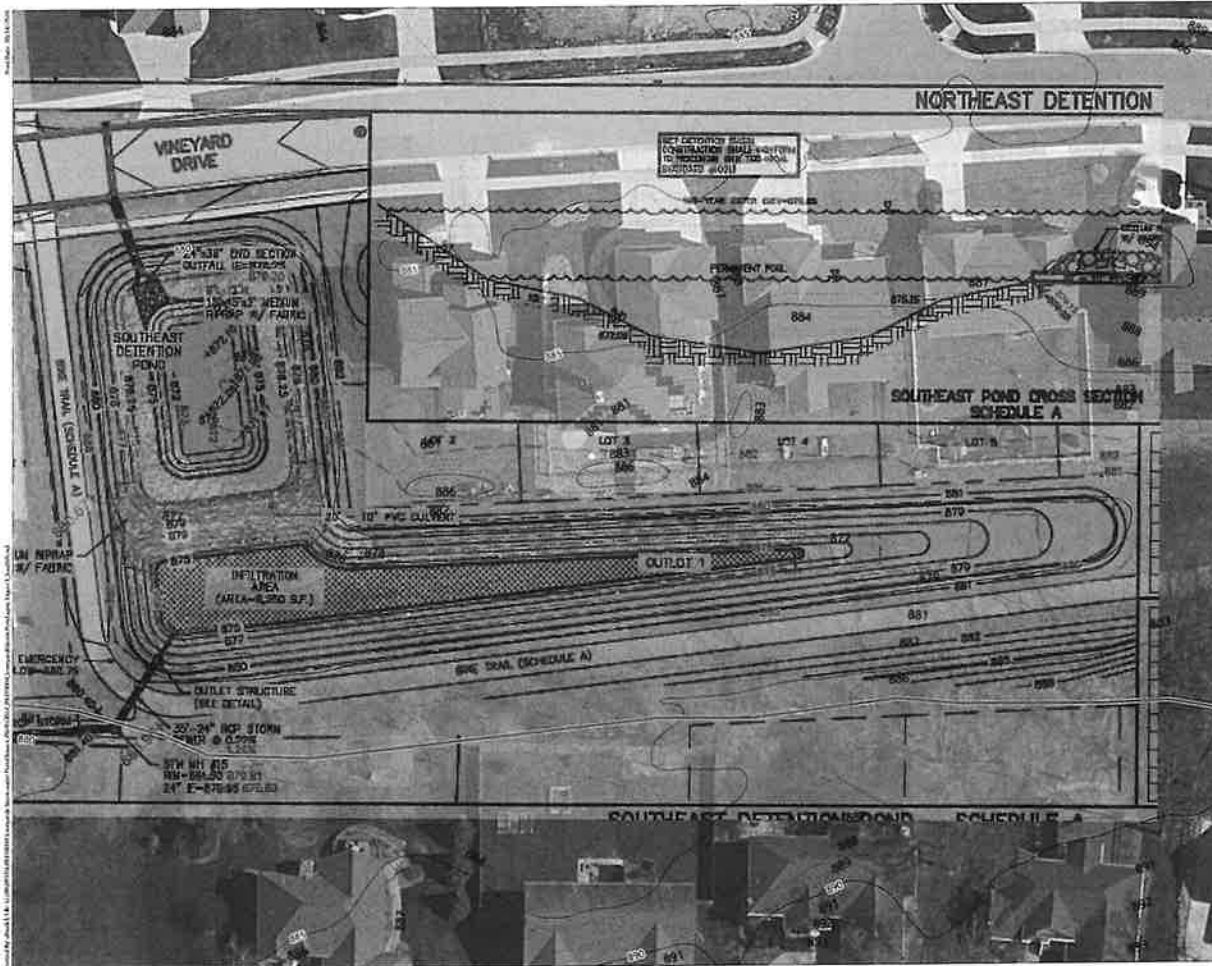
Figure 3: Aerial Footprint Comparison for South Vineyards Pond

As shown in Figure 3, the South Vineyards Pond consists of a wet detention basin and infiltration area located south of Vineyard Drive. The following observations were identified as a result of MSA's inspection.

1. There are large trees and vegetation on the pond banks and berm separating the infiltration and detention basins.
2. Erosion fabric has been exposed on the dividing berm.
3. The inlet structure is overgrown.
4. There is a small amount of standing water in the infiltration basin.
5. Both the infiltration and detention basins are full of cattails which indicates insufficient depth of the permanent pool; Infiltration basin design plans indicate no vegetation within basin.
6. The pipe to the outlet structure is overgrown.
7. The outlet structure is full of lawn clippings.

1. Clear the inlet and outlet structures of growth and debris for all ponds.
2. Remove vegetation and trees from the banks of all ponds.
3. Cut or remove cattails located in the South Vineyards Pond infiltration basin south of the berm.
4. Infiltration basin for the North Vineyards Ponds – West to be excavated back to design depth and plant appropriate bioretention vegetation.
5. Replenish rock supply to dividing berm in Vineyards South Pond.
6. After maintenance items 1-5 are completed, re-inspect ponds within one year to evaluate effects of maintenance on basins and potential functionality improvements. Additionally, re-inspect for evaluation of condition and expanse of permanent pools.

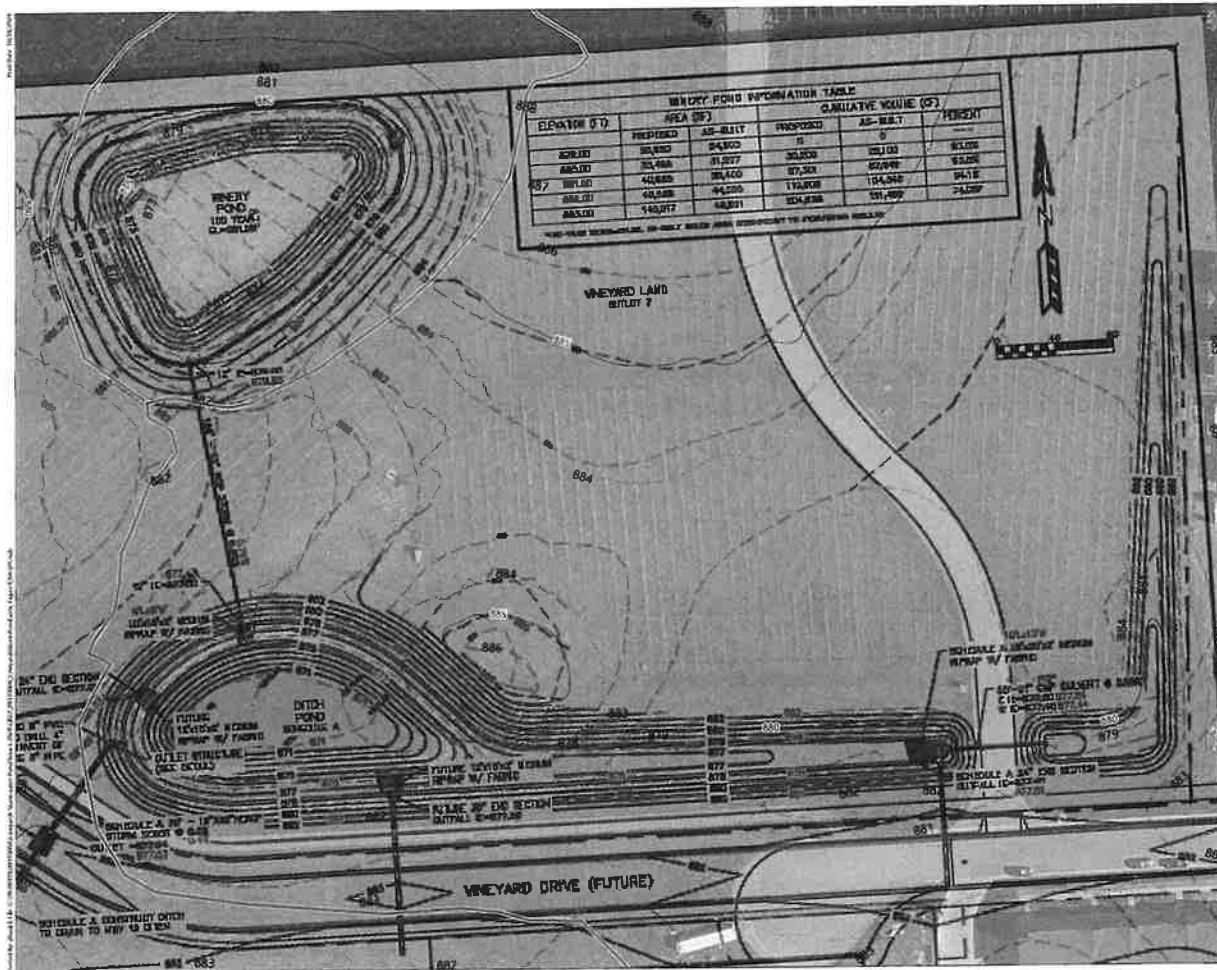
Figure 4: Aerial Footprint Comparison for North and South Winery Ponds  
Village of Cambridge  
Dane County, WI

As shown in Figure 4, the North Winery Pond consists of an infiltration basin located south of the Dancing Goat Distillery. The following observations were identified as a result of MSA's inspection.

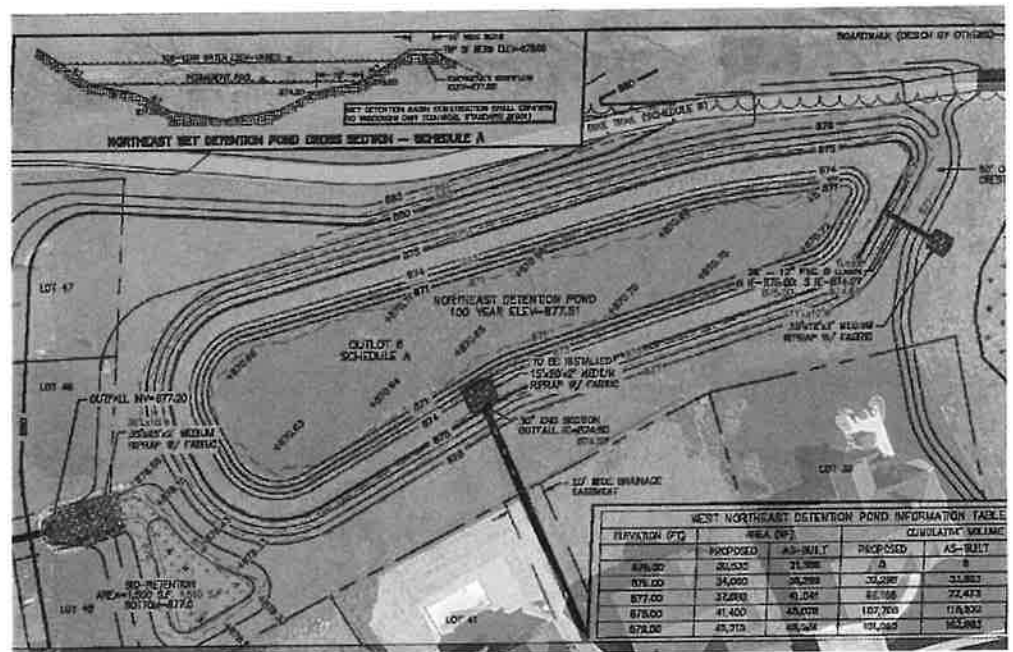
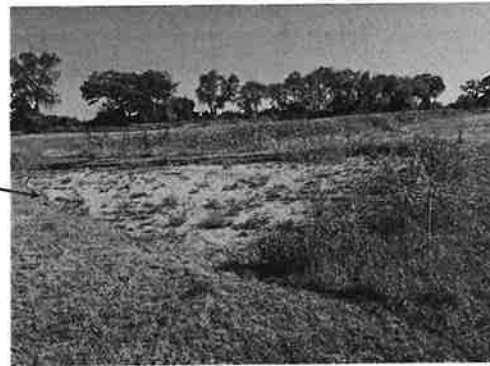
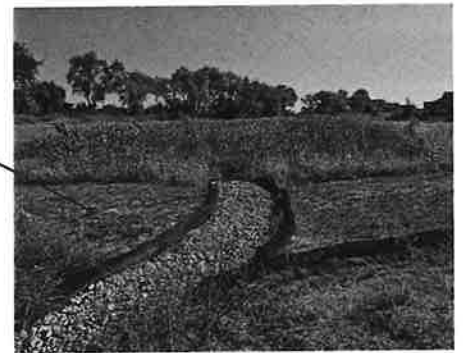
# North Vineyards Ponds - West

1. The infiltration basin located adjacent to the west pond has been filled in and is no longer functioning as designed.
2. The infiltration basin is lacking bio-retention vegetation called out in design plan.
3. Rip rap has been installed between the infiltration basin and the detention basin that is not included in the original design.
4. The erosion socks located in the filled-in infiltration basin are insufficient for a permanent solution of directing water to the pond.

1. Excavate infiltration basin back to design depth and plant appropriate bio-retention vegetation.
2. Correct design of inlet structure to flow to infiltration basin, as per design.

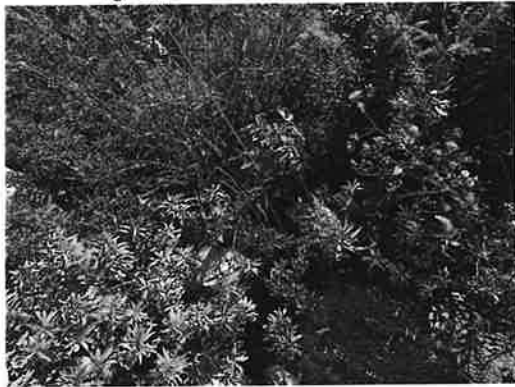
Overgrown inlet on west side of pond

1. Clear excess growth from banks and structures.

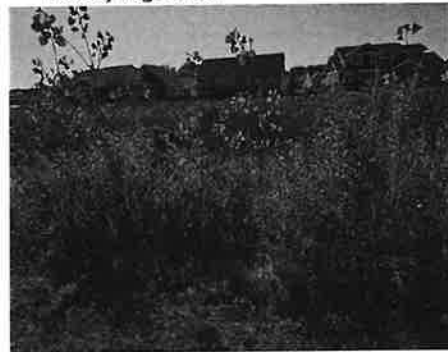
Woody vegetation on north bank

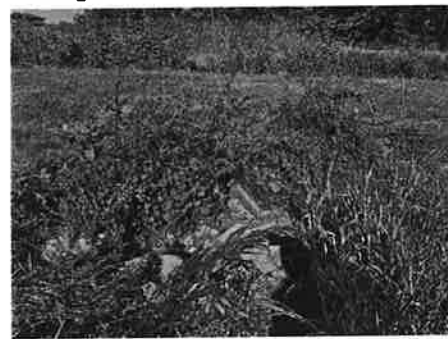
Overgrown outlet structure to wetland

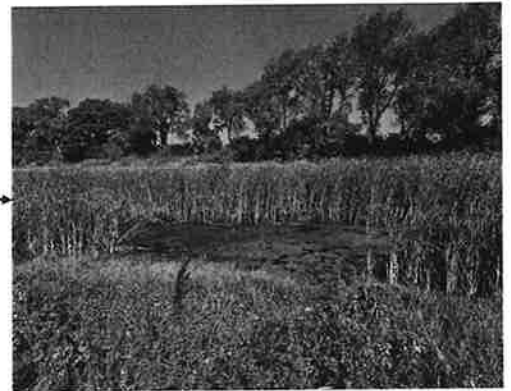
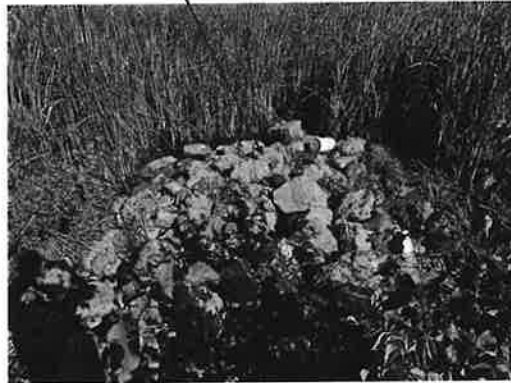
1. Large cattails are present within the majority of the wet detention basin and extend into the designed permanent pool, which is indicative of insufficient depth of permanent pool.
2. Trash was observed at the southern inlet rip rap.

1. Remove trash from rip rap.

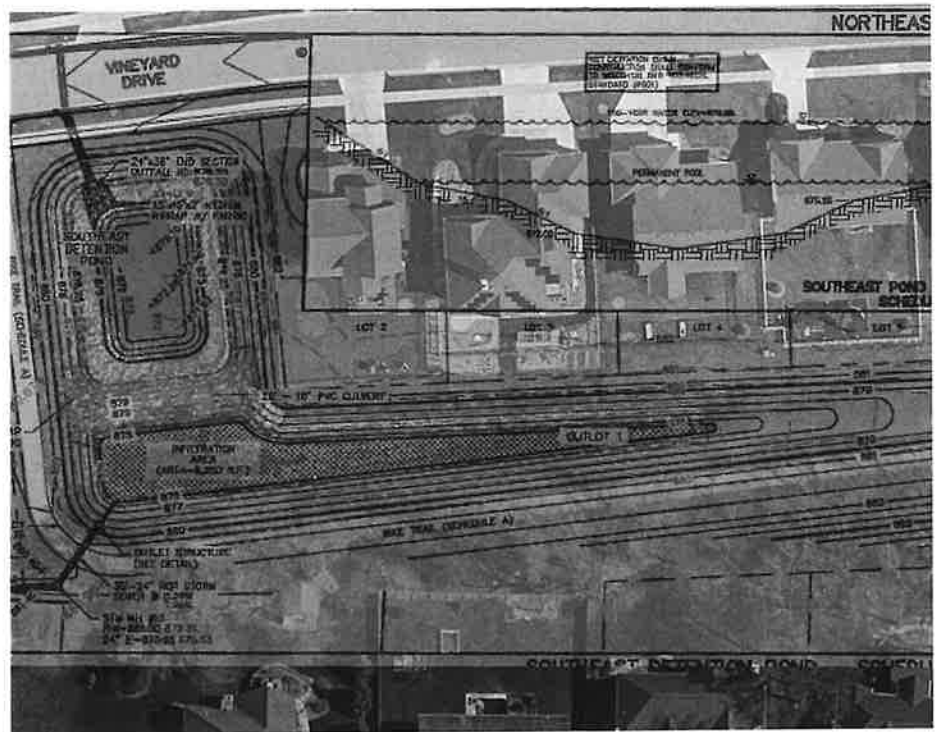
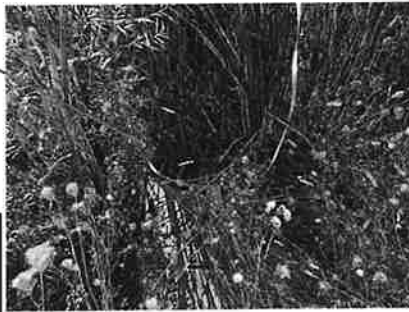
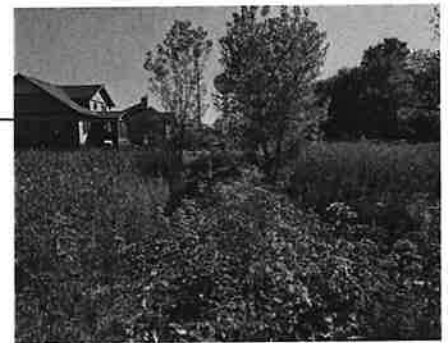
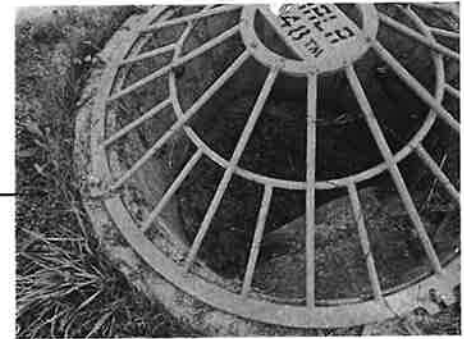
# South Vineyards Pond

1. There are large trees and vegetation on the pond banks and berm separating the infiltration and detention basins.
2. Erosion fabric is exposed on the dividing berm.
3. The Pond Inlet structure is overgrown.
4. Both the infiltration and detention basins are full of cattails which indicates insufficient depth of the permanent pool
5. The pipe to the outlet structure is overgrown.
6. The outlet structure is full of lawn clippings.

1. Clear excess growth from banks, the berm, and structures.
2. Replenish rock supply to the berm to cover all fabric.
3. Cut or otherwise remove the cattails from the infiltration basin.
4. Clean the outlet structure.

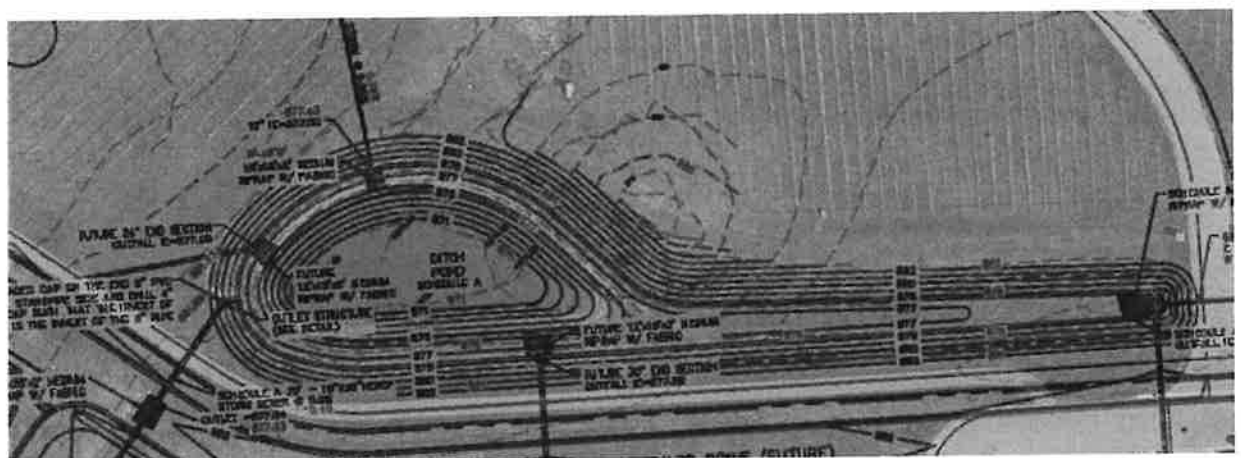
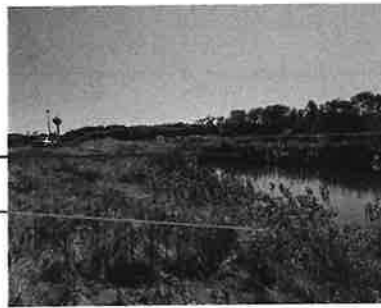
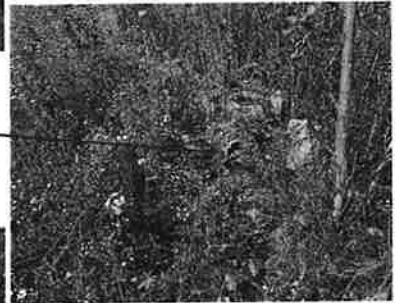
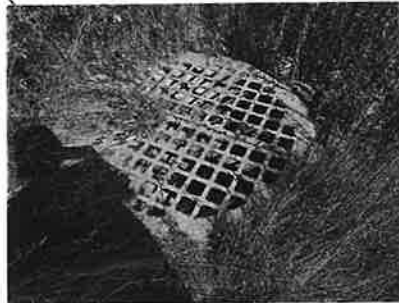
## South Winery Pond

1. Cattails are filling much of permanent pool, indicating insufficient depth.
2. There is overgrowth and woody vegetation present on the pond's banks.
3. There is woody vegetation along the east edge of the pond obstructing the inlet structures.
4. Dense woody vegetation is obstructing the outlet pipe. The standpipe is overgrown with grass.

1. Clear excess growth from the banks and structures.
