Subject: Riverside Park Shelter Nekoosa, WI – Inspection Services  
GEC # 2-0124-59B

**Introduction.** General Engineering Company was contacted by ADCI to inspect an open-air park shelter located at Riverside Park in the City of Nekoosa, Wood County, WI. The purpose of this inspection is to evaluate the structure of the park shelter to determine why the shelter is leaning. Robbie Freitag of General Engineering Company completed a visual, non-destructive inspection of the property on November 7<sup>th</sup>, 2024.

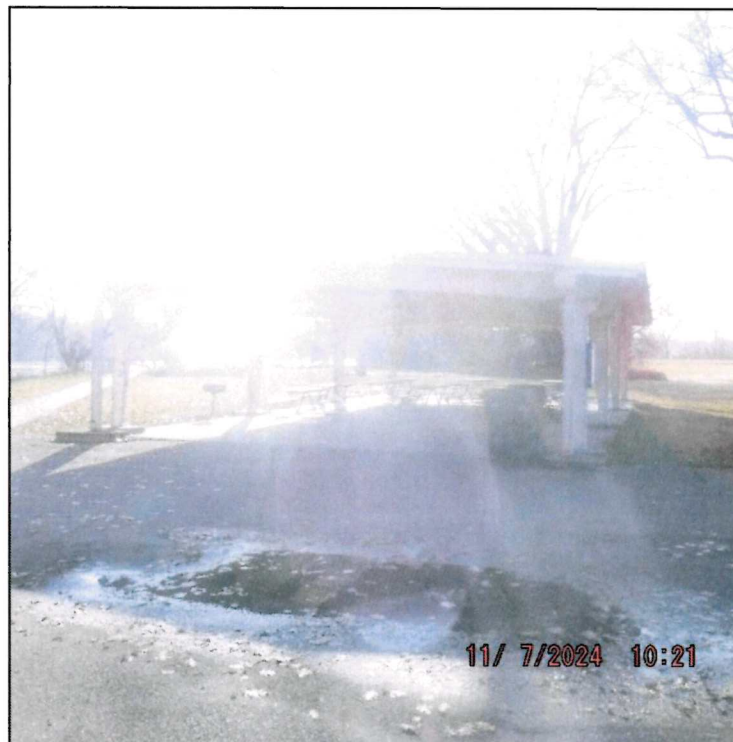
**Figure 1. Subject property.**

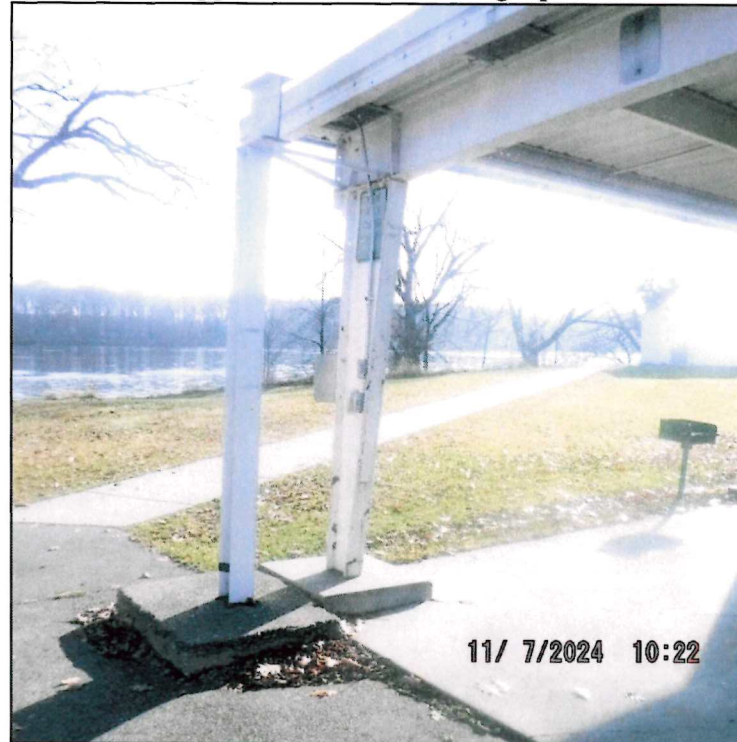
**A. Park shelter.** The park shelter in question is roughly 60 ft. by 30 ft. pre-engineered steel open-air structure located at Riverside Park in Nekoosa that runs north and south. The reason for the inspection is due to column piers for the shelter that appear to be rising out of the ground and the shelter leaning to the south. During the inspection these observations were determined to be true. A spinning laser level and rod were used to shoot the relative elevations of each pier foundation of the park shelter. In doing so it was determined that the top of the piers get consistently higher from the southernmost pier to the northernmost pier on the side closest to the river (to the east), and higher from the southernmost pier to northernmost pier (but not as consistently from pier to pier) on the side away from the river (west side). On the east side of the shelter the northernmost pier is roughly 6 in. higher than the southernmost pier, while on the west side of the shelter the northernmost pier is roughly 3 in. higher than the southernmost pier.

The way these foundations were constructed has caused the issue of frost heave on the piers. Since the top cap was poured wider than the pier foundations, this allows the soil under the lip of the top cap to push up on the underside of this lip and heave the foundations as the soil beneath freezes and thaws. The reason that some have raised more than others is likely due to differences in ground water in each of the locations as there are three things needed for frost heave: Water present in the soil, freezing temperatures in the soil at that location, something restricting the soil and water from expanding (the pier top cap).

**Figure 2. Typical raised pier foundations (Northernmost piers).**

If it is desired to address the issues being observed, there are no quick easy fixes. The only way to address the issue with the existing shelter would be to pick up and move the shelter, remove the existing foundations, pour in new foundations that are properly designed and constructed, and place the shelter back on the new foundations.

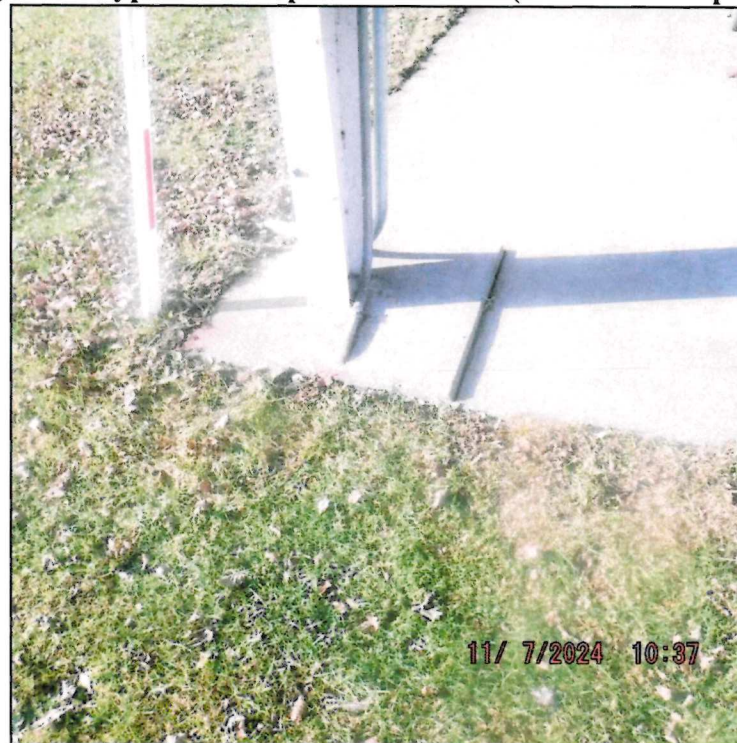
**Figure 3. Southernmost pier.**

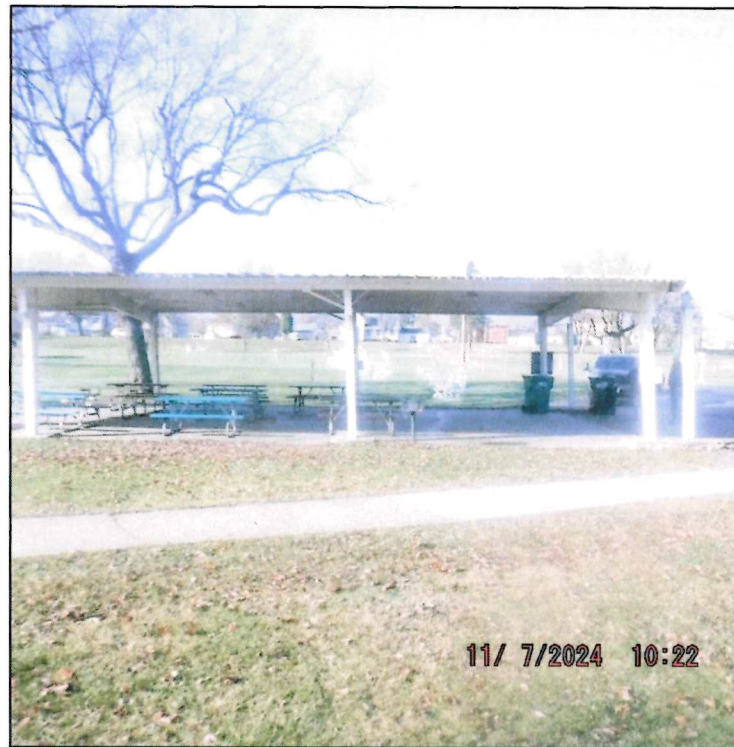
During the inspection a 4 ft. level was also used to determine how far out of plumb each column of the shelter is. The results are consistent at each column, being roughly 2 in. out of plumb leaning toward the south. This is what would be expected with the north piers being higher than the southern piers.

**Figure 4. Shelter visibly leaning to the south (left).**

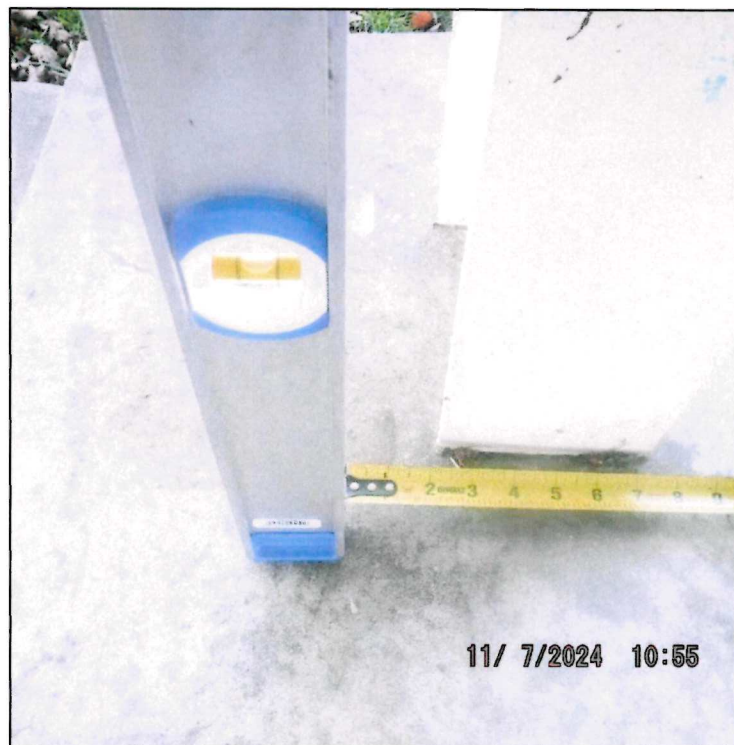
**Figure 4. Columns roughly 2 in. out of plumb.**

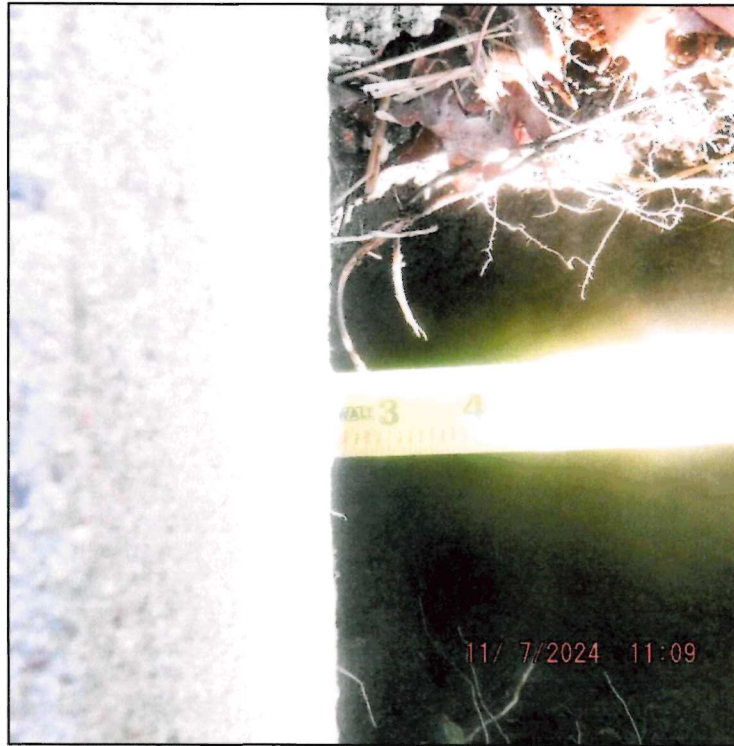
**Figure 5. Difference in width of pier and top cap.**

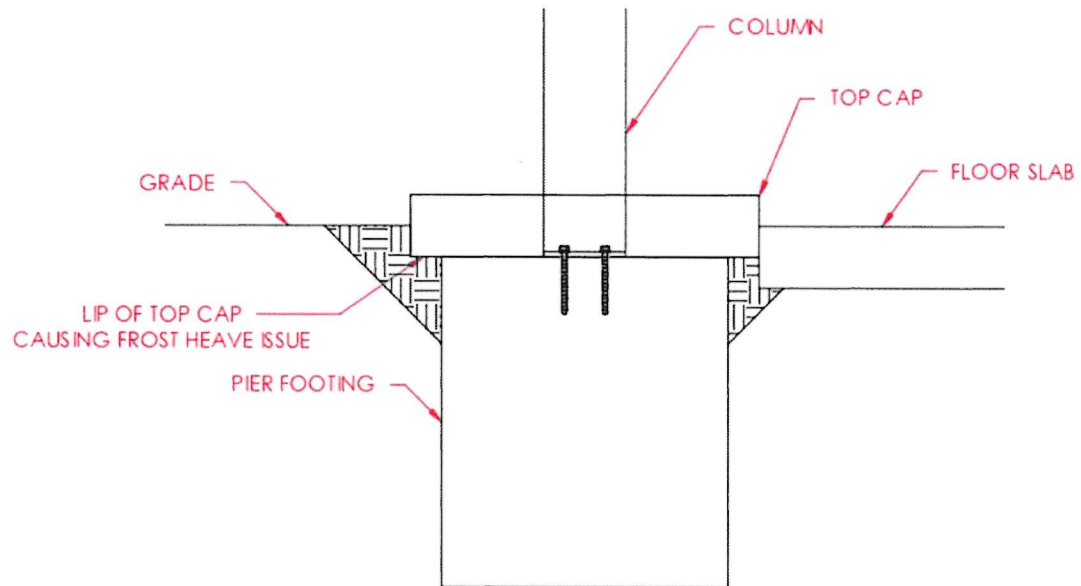
## Appendix B – Foundation Diagram

To investigate the reason for the piers lifting, soil was dug out adjacent to two separate piers to determine the depth of the piers, size of the piers, and to get a better understanding of how they were constructed. The results of this excavation determined that the pier foundations are 32 in. deep from grade. It was also determined that the pier foundations were not poured as wide as the top cap that was poured over the top of the pier. What this means is that the columns were originally placed on a square pier that appears to be roughly 28 in. wide by 28 in. long prior to the floor slab being poured. There was then a roughly 6 in. thick by 32 in. by 32 in. concrete cap poured over each of the pier footings and around the base of the columns to the piers to be the same elevation as the floor slab. (See diagram in Appendix B).
