**Town of Oregon**  
**Road and Traffic Safety Committee Agenda Thursday,**  
**January 8, 2026, 9:00 a.m.**  
**Oregon Town Hall, 1138 Union Road, Oregon, WI 53575**

**BELL BROOK RD over BR STORY CREEK**

**Sep 25, 2025**

## BELL BROOK RD over BR STORY CREEK

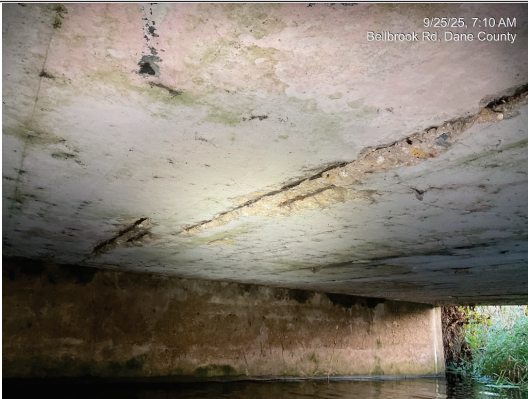
Routine Item 4

| Chk | Element | Defect | Description | UOM | Total | Quantity in Condition State | | | |
|---|---|---|---|---|---|---|---|---|---|
| | | 1080 | Spall at SW drain (2' x 2'), SE drain (1' x 1') - 5 SF CS3.<br>N. side has 6"x3' spall w/ exposed rusting rebar near N edge, W half - 3 CS3.<br>1'x4' spall w/ exposed rusting rebar near S edge, W half - 4 SF CS3.<br>1'x3' spall w/ exposed rusting rebar near S edge at midspan - 3 SF CS3.<br>1'x4' & 1' x 8' spalls w/ exposed rusting rebar <b>at CL</b> - 12 SF CS3.<br>5 scattered 1' x 1' spalls with exposed rebar - 5 SF CS3.<br>1' x 2' spall near N edge, E half with exposed rebar - 2 SF CS3.<br>Multiple delams throughout (est. 10% - 60 SF) | | | | | | |

Spalls with exposed rebar at centerline

| Item | Priority | Recommended by | Status | Status change |
|---|---|---|---|---|
| Comment:<br>Replace unsound patches with partial or full depth concrete surface repairs. | | Status Comment: | | |

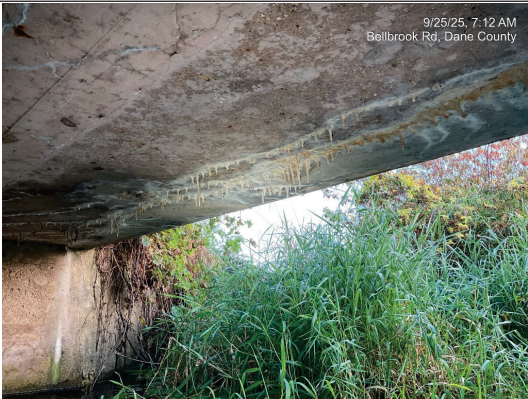
Routine Item 5

| Chk | Element | Defect | Description | UOM | Total | Quantity in Condition State | | | |
|---|---|---|---|---|---|---|---|---|---|
| | | 1130 | Cracking (RC)<br>N. side map cracking w/ delamination and heavy efflorescence and stalactites full length x 3-feet wide - 70 CS3.<br>Numerous mod. long. cr., delam., and spalls w/ eff. - 56 CS2.<br>Full width by 4' long at each end has light efflorescence.<br>About 50% of curb is cracked. | SF | | 0 | 325 | 70 | 0 |

Cracking with heavy effl. At north deck edge

| Item | Priority | Recommended by | Status | Status change |
|---|---|---|---|---|
| Comment:<br>Seal deck cracks. | | Status Comment: | | |

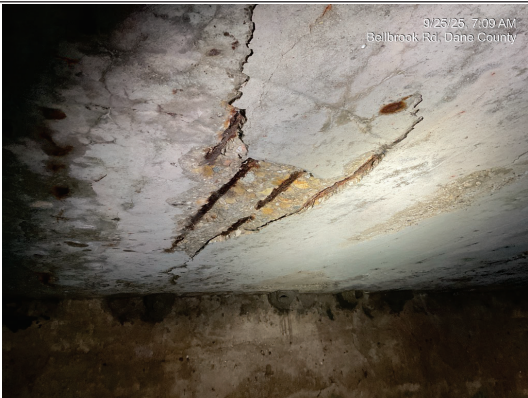
Routine Item 6

Spalls at south deck underside near west abutment

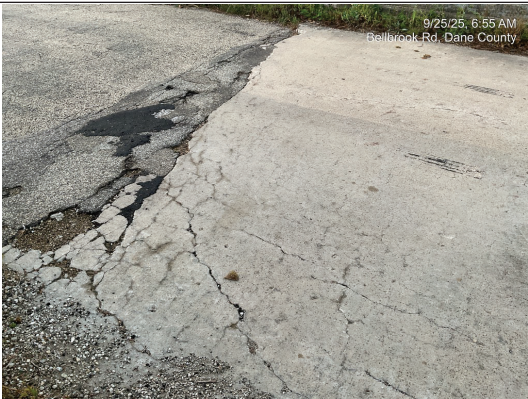
Routine Item 7

| Chk | Element | Defect | Description | UOM | Total | Quantity in Condition State | | | |
|---|---|---|---|---|---|---|---|---|---|
| | | 3210 | Debonding/Spall/Patched Area/Pothole<br>East: Unsound AC patches at the east deck end - <b>2.5' avg x 20' wide = 50 SF CS3</b> ; 12"x18" and 10"x12" potholes - 3 SF CS4<br>West: Unsound AC patches at the west deck end - 20 SF CS3.<br>W. and E. ends cracked/spalled and patched with asphalt, failing.<br>N. half of WBL is delaminated - 100 SF CS2. | SF | | 0 | 80 | 70 | 3 |

Failed deck patching and cracks at east deck end

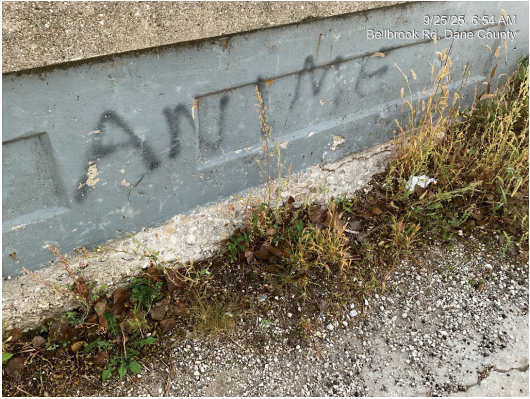
Routine Item 8

| Spalling along north girders/rail | <p>9/25/25, 6:54 AM<br/>Bellbrook Rd, Dane County</p> <p>p13-209_25_Rd5.jpg</p> |

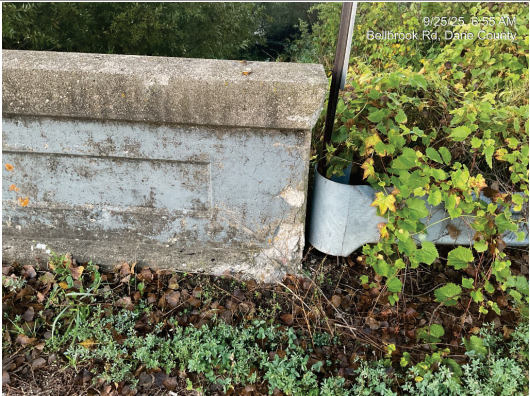
Routine Item 9

| Chk | Element | Defect | Description | UOM | Total | Quantity in Condition State | | | |
|---|---|---|---|---|---|---|---|---|---|
| | | 1080 | Delamination - Spall - Patched Area<br>South girder: spalled 15" high x 2" to 4" deep x full length- 19 LF CS3; 3' exposed rusting rebar <b>with approx 30% SL</b> at 1/4 points - 3 LF CS4. (Spalls on inside and outside faces)<br>North girder: spalls along inside curb face, up to 6" deep - CS3 (overlaps cracking) | LF | | 0 | 0 | 19 | 3 |

| Spall at south girder, west end | <p>9/25/25, 6:55 AM<br/>Bellbrook Rd, Dane County</p> <p>p13-209_25_Rd6.jpg</p> |

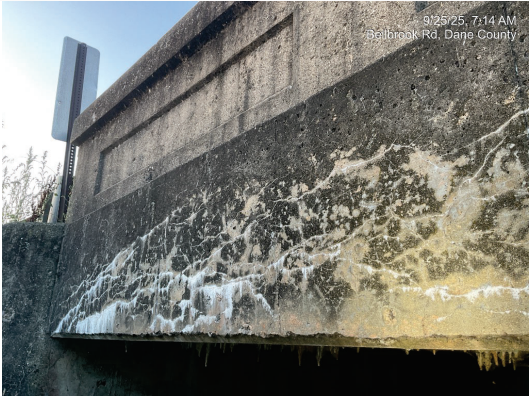
Routine Item 10

| Chk | Element | Defect | Description | UOM | Total | Quantity in Condition State | | | |
|---|---|---|---|---|---|---|---|---|---|
| X | 215 | 1130 | Cracking (RC)<br>N. girder has full length horiz. 1/8" wide crack, 2' up from bottom along edge. North girder: vertical cracks every 2'+/-. Cracking at N. deck edge throughout with stalactites - 22CS3. | LF | | 0 | 0 | 22 | 0 |

| Map cracking with effl. at north deck fascia/girder | <p>9/25/25, 7:14 AM<br/>Bellbrook Rd, Dane County</p> <p>p13-209_25_Rd11.jpg</p> |

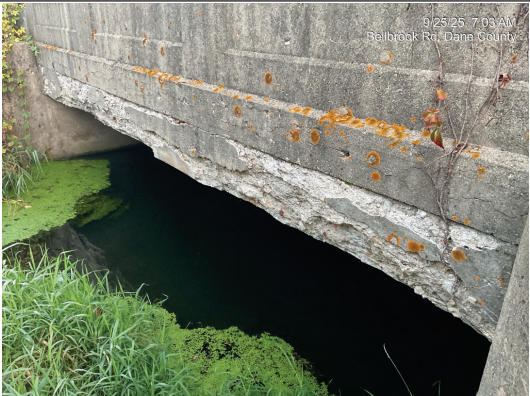
Routine Item 11

| South girder/deck spalling | <p>9/25/25, 7:03 AM<br/>Bellbrook Rd, Dane County</p> <p>p13-209_25_Rd13.jpg</p> |

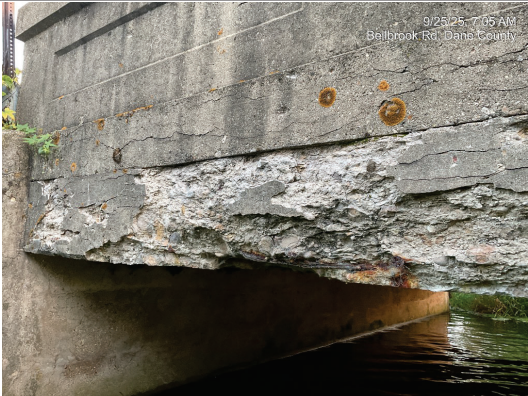
**Routine Item 12**

SW deck and girder spalls with exposed rebar

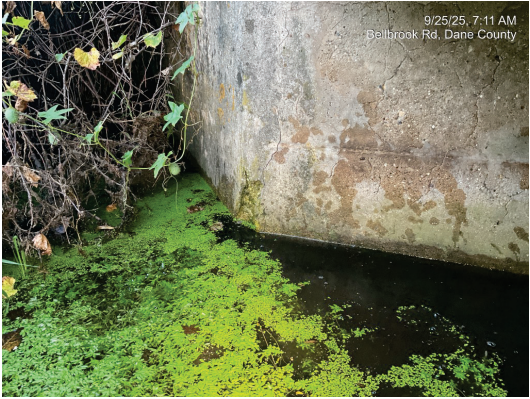
Routine Item 15

| Chk | Element | Defect | Description | UOM | Total | Quantity in Condition State | | | |
|---|---|---|---|---|---|---|---|---|---|
| | | 1080 | Delamination - Spall - Patched Area<br>W Abut: Spall at SW corner w/exposed rusting rebar <b>below waterline</b> - 4 CS3 (not found 2024 due to high water).<br>W Abut: Spall at NW corner <b>below waterline</b> - 3CS3 (not found 2024 due to high water).<br>E. Abut: 6" dia. spall at NE corner - 1 CS3. | LF | | 0 | 0 | 8 | 0 |

| Spall at SW abutment corner | <p>9/25/25, 7:11 AM<br/>Bellbrook Rd, Dane County</p> <p>p13-209_25_Rd9.jpg</p> |

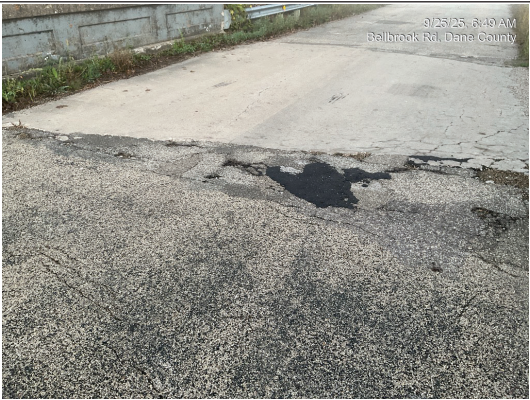
Routine Item 16

| Chk | Element | Defect | Description | UOM | Total | Quantity in Condition State | | | |
|---|---|---|---|---|---|---|---|---|---|
| | | | Both approaches: map cracking and waviness.<br>Dips in WBL at E. <b>approach</b> and <b>full-width</b> at W. approach. | | | | | | |

| West approach deterioration | <p>9/25/25, 8:49 AM<br/>Bellbrook Rd, Dane County</p> <p>p13-209_25_Rd3.jpg</p> |

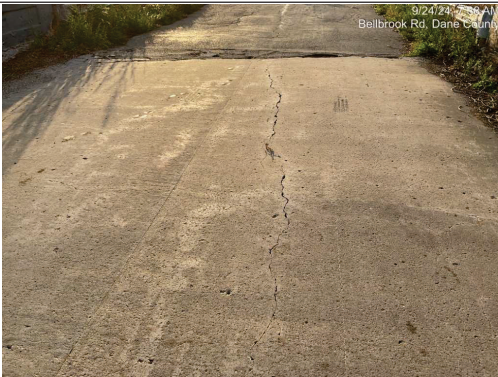
**Routine Item 5**

| Chk | Element | Defect | Description | UOM | Total | Quantity in Condition State | | | |
|---|---|---|---|---|---|---|---|---|---|
| | | 3220 | Crack (Wearing Surface)<br>Widespread <b>moderate</b> map cracking - 411 CS2<br>1/8" wide, full-length cracks 2' south and 8' north of CL - <b>56 CS3</b> . | SF | | 0 | <b>386</b> | 56 | 0 |

| CS3 longitudinal cracks in wearing surface | <p>9/24/24, 6:59 AM<br/>Bellbrook Rd, Dane County</p> <p>p13-209_24_Rd19.jpg</p> |

| Item | Priority | Recommended by | Status | Status change |
|---|---|---|---|---|
| Comment:<br>Seal deck cracks. | | Status Comment: | | |

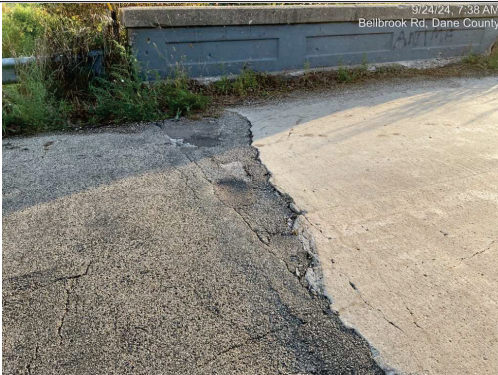
**Routine Item 6**

| Chk | Element | Defect | Description | UOM | Total | Quantity in Condition State | | | |
|---|---|---|---|---|---|---|---|---|---|
| | | | <b>East:</b> Unsound AC patches at the east deck end - <b>30 SF CS3</b> ; 12"x18" and 10"x12" potholes - 3 SF CS4<br><b>West: Unsound AC patches at the west deck end - 20 SF CS3</b> .<br>W. and E. ends cracked/spalled and patched with asphalt, failing.<br>N. half of WBL is delaminated - 100 SF CS2. | | | | | | |

| West approach condition, west deck edge spalls and HMA patches | <p>9/24/24, 7:38 AM<br/>Bellbrook Rd, Dane County</p> <p>p13-209_24_Rd18.jpg</p> |

| Item | Priority | Recommended by | Status | Status change |
|---|---|---|---|---|
| Comment:<br>Replace unsound patches with partial or full depth concrete surface repairs. | | Status Comment: | | |

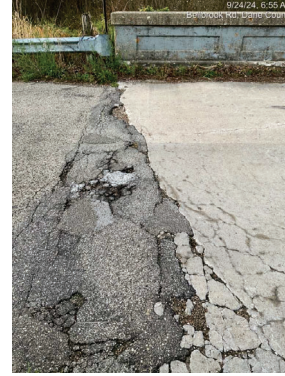
**Routine Item 7**

East approach, typical condition. HMA patching at end of deck.

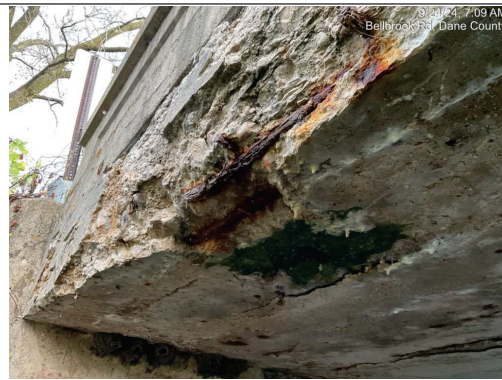
**Routine Item 8**

| Chk | Element | Defect | Description | UOM | Total | Quantity in Condition State | | | |
|---|---|---|---|---|---|---|---|---|---|
| | | 1080 | Delamination - Spall - Patched Area<br>South girder: spalled 15" high x 2" to 4" deep x full length- 19 LF CS3; 3' exposed rusting rebar at 1/4 points - <b>3 LF CS4. (Spalls on inside and outside faces)</b><br><b>North girder: spalls along inside curb face, up to 6" deep - CS3 (overlaps cracking)</b> | LF | | 0 | 0 | 19 | 3 |

South girder, exterior facia, large spalls with exposed rebar

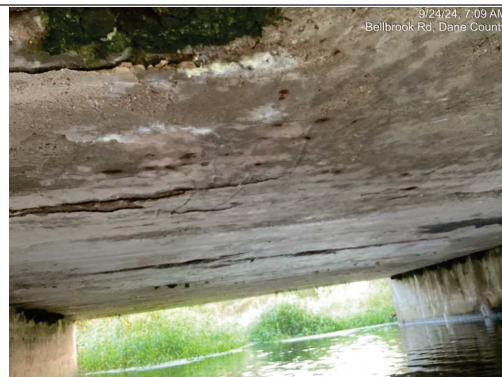
**Routine Item 9**

| Chk | Element | Defect | Description | UOM | Total | Quantity in Condition State | | | |
|---|---|---|---|---|---|---|---|---|---|
| | | 1080 | Spall at <b>SW drain (2' x 2')</b> , <b>SE drain (1' x 1')</b> - <b>5 SF CS3</b> .<br>N. side has 6"x3' spall w/ exposed rusting rebar <b>near N edge, W half</b> - 3 CS3.<br>1'x4' spall w/ exposed rusting rebar <b>near S edge, W half</b> - 4 SF CS3.<br>1'x3' spall w/ exposed rusting rebar <b>near S edge at midspan</b> - 3 SF CS3.<br>1'x4' & 1' x 8' spalls w/ exposed rusting rebar - <b>12 SF CS3</b> .<br><b>5 scattered 1' x 1' spalls with exposed rebar - 5 SF CS3</b> .<br>1' x 2' spall <b>near N edge, E half with exposed rebar</b> - 2 SF CS3.<br><b>Multiple delams throughout (est. 10% - 60 SF)</b> | | | | | | |

Typical underside view with large spalls

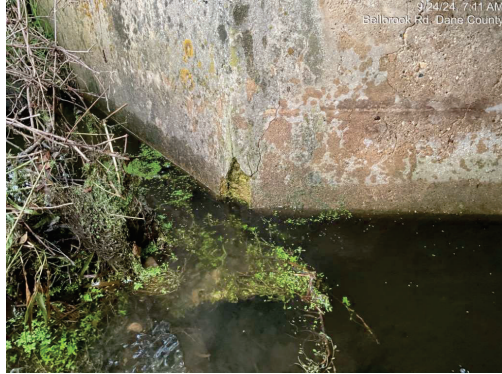
**Routine Item 10**

| Chk | Element | Defect | Description | UOM | Total | Quantity in Condition State | | | |
|---|---|---|---|---|---|---|---|---|---|
| | | 1080 | Delamination - Spall - Patched Area<br>W Abut: Spall at SW corner w/exposed rusting rebar - 4 CS3 ( <b>not found 2024 due to high water</b> ).<br>W Abut: Spall at NW corner - 3CS3 ( <b>not found 2024 due to high water</b> ).<br>E. Abut: 6" dia. spall at NE corner - 1 CS3. | LF | | 0 | 0 | 8 | 0 |

| SW abutment/wing corner spall | <p>9/24/24, 7:11 AM<br/>Ballbrook Rd., Dane County</p> <p>p13-209_24_Rd11.jpg</p> |

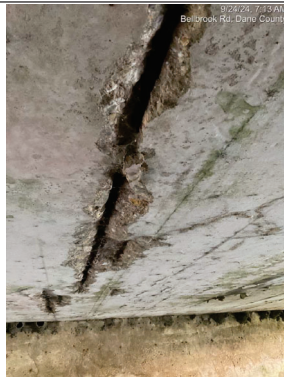
**Routine Item 11**

| Near centerline at mid span with exposed rebar | <p>9/26/24, 7:13 AM<br/>Ballbrook Rd., Dane County</p> <p>p13-209_24_Rd12.jpg</p> |

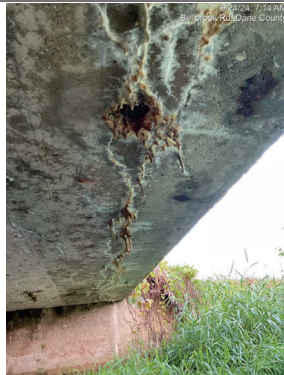
**Routine Item 12**

| Chk | Element | Defect | Description | UOM | Total | Quantity in Condition State | | | |
|---|---|---|---|---|---|---|---|---|---|
| | | 1130 | Cracking (RC)<br>N. side map cracking w/ delamination and heavy efflorescence and stalactites full length x 3-feet wide - 70 CS3.<br>Numerous <b>mod.</b> long. cr., delam., and spalls w/ eff. - 56 CS2.<br>Full width by 4' long at each end has light efflorescence.<br>About 50% of curb is cracked. | SF | | 0 | <b>325</b> | 70 | 0 |

| Cracking and leaching at North deck edge | <p>9/26/24, 7:14 AM<br/>Ballbrook Rd., Dane County</p> <p>p13-209_24_Rd13.jpg</p> |

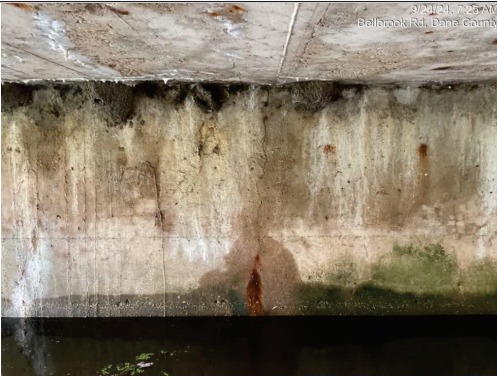
**Routine Item 15**

| Chk | Element | Defect | Description | UOM | Total | Quantity in Condition State | | | |
|---|---|---|---|---|---|---|---|---|---|
| | | 1130 | Cracking (RC)<br>W Abut: Widespread <b>mod. &amp; wide</b> vert & map cracking w/ some eff. - 19 CS2<br>E Abut: Widespread <b>mod. &amp; wide</b> vert & map cracking w/ eff. - 24 CS2 + some rust stain -1 <b>CS3</b> | LF | | 0 | 43 | 1 | 0 |

| East abutment CS3 vertical crack | <p>p13-209_24_Rd16.jpg</p> |

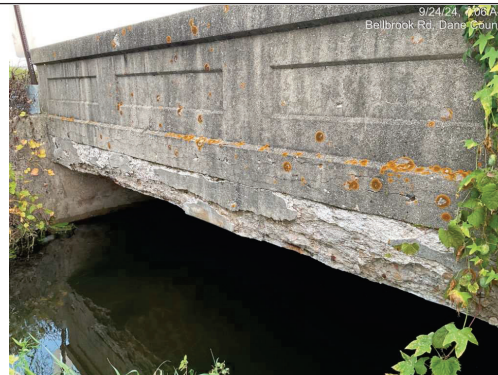
**Routine Item 18**

South girder, exterior facia, large spalls with exposed rebar
