INDOOR AIR QUALITY ASSESSMENT

**Peru Town Hall
3 East Main Road
Peru, Massachusetts**

Prepared by:
Massachusetts Department of Public Health
Bureau of Climate and Environmental Health
Indoor Air Quality Program
October 2024

Building:	Peru Town Hall (PTH)
Address:	3 East Main Road, Peru, MA
Reason for Request:	Mold odor in kitchen/meeting hall
Date of Assessment:	July 30, 2024
Massachusetts Department of Public Health/Bureau of Climate and Environmental Health (MDPH/BCEH) Staff Conducting Assessment:	Michael Feeney, Director, and Stefanie Santora, Environmental Analyst, Indoor Air Quality (IAQ) Program
Building Description:	The PTH was constructed as a school that had a one-story over a dirt floor cellar. An addition was made to the building that included a two-story wing with a kitchen/cafeteria at ground level.
Building Population:	Approximately ~10 employees
Year of Construction:	1950s
Windows:	Openable

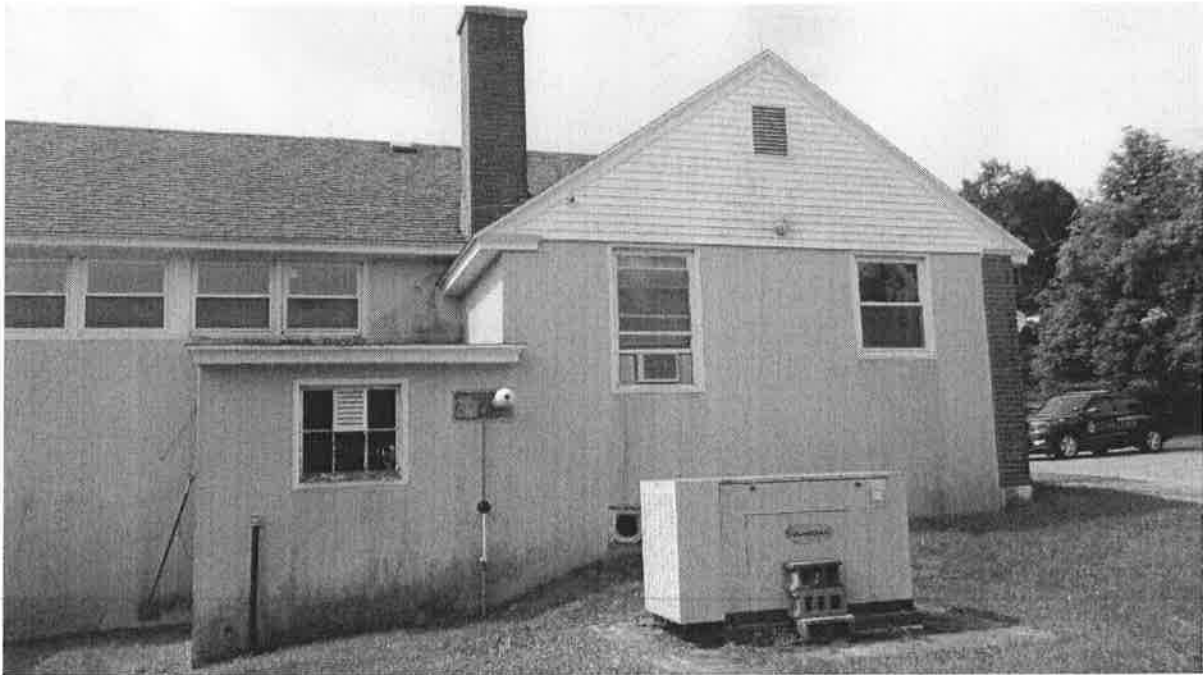
Picture 1

North AHU shed, note gable attic vent above furnace exhaust

1. Install carbon monoxide detectors in the main office as well as both floors of the PTH.
2. Examine the feasibility of separating the AHU flue and combustion air vents. It is recommended that the furnace exhaust flue terminate at a level above the roof peak to prevent combustion air from entering the roof via soffit vents.

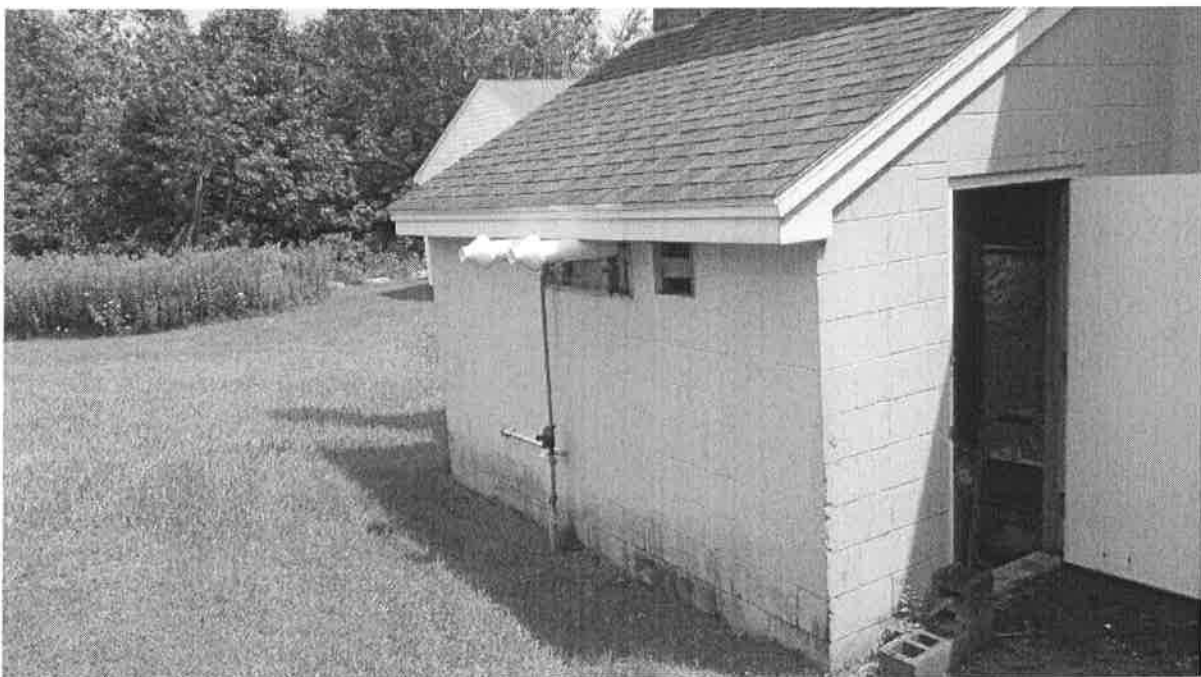
Picture 2

shed (Picture 11), which in time can damage roof shingles and result in water penetration. Water runoff from the fire escape corner of the PTH travels downhill to impact the exterior walls of the east furnace shed (Picture 2). This condition causes the eastern furnace shed to become moistened (Picture 12) with possible standing water after rainstorms.

South AHU shed that contains two furnaces/AHUs

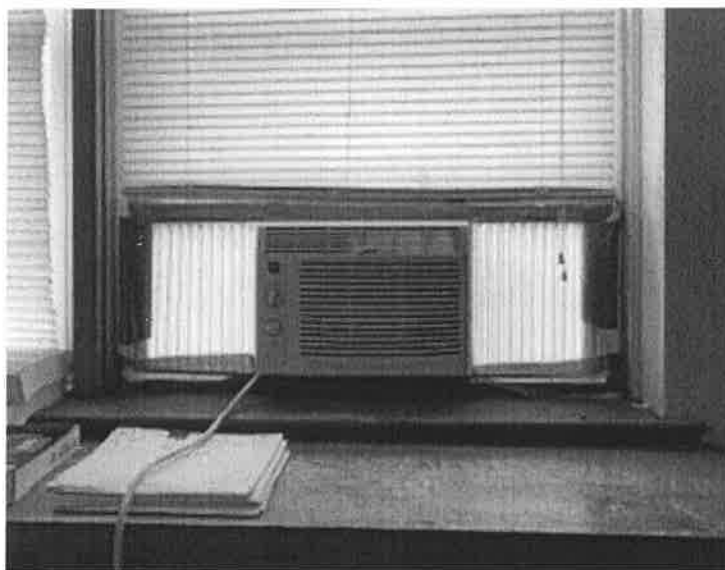
Picture 5

Window-style air conditioners were mounted in the windows of several office spaces (Picture 5). These units can supply some amount of fresh air while operating. They are equipped with filters that need to be cleaned periodically. When these air conditioners are operating, windows should be closed in addition to closing interior doors to individual office spaces.

Window-mounted air conditioner

4. Install weatherstripping around exterior doors to seal doors from water infiltration, unconditioned air, and pests.
5. Seal around window-mounted air conditioners to prevent water infiltration.

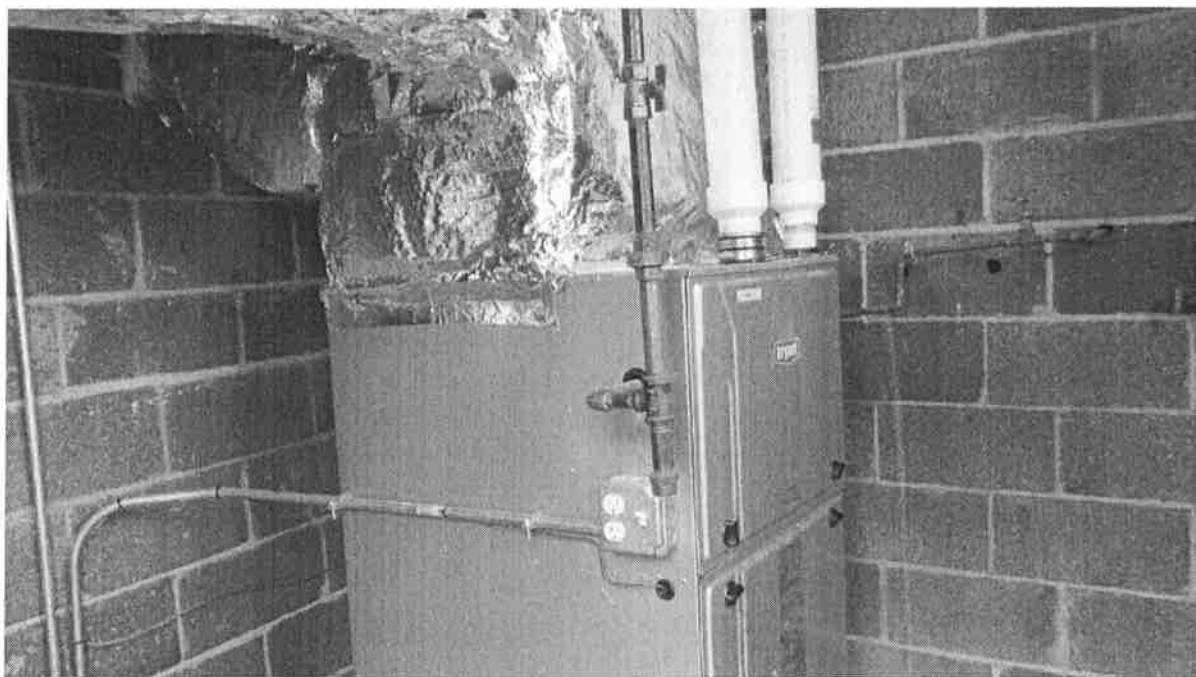
Picture 6

PVC pipes that are combustion air and combustion exhaust vent

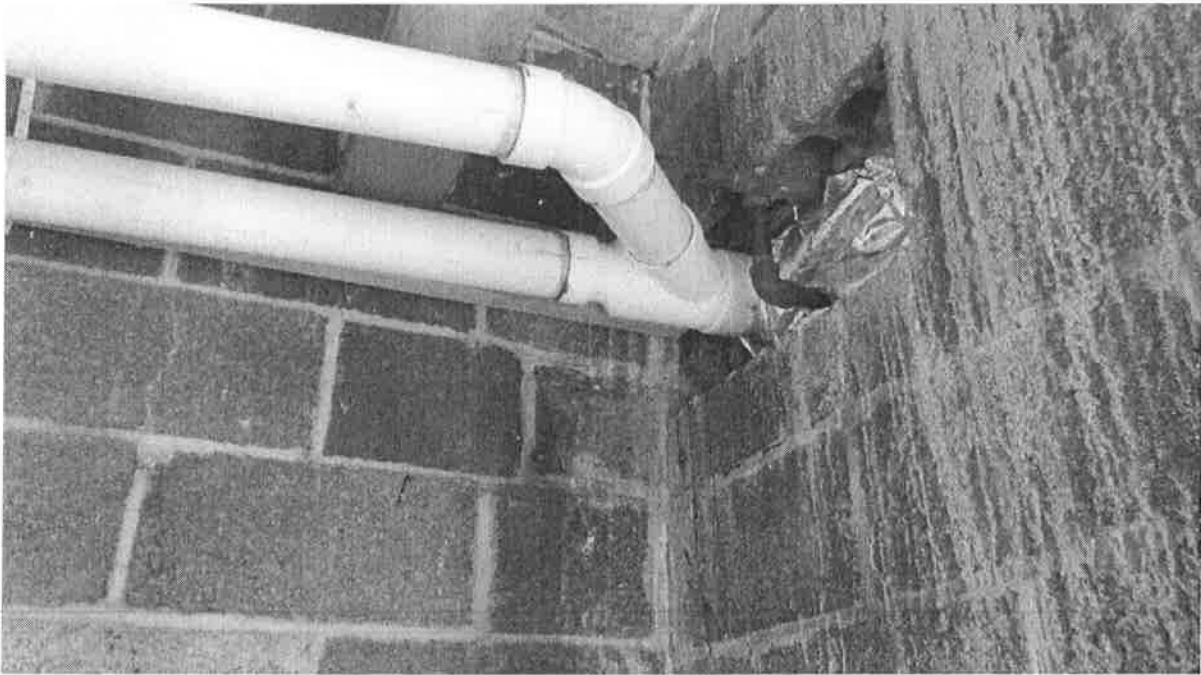
Picture 7

Joined PVC pipes that are combustion air and combustion exhaust vent

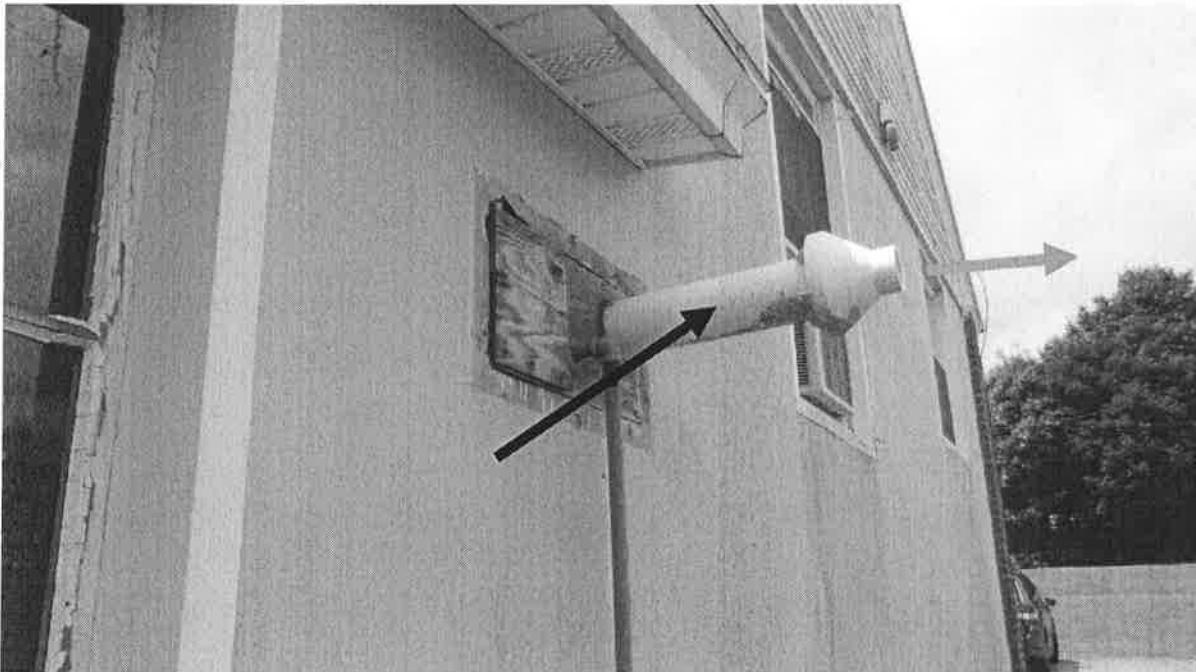
Picture 8

Combination flue terminus with combustion air intake. Black arrow indicates likely combustion air intake, blue arrow indicates likely furnace exhaust flue.

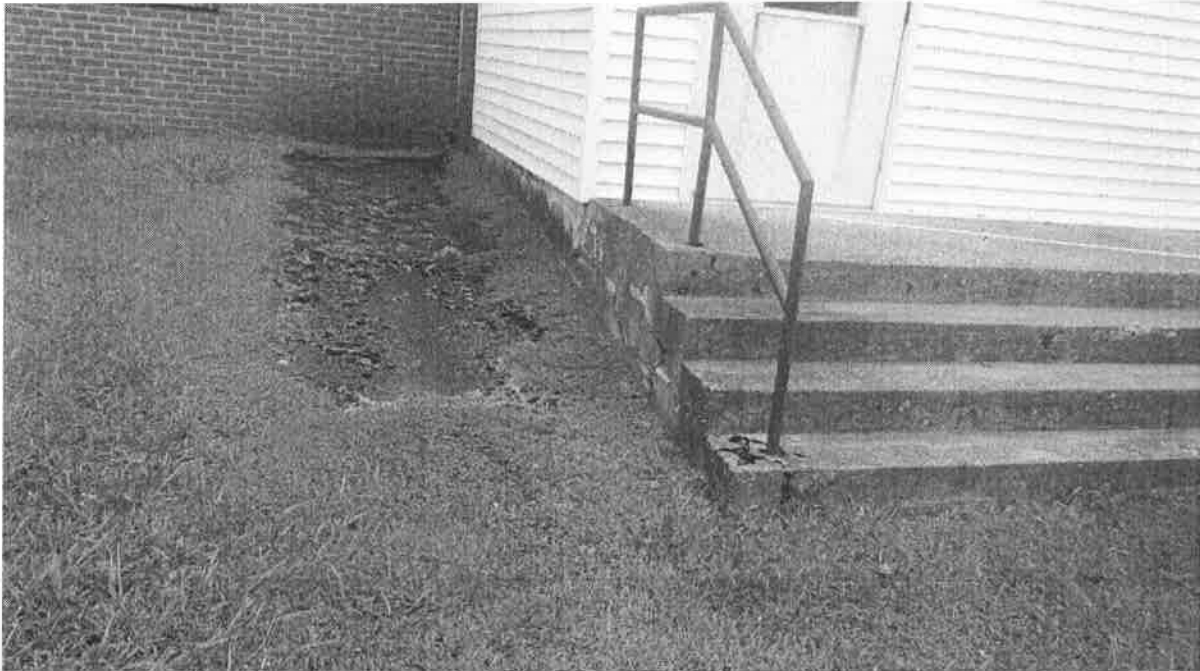
Picture 9

There is significant water accumulation around the exterior of the building which leads to water infiltration of the PTH. Due to the lack of gutters and downspouts on roof edges to capture water, water sheds off the roof edge to impact the base of the exterior walls. Signs of chronic moisture can be seen from the dark staining, accumulation of moss, and erosion to the brick and mortar on the front of the PTH (Picture 9) and the dark staining and accumulation of moss in the rear of the building under the fire escape (Picture 10). The lack of gutters and downspouts along the roof edge of the PTH causes water to penetrate into the sheds that contain the furnaces/AHUs (Pictures 1 and 2). Water from the main roof empties directly onto the roof of the west furnace

Water accumulation on exterior of front of PTH indicated by dark staining, moss growth, and erosion to brick and mortar

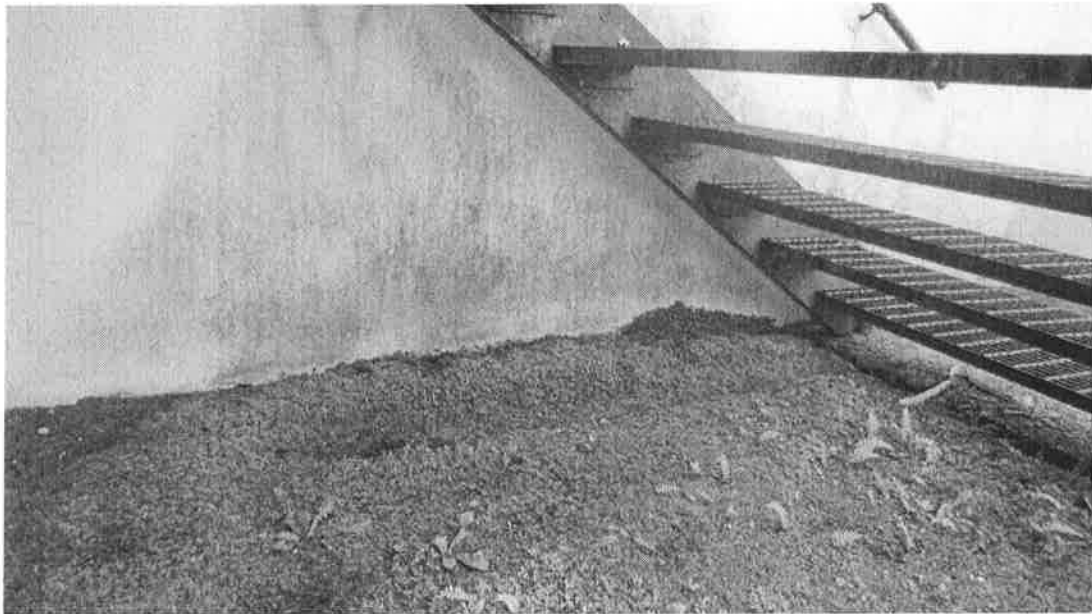
Picture 10

Water accumulation on exterior of rear of PTH indicated by dark staining and moss growth.

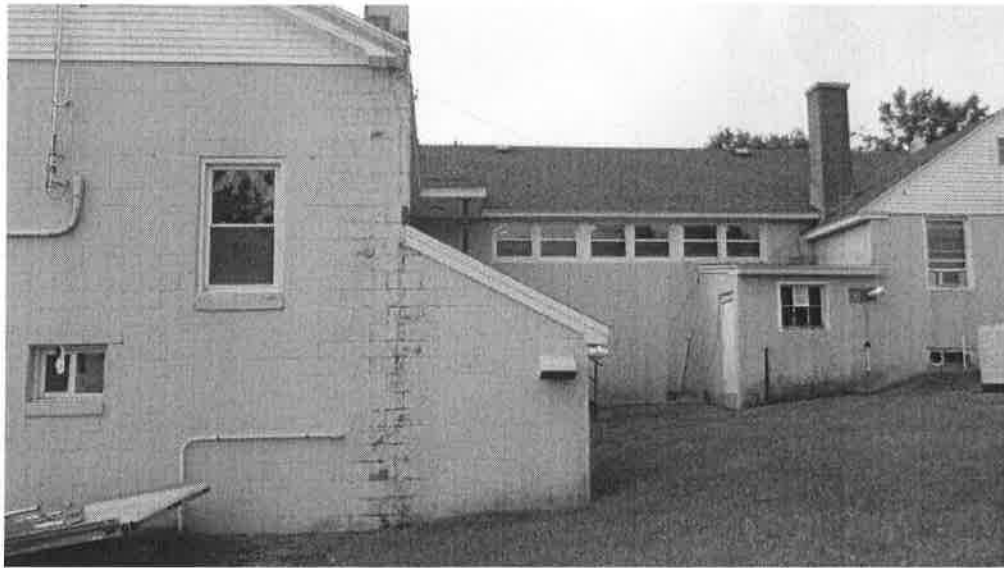
Picture 11

Water from the main roof empties directly onto the roof of both east and west furnace sheds. Note dark stains at the base of both furnace sheds, indicating chronic water exposure and possible water penetration

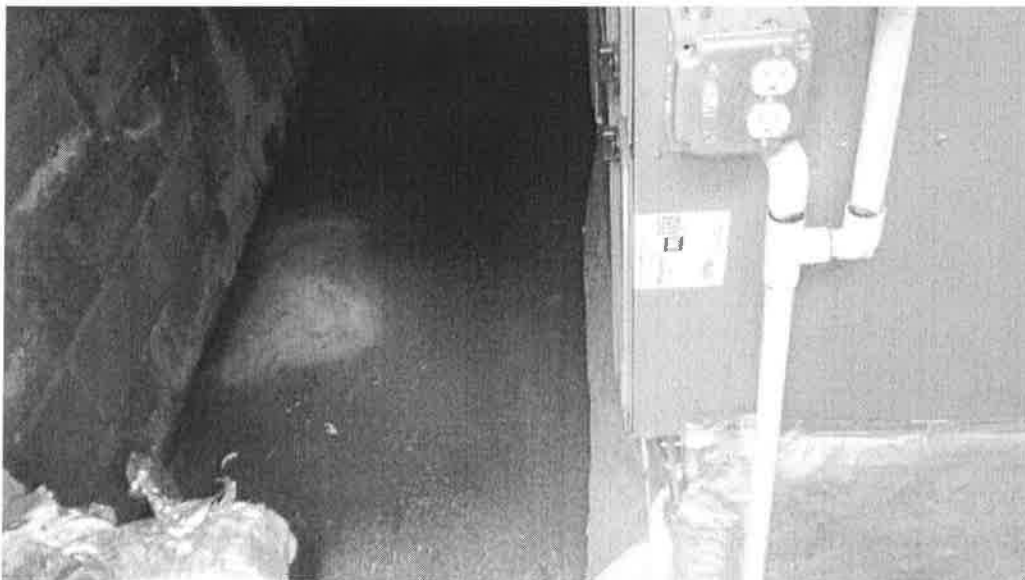
Picture 12

Moistened cement floor of east furnace shed

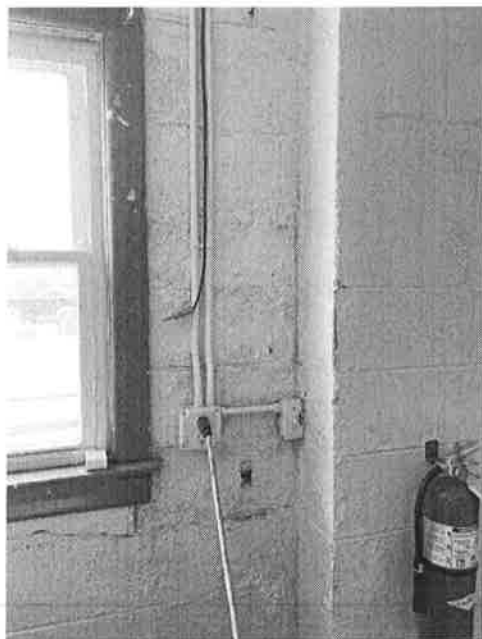
Picture 13

Efflorescence on interior wall of community room

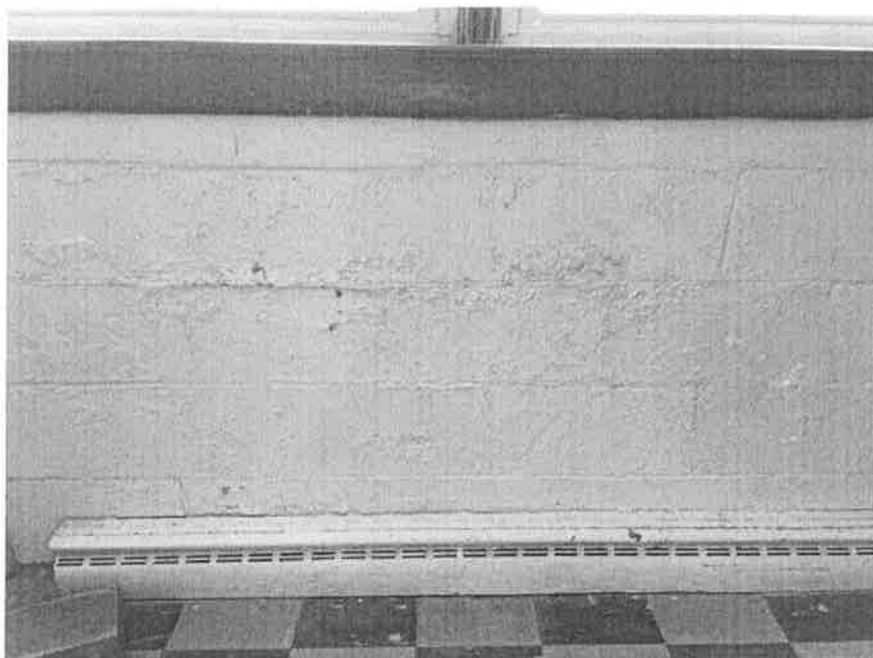
Picture 14

Efflorescence on interior wall of community room

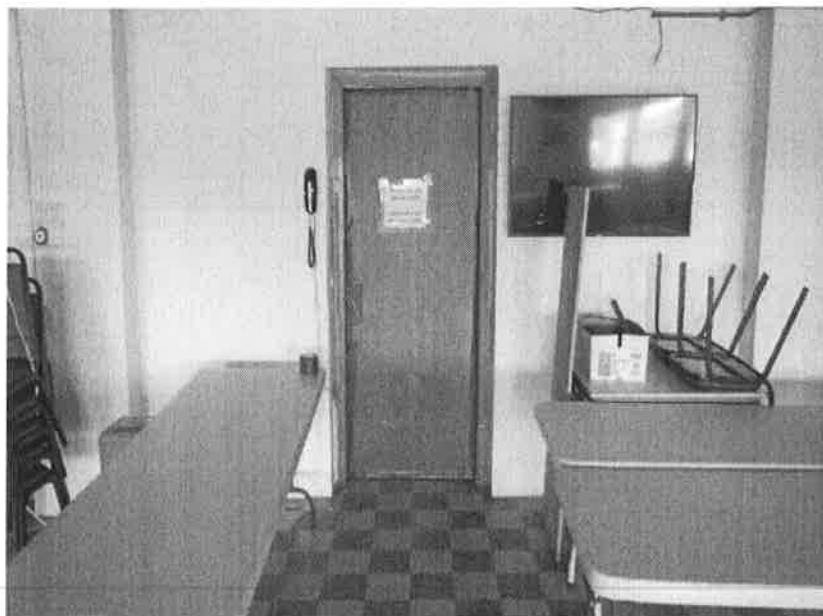
Picture 1

Cellar access door in meeting hall

2. In order to permanently seam the cellar from the meeting hall, installing an outdoor entrance door/frame outfitted with weatherstripping and solid door sweep is recommended.

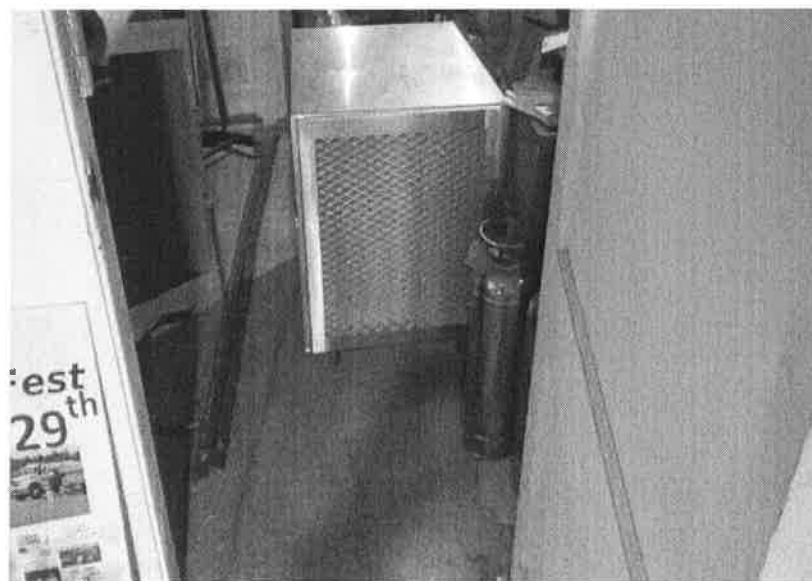
Picture 2

Dehumidification unit in cellar

4. Continue to operate the dehumidifier. If possible, relocate this equipment as close to the cellar window to maximize the draw of the dehumidifier to eject air directly outdoors.

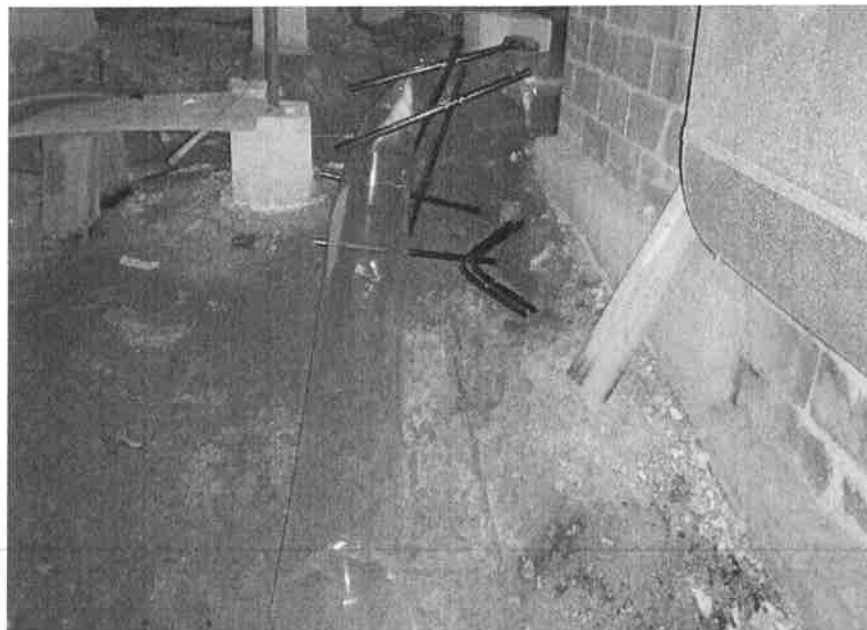
Picture 3

Plastic tube used to vent exhaust air from dehumidifier

7. Consider replacing plastic tubes used for dehumidifier exhaust air with a more durable material.
8. For more information on mold consult with the US EPA's "Mold Remediation in Schools and Commercial Buildings". Available at: <http://www.epa.gov/mold/mold-remediation-schools-and-commercial-buildings-guide> (US EPA, 2008).

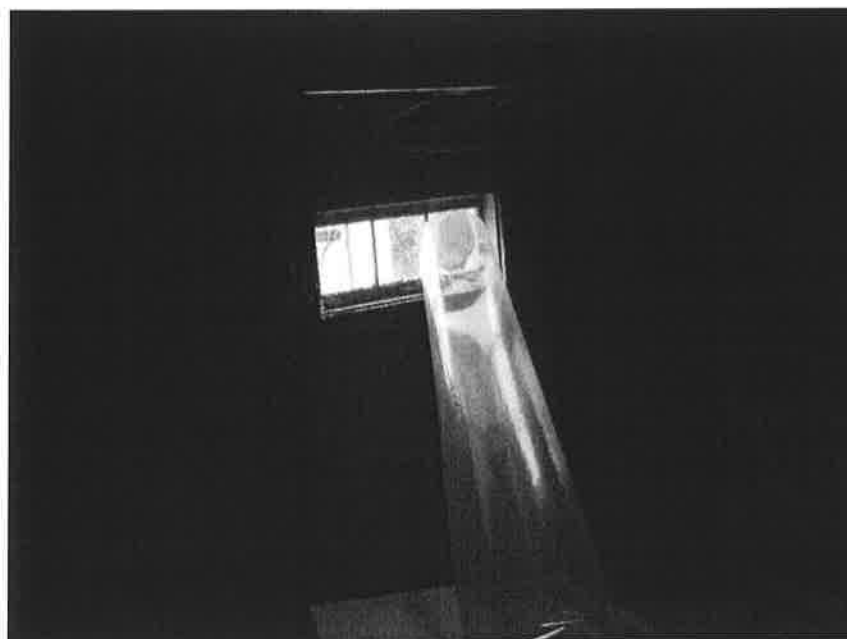
Picture 4

Plastic tube used to vent exhaust air from dehumidifier connected to cellar window

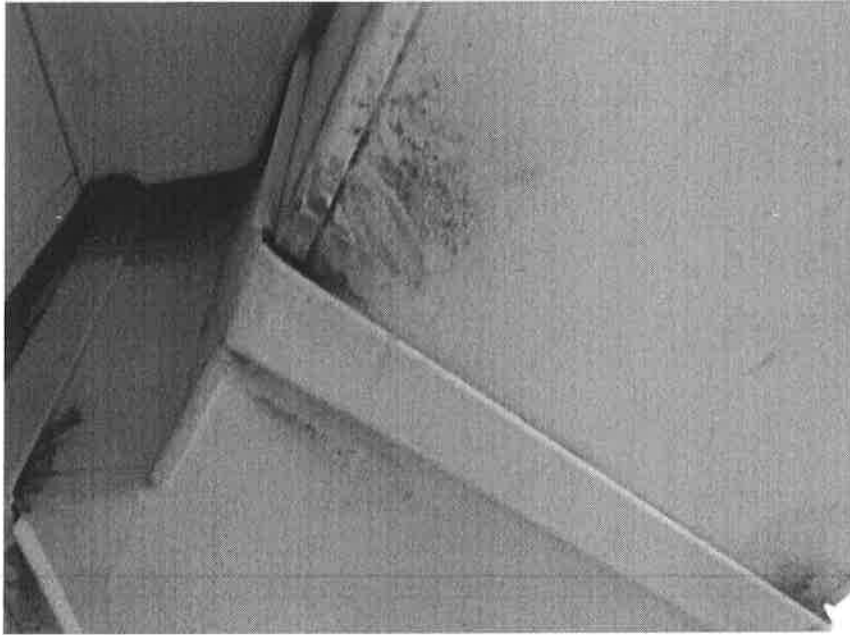
Picture 7

Seam with debris, indicating an opening in meeting hall
