EXISTING CONDITIONS AND CONCEPT STUDY FOR THE VILLAGE OF
PALMYRA PUBLIC SAFETY DEPARTMENT

PALMYRA, WI

MARCH 2026

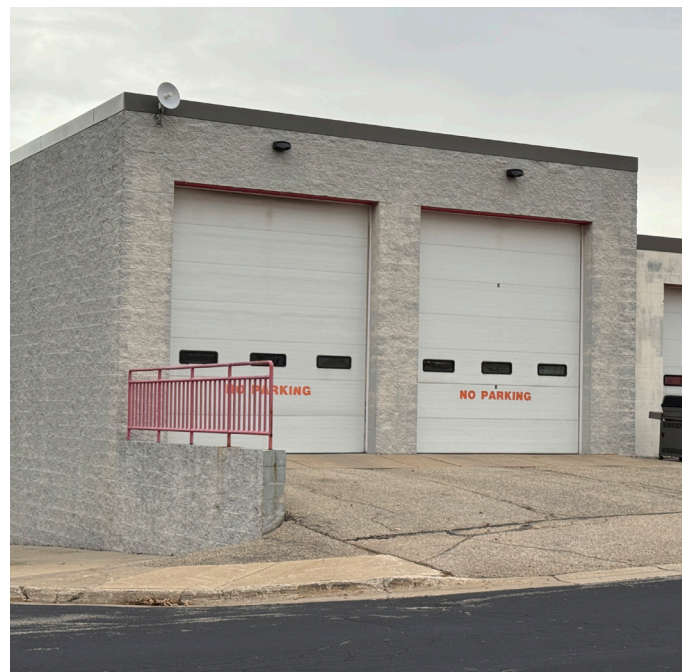
The response apron has additional challenges as well. It is too shallow and too steep with a slope of almost 10% at the steepest point. Many of the apparatus cannot be parked on the apron without sticking out into the street. When exiting the building, due to uneven pavement and awkward turns, vehicles have to move very slowly to prevent vehicle or building damage which can impact response times. Also, because the bays are back-in, the apparatus block traffic when

RETAINING WALL AND STEEP SLOPE AT APPARATUS BAY APRON

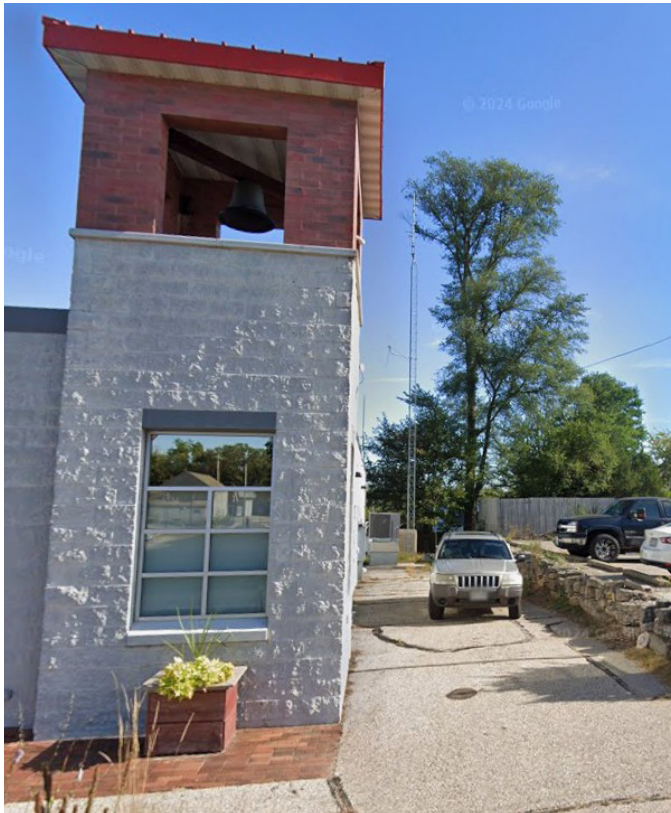
NARROW DRIVE / PARKING ON SOUTHEAST SIDE

they are maneuvering to back into the bays. This is major safety concern and should be avoided.

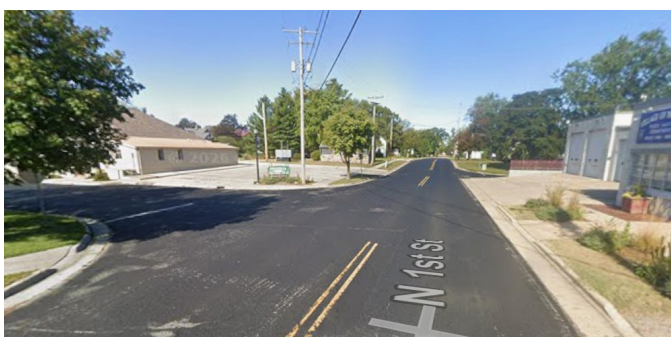
LOOKING NORTHWEST ON N 1ST ST. - NO SIGNS, OR MARKINGS WARNING OF RESPONSE TRAFFIC

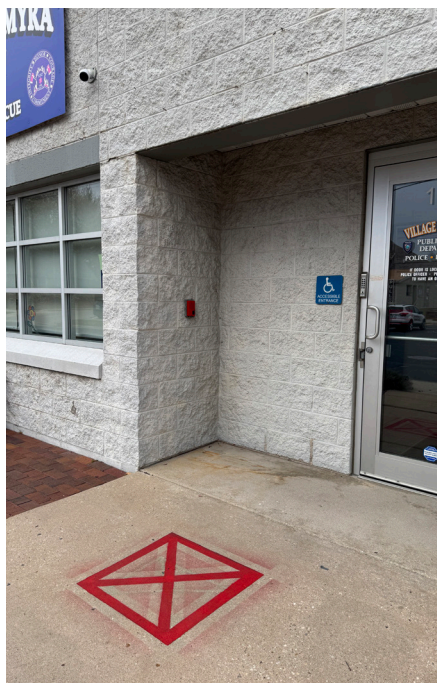
MAIN ENTRY SECURITY

The main, public entry to the building is accessible off of N 1st St.. On the sidewalk in front of the building is a red X where visitors must stand to be allowed entry into the building due to the location of the security camera. This process is awkward and requires visitors to first step up close to the building and use the voice intercom to explain to department staff the purpose of their visit. Because there are no windows that look out onto the entry door area, visitors then need to step back onto the red X to be seen by a security camera before being allowed to enter the secured vestibule.

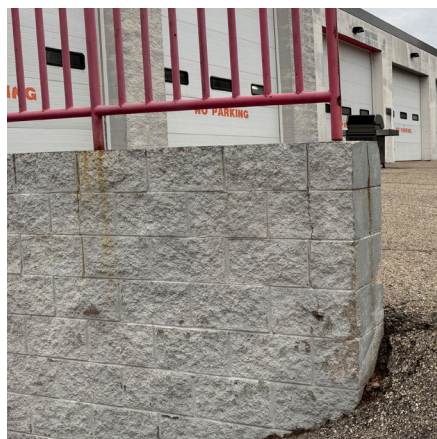
RETAINING WALL CRACKING

The retaining wall on the west side of the property along the response apron shows signs of water infiltration. There is deterioration at the connections between the guardrail and the wall allowing water to infiltrate and crack the retaining wall due to freeze/thaw cycles. To prevent further structural damage and potential wall failure, the railing should be replaced, and the top of the wall should be crowned to force water to drain off. Cracks should be properly repaired and sealed.

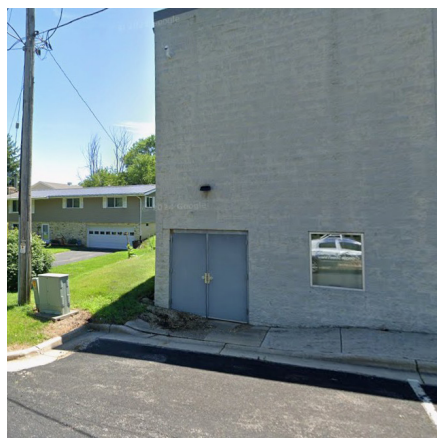
SITE EROSION AT BASEMENT DOORS

As the site slopes downhill to the north along the northwest side of the building, it begins to slope back up slightly just beyond a set of double doors that leads into the basement of the building at the northwest corner. This creates a drainage issue and there is evidence of water infiltration at the building under the doors and dirt and debris washed down from the adjacent landscape area seen in front of the doors. Ideally the grade at the doors would be flat at the building and slope away towards the street to direct water north down Mill Rd. where it can be collected in the storm sewer.

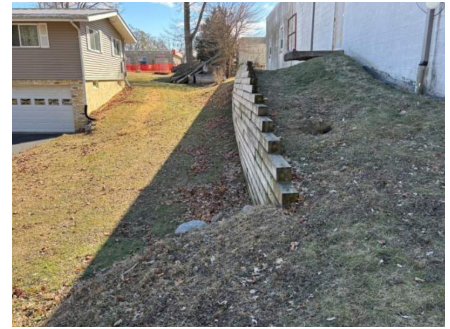
separating the site from the adjacent residence. The grade adjacent to the wall is severely deteriorated which has undermined a concrete stoop that is outside an emergency exit door. This is not code compliant and is an extremely dangerous condition. This side of the building should be completely re-graded, the retaining wall should be replaced and a new code-compliant, structurally sound exit stoop constructed. Underground drainage should be re-designed to ensure it is adequate and installed properly to direct water away from the foundation.

WOOD RETAINING WALL AND ADJACENT SITE EROSION

This side of the building should be completely re-graded, the retaining wall should be replaced and a new code-compliant, structurally sound stoop constructed. Stormwater management should be re-evaluated and re-designed for proper drainage to prevent further failure of the building foundation.

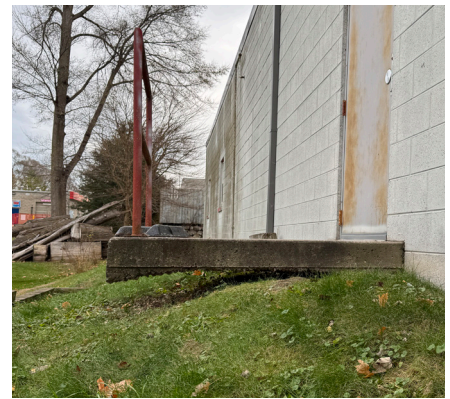
UNDERMINED EXIT STOOP

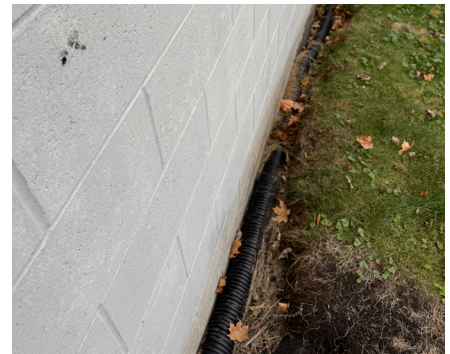
FOUNDATION DRAINAGE EROSION

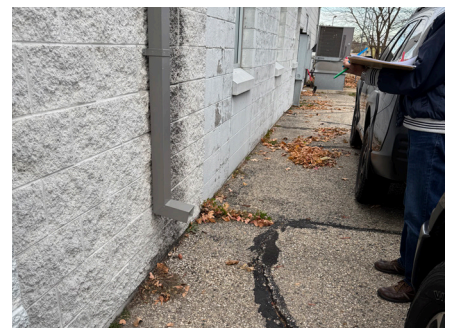
DOWNSPOUT DRAINS AT GRADE AT PARKING

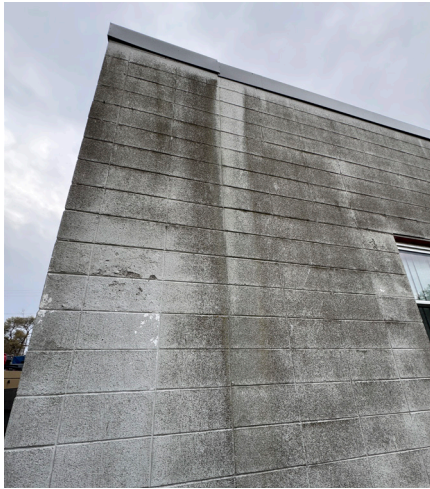
NORTHEAST WALL CONDITION FROM WATER RUNOFF

The original building roof is tapered to the back (northeast side) of the building. There are no gutters to collect water, so water sheet drains off the roof, down the face of the wall and splashes to grade. This has caused significant dirt and mildew to form on the CMU, erosion of the CMU in various locations, rusting lintels and damage to stone windowsills. This is also a contributing factor to the grading issues along this wall. Gutters and downspouts that are right sized for the watershed needs should be added to this wall to prevent further damage. The walls should also be cleaned and then protected with a waterproof but breathable sealer, windowsills repaired, masonry joints resealed and window sealants replaced.

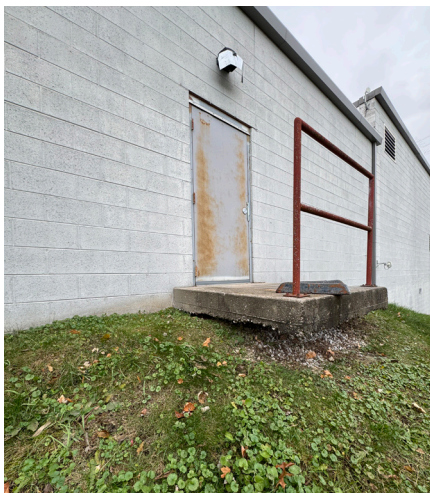
RUST ON DOOR AT NORTHEAST WALL

The west addition roof is also tapered to the back (northeast) of the building, but gutters and downspouts have been installed to collect rainwater. They do not appear to be right-sized, however, as evidenced by notable rusting on the face of the metal door and the pronounced degradation of the site grading and the undermining of the concrete stoop on this side of the building. Gutters and downspouts here should be replaced and right sized for the watershed needs of the building and the site re-graded as indicated previously.

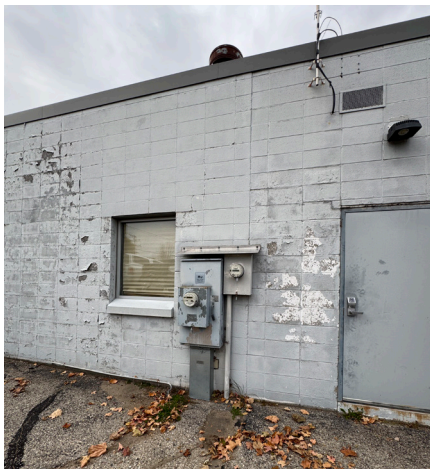
SOUTHEAST WALL PAINT PEELING OFF CMU

Along the southeast side of the building, the paint is peeling off the CMU and there is cracking and rusting of steel lintels and metal doors and frames. This is possibly caused by water if the wrong kind of paint/sealer was used and improper flashing above the door frame and the location of the door frame within the wall being flush with the exterior face. Because the building is constructed of single-wythe CMU, there is no drainage cavity for moisture in the wall, so any water that is absorbed by the masonry will either be pushed to the interior or exterior of the building. The existing paint should be removed, and new paint or sealer applied that repels rain but also lets moisture from the wall escape as needed.

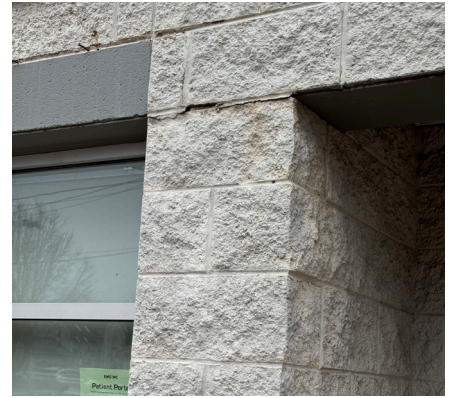
The entry addition on the south side of the building is in average condition overall. There is some cracking of the split-face CMU and sealants are cracking and failing and should be replaced. The cause of the cracking should be investigated to ensure it is not due to water infiltration / foundation settling. There is some discoloration under the windowsills that is indicative of water infiltration. The source should be investigated and corrected or structural damage could occur.

CRACKING & SEALANT FAILURES AT ENTRY

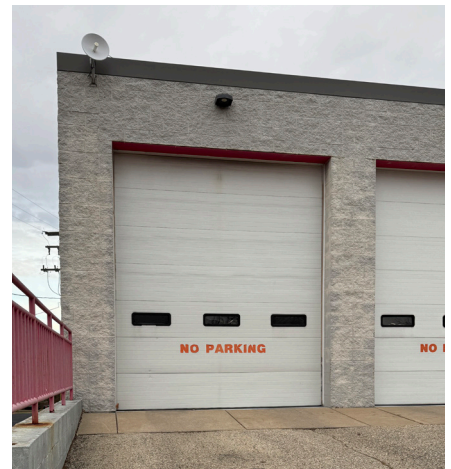
The overhead doors on the southeast elevation appear to be past their useful life cycle, with signs of denting, warping and staining. These doors account for a very large portion of the exterior envelope. It is recommended and may be required by current energy codes that the doors get replaced, if any major remodeling were to occur, with doors that have higher thermal efficiency ratings.

OVERHEAD DOOR

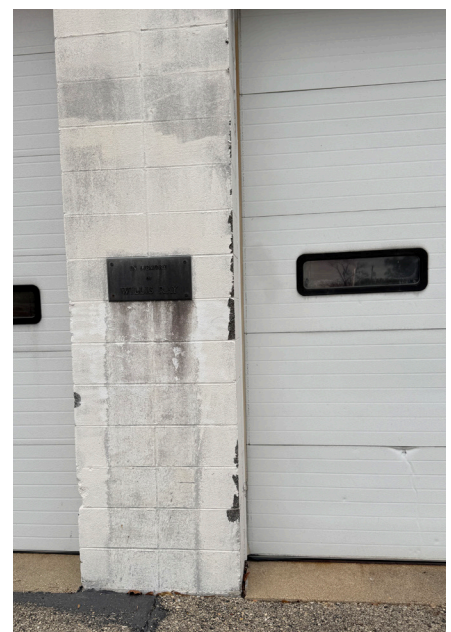
The walls in this area show normal signs of wear and staining with the jambs at the original building showing damage where vehicles have hit them entering or exiting the building.

DAMAGE TO OVERHEAD DOOR JAMBS

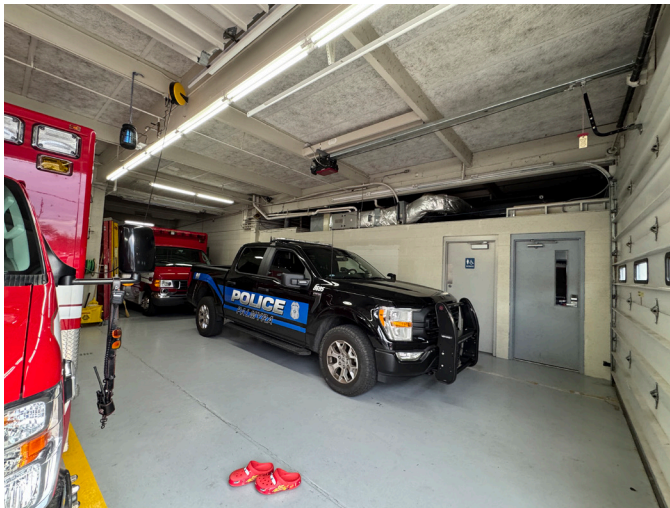
PD SQUAD PARKED IN FRONT OF AMBULANCE

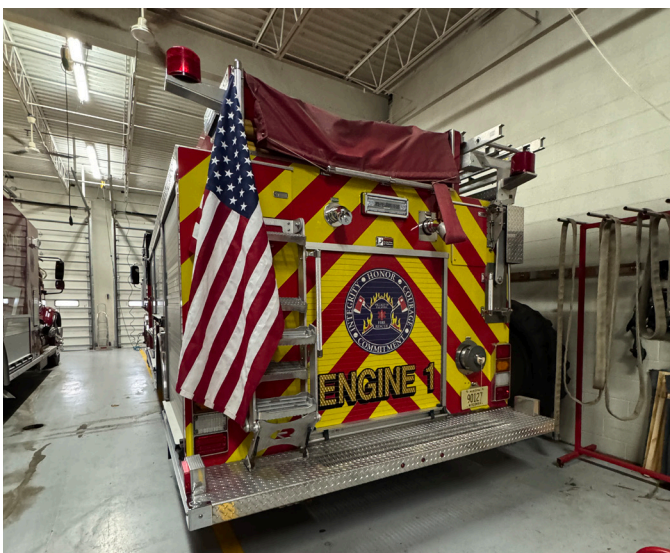
NOT ENOUGH ROOM TO MANEUVER AROUND APPARATUS

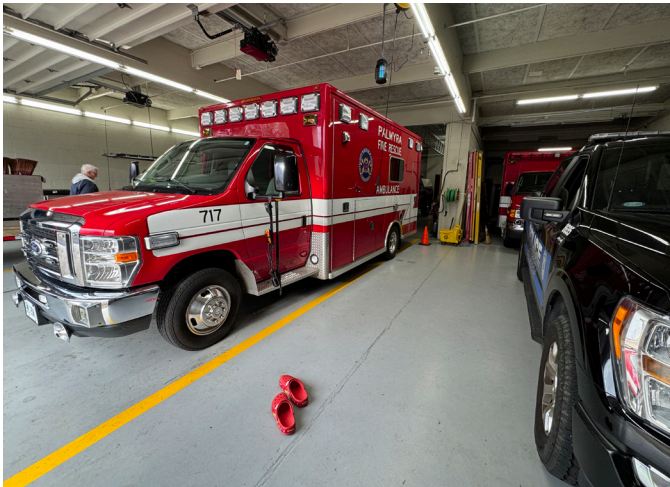
APPARATUS BAY LOW CEILINGS

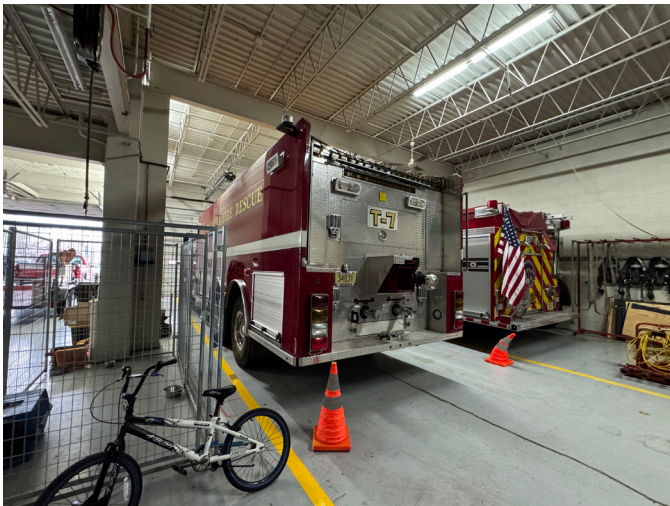
INADEQUATE LIGHTING LEVELS IN APP BAY

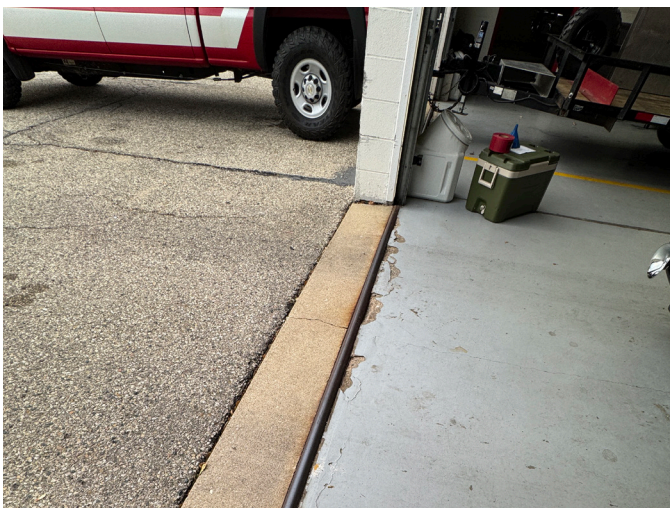
DAMAGED SLAB EDGE & LIKELY LOCATION FOR WATER INFILTRATION INTO BASEMENT

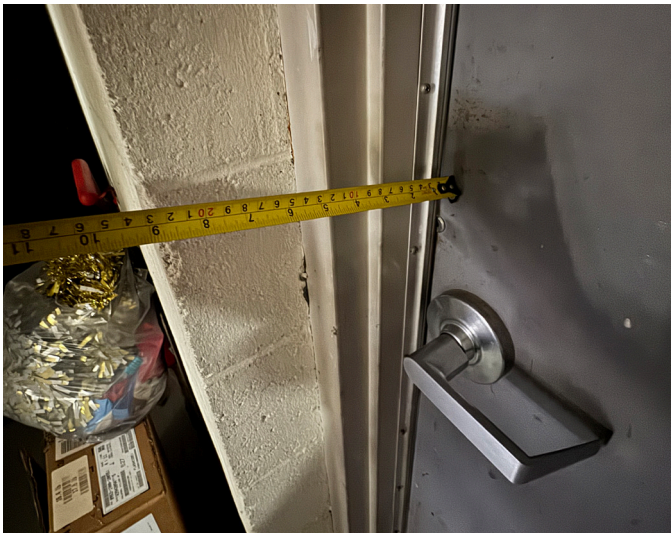
NON-ADA COMPLIANT EXIT DOOR

Along the back of the bays in the addition part of the building, is a stair that also serves as an exit door to the exterior of the building, and an elevator. The stairs and elevator lead down into the basement. The exit door does not meet ADA required push/pull clearance, and as mentioned in the site conditions portion of this report, the stoop outside the door is structurally undermined and unsafe.

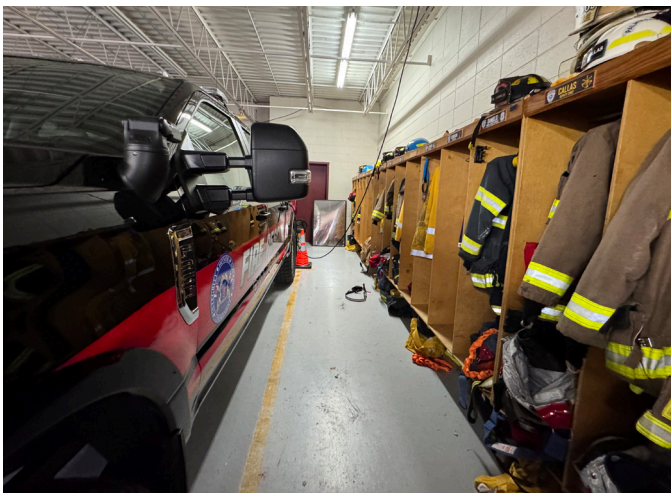
PPE ON BAY FLOOR & CLOSE TO APPARATUS

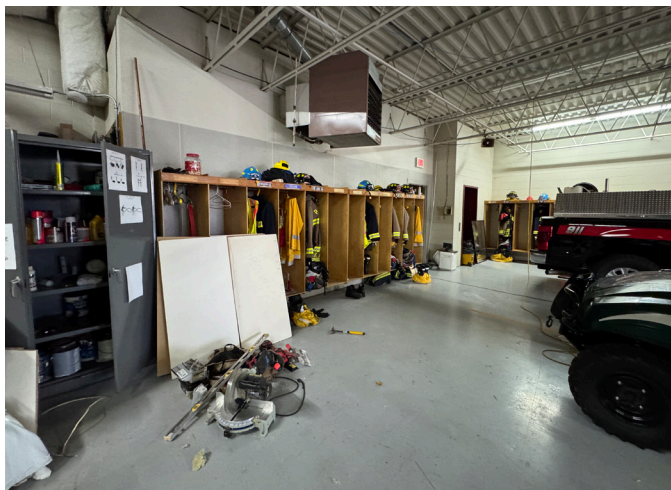
PPE AND TOOLS ON BAY FLOOR

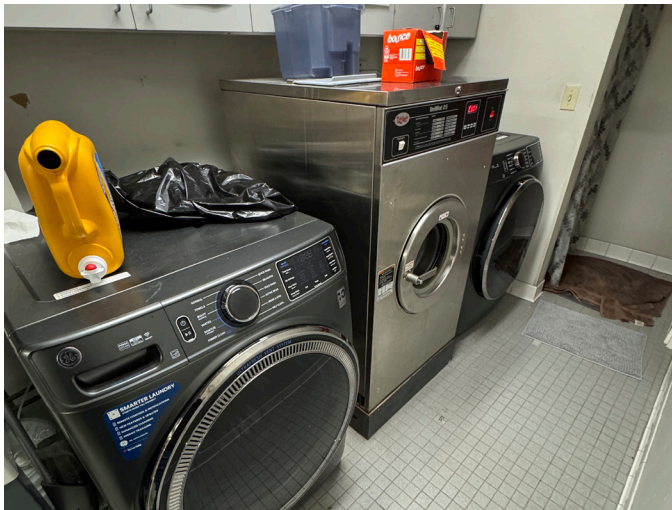
SMALL DECON ROOM WITH NON-ADA COMPLIANT SHOWER

The current facility is equipped with a small decon / gear laundry room that contains a gear extractor, a residential style washer and dryer, a shower (which is not ADA compliant) and a utility sink. The space is small and inefficient, and because responders have to re-enter the apparatus bays with their clean gear to put it away and to access the admin and living spaces of the facility, it is not per NFPA recommendations.

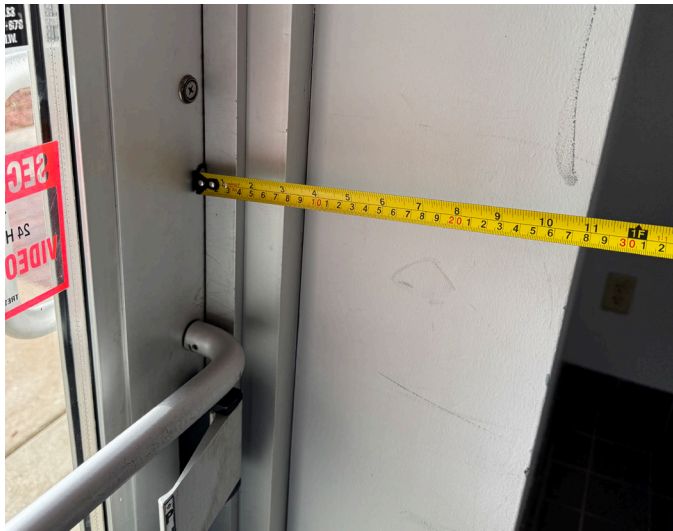
NON-ADA COMPLIANT EXIT DOOR

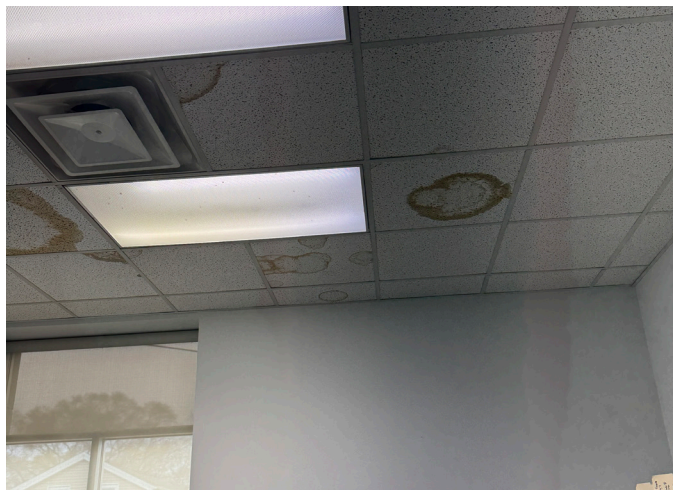
POLICE DISPATCH DAMAGED CEILING TILES

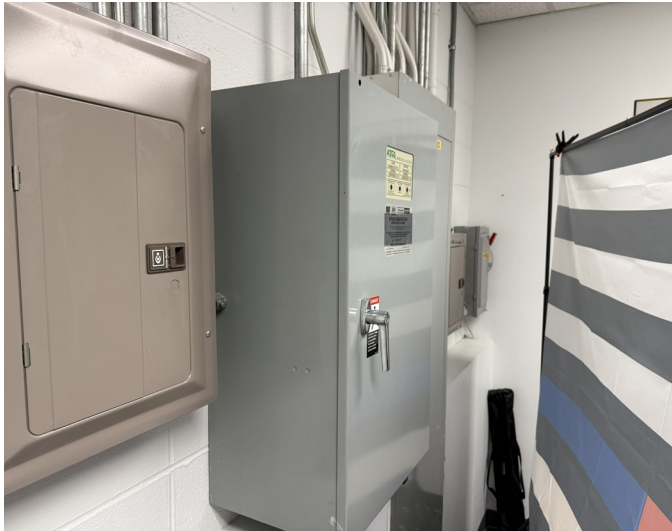
POLICE CHIEF OFFICE WALL LINED WITH ELECTRICAL PANELS

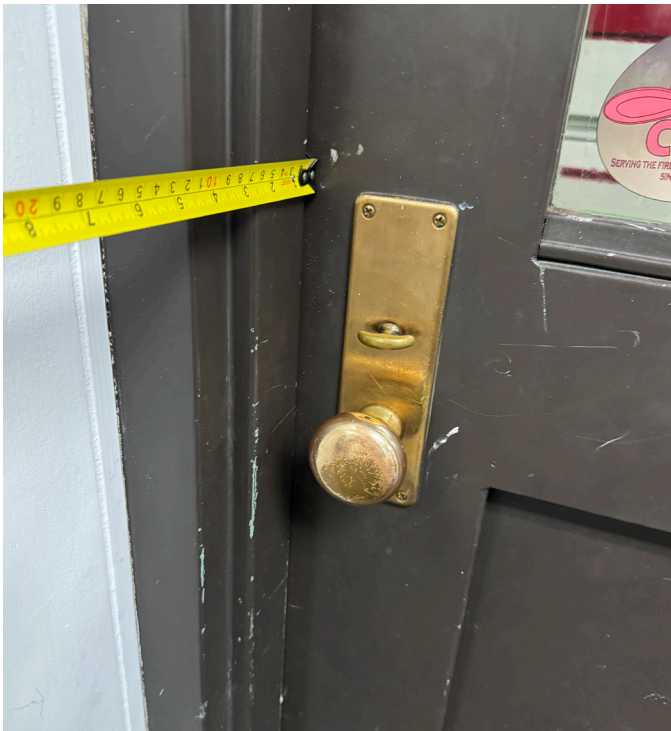
NON-ADA COMPLIANT EXIT DOOR

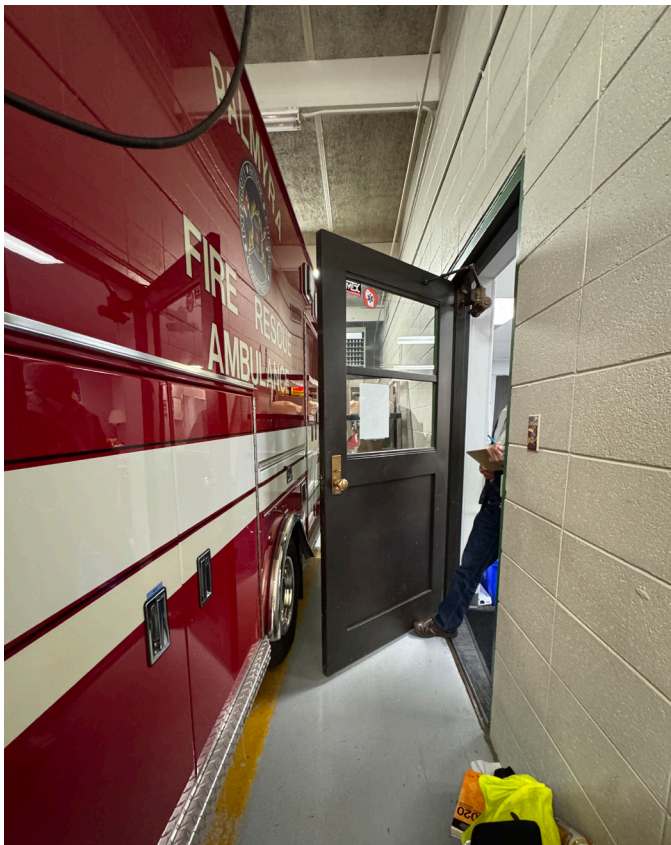
NON-CODE COMPLIANT EXIT AND UNSAFE PATH OF RESPONSE TRAVEL

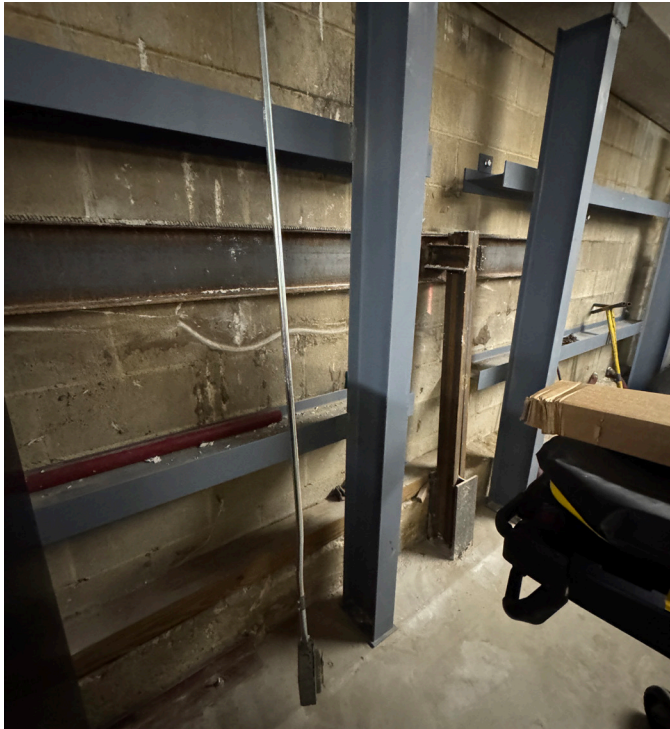
TWO PREVIOUS STRUCTURAL REPAIRS ALONG BASEMENT WALLS

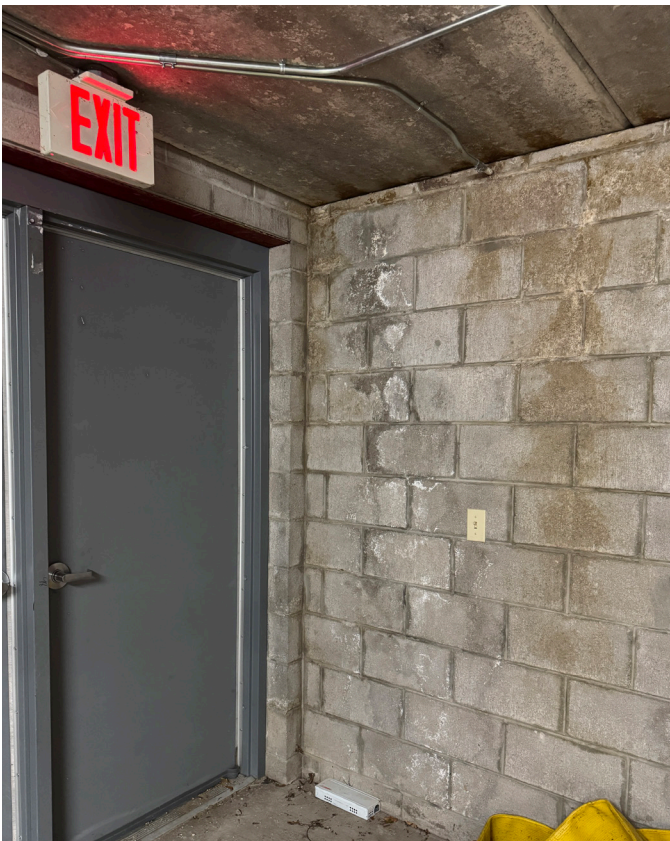
EVIDENCE OF WATER INFILTRATION AT BASEMENT WALLS

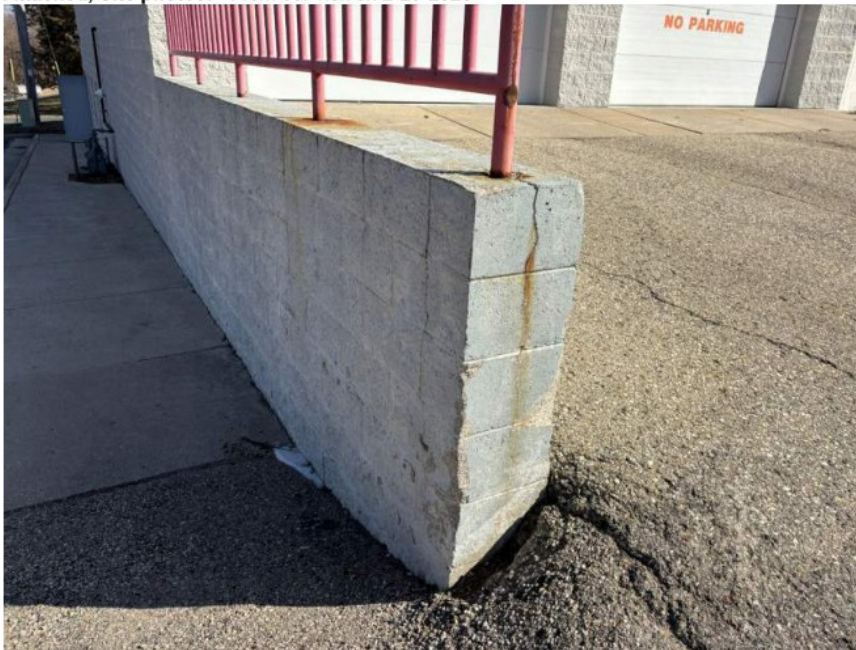
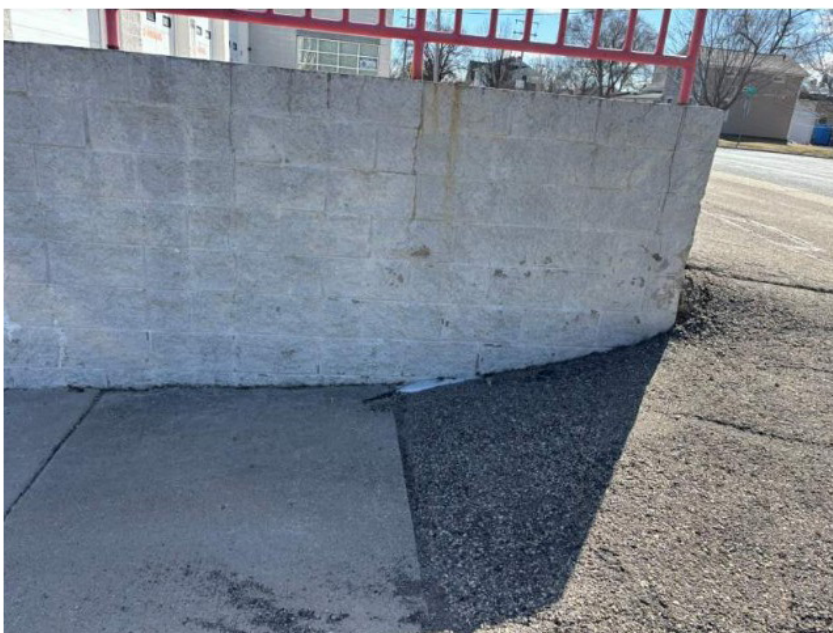
Photo 1 and 2 : Southwest Corner – Retaining wall – The Base of the railings is deteriorated, the wall itself is performing adequately, however the deteriorating handrail columns allow water into the wall, which freezes and cracks the masonry from within. The railings should be replaced, and cracks routed out and caulked, the cap should have flashing and the masonry should be re-coated.

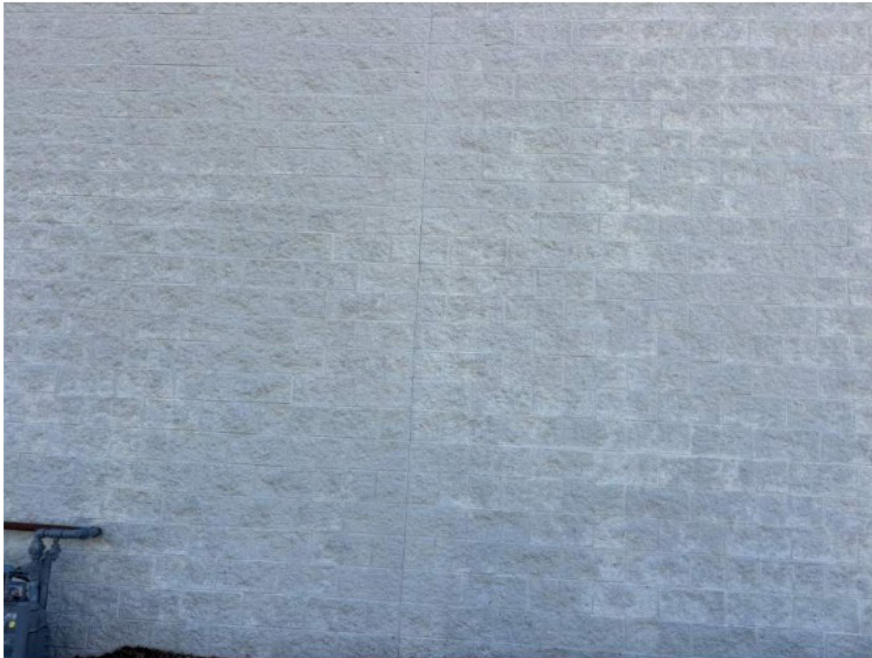
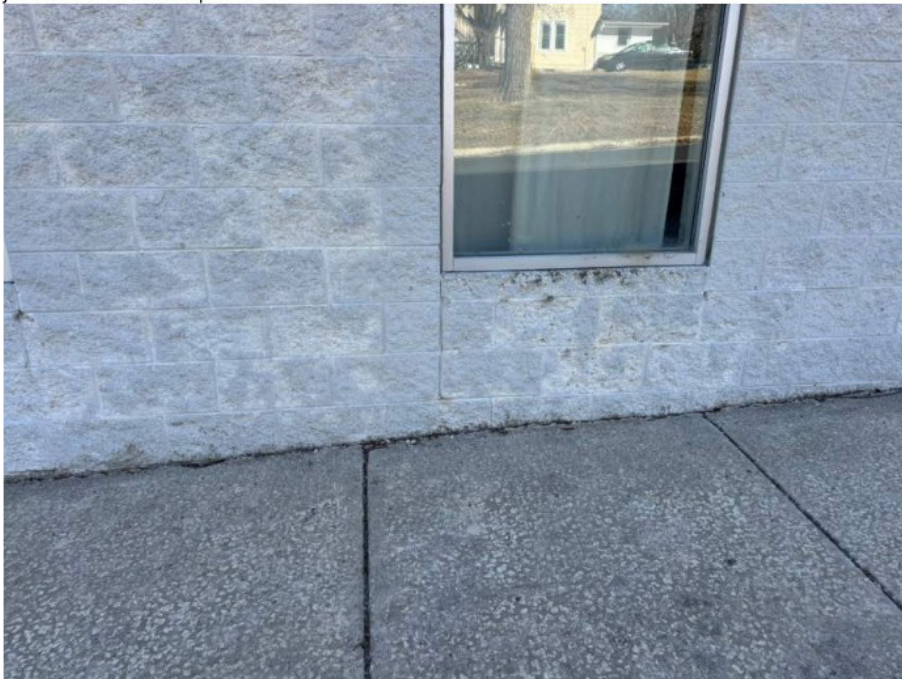
Photo 3 and 4 – West exterior wall – Joints appear to be performing adequately, however the masonry coating and caulk joints are in need to replacement.

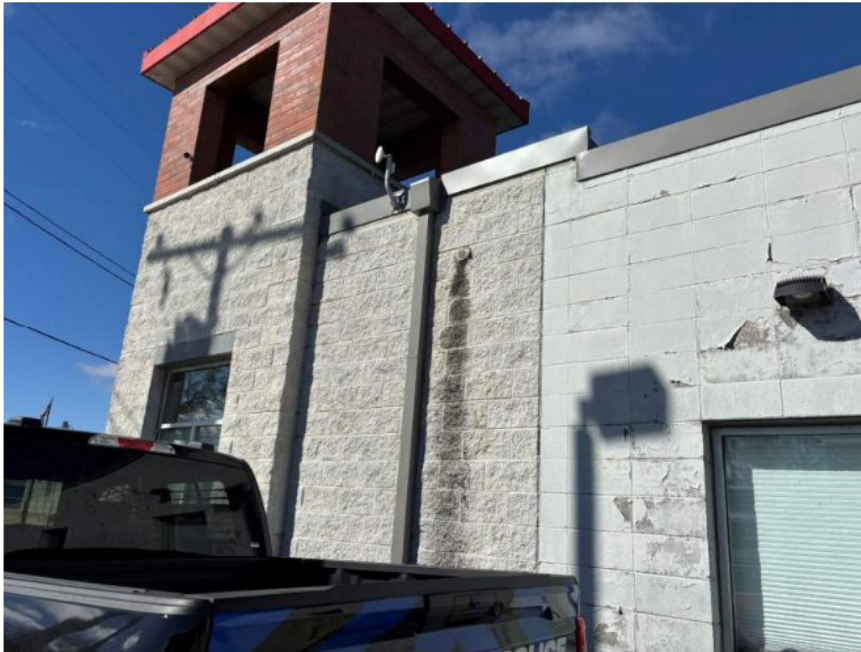
Photo 5: East exterior wall looking southwest – note deteriorated masonry coatings, exhaust vent should extend further out etc. to protect the integrity of the masonry walls.

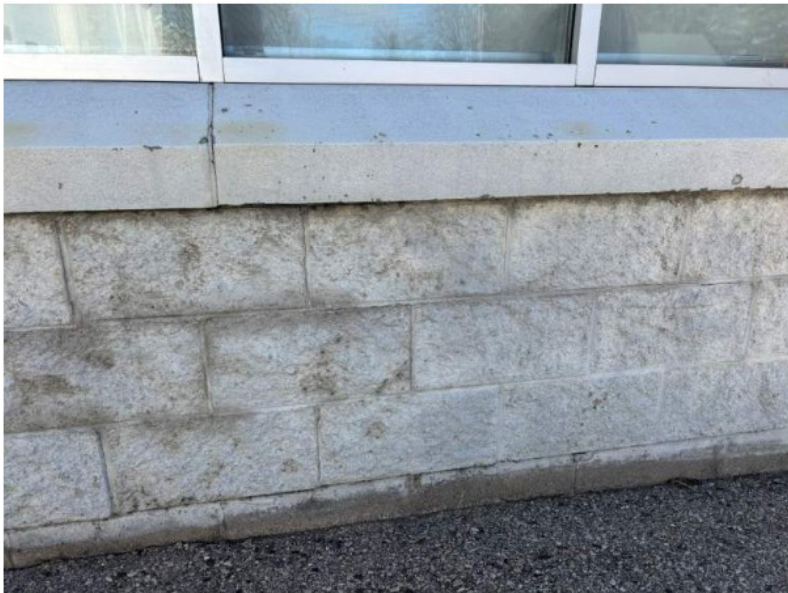
Photo 6: Caulk Joints on the Sills are in poor condition, allowing moisture into the wall, which if not corrected, will deteriorate the masonry walls.

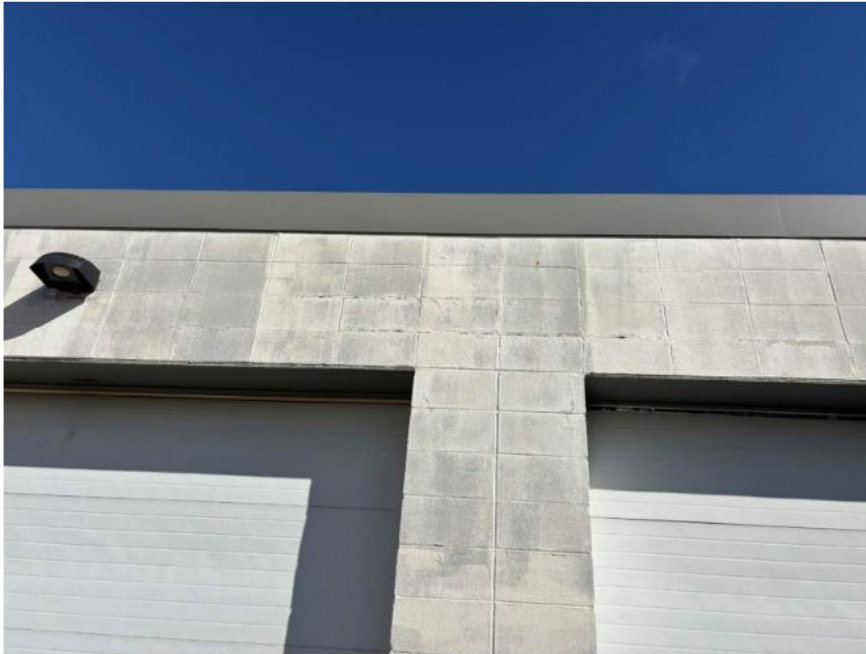
Photo 7: Exterior wall coatings are in poor condition.

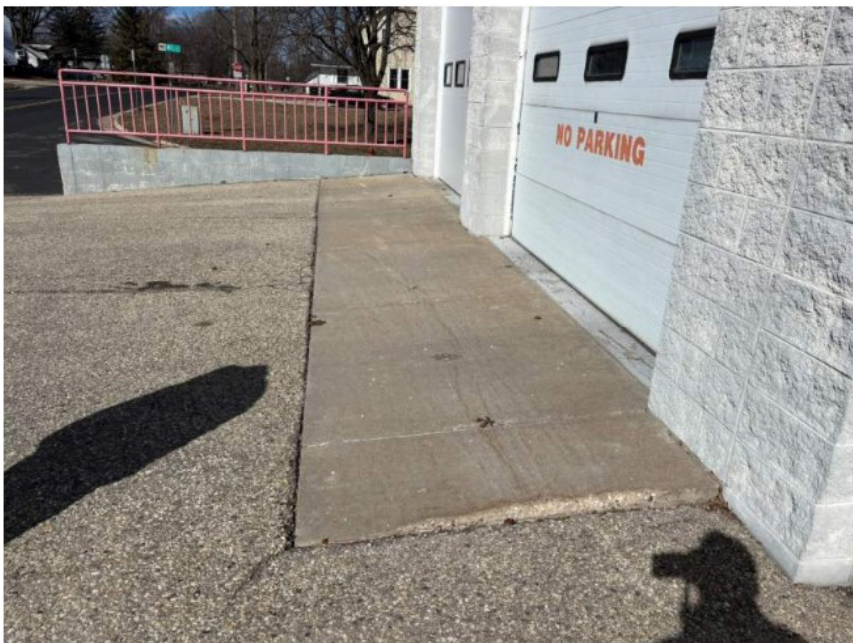
Photo 8: South exterior wall o pavements are in poor condition, transition concrete toppings at the overhead doors are cracked and should be replaced and coated with a traffic coating to prevent water intrusion. Waterproofing along this wall appears to also be inadequate (see basement photos)

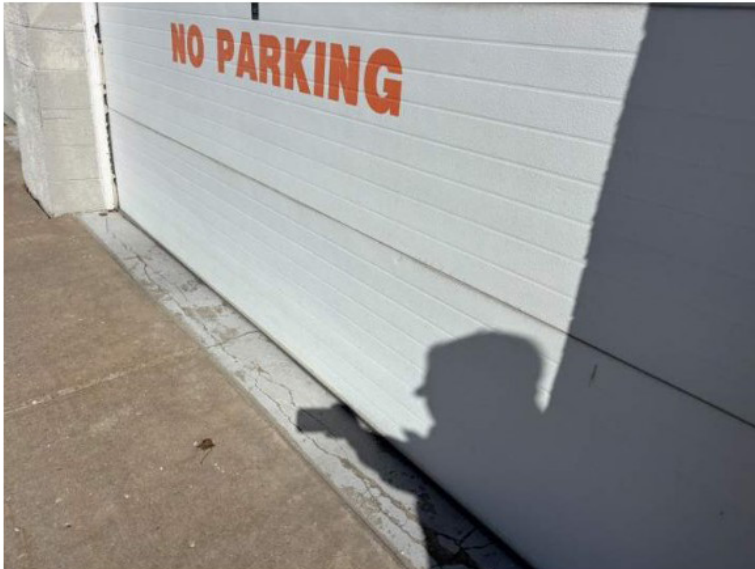
Photo 9: South Apparatus Bay doors – close-up view of threshold – damaged topping allows water to penetrate. Topping should be repaired / replaced and coated to prevent moisture intrusion.

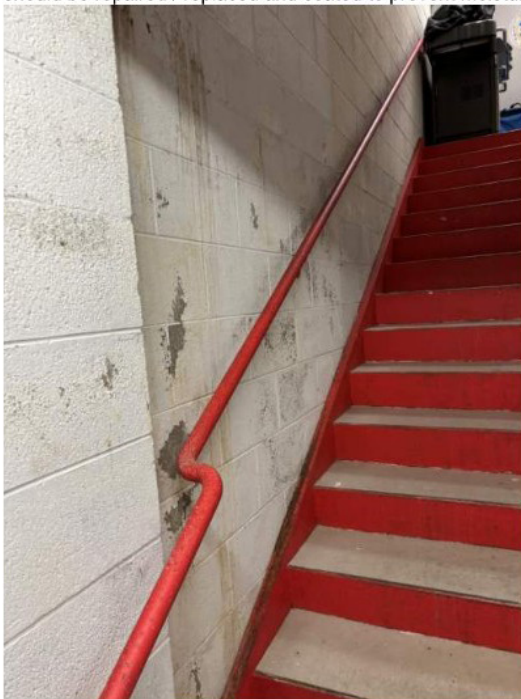
Photo 10: North Basement wall: Note evidence of inadequate waterproofing below grade on this north wall.

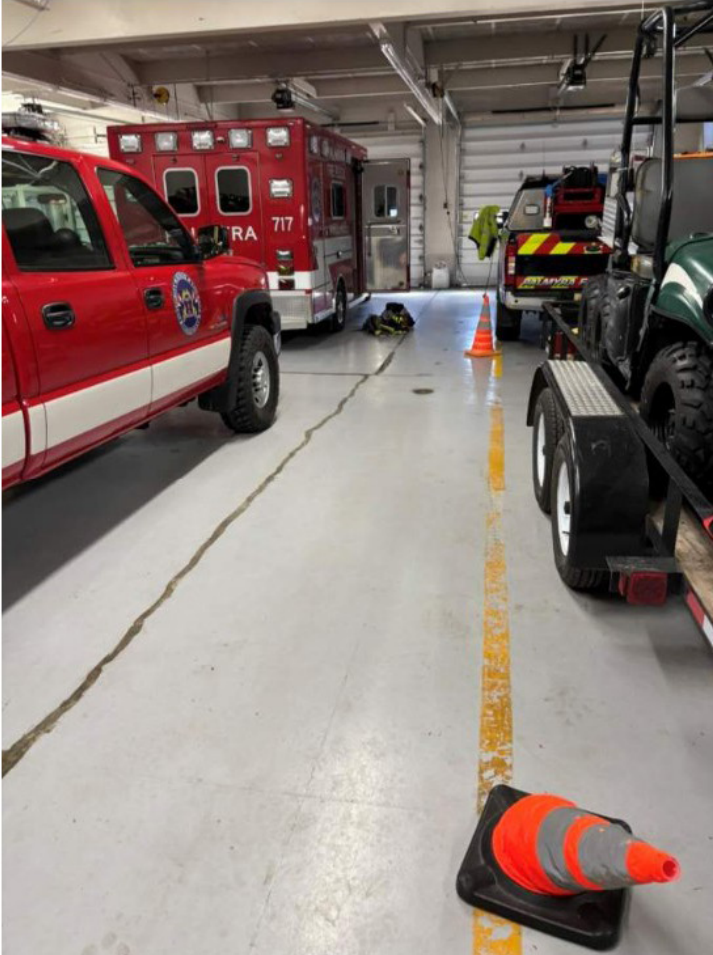
Photo 11: Interior of 1997 Apparatus Bay – Note cracks have been sealed, however the users report that they do not wash in the bays due to excessive leaks. The floor should properly coated with a traffic coating / waterproofing to protect the floor plank. Note vehicles parked in the bays are not excessively heavy, but we did not observe signage for guidance on maximum axle loads.

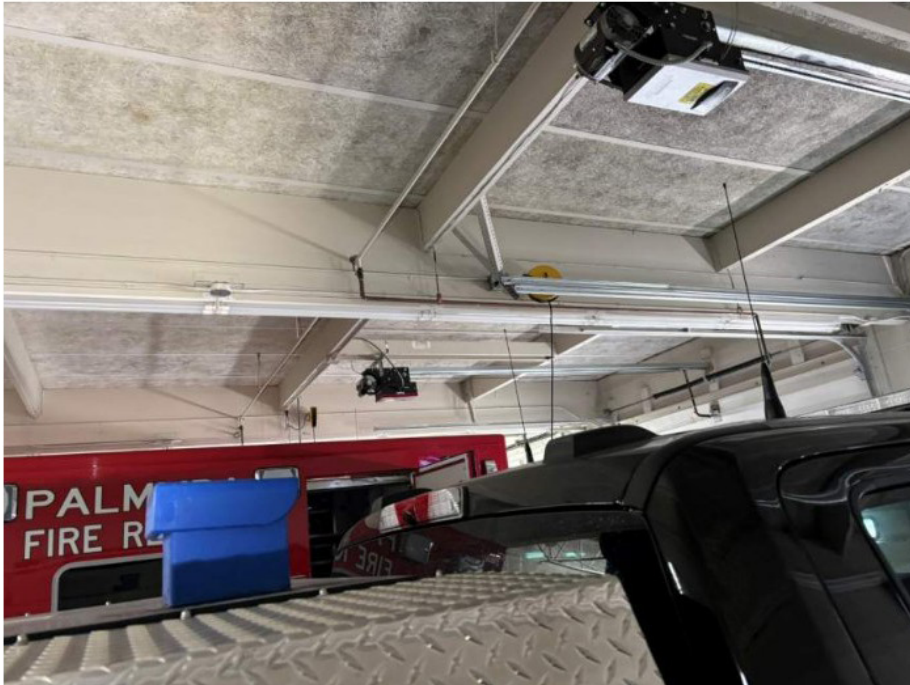
Photo 12: Original roof structure – timber with gypsum panel decking, appears to be performing adequately.

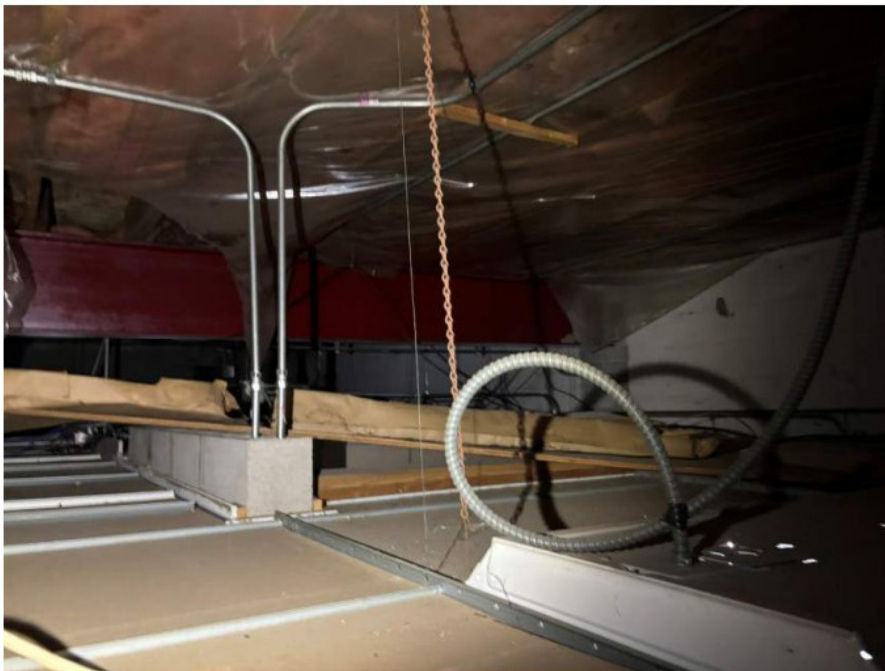
Photo 13: Roof structure above the meeting room space.

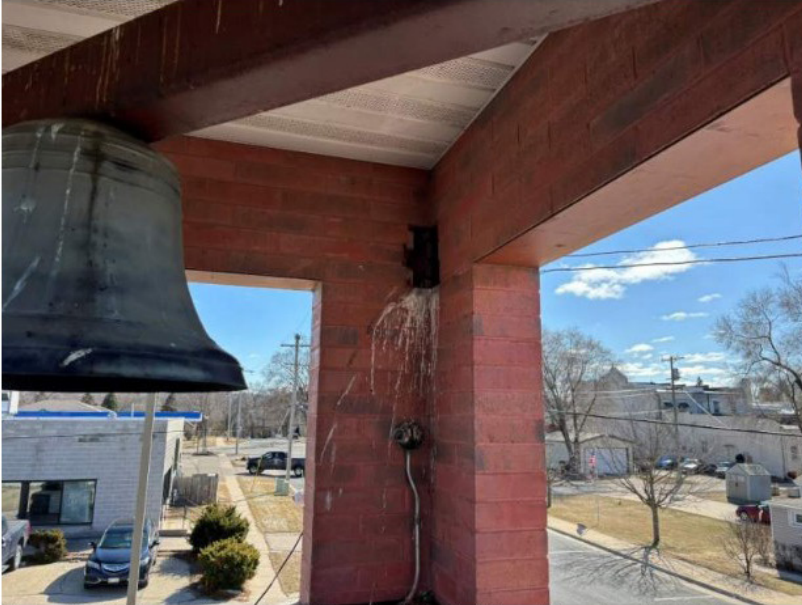
Photo 14: Bell Tower Structure at SE corner of the building. Note a large hole in the masonry should be repaired to prevent water infiltration.

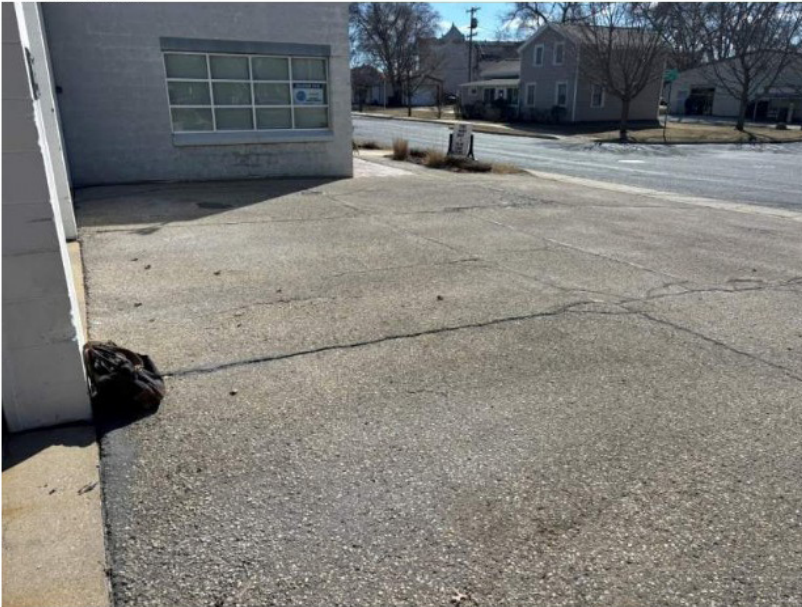
Photo 15: Exterior pavements are in poor condition.

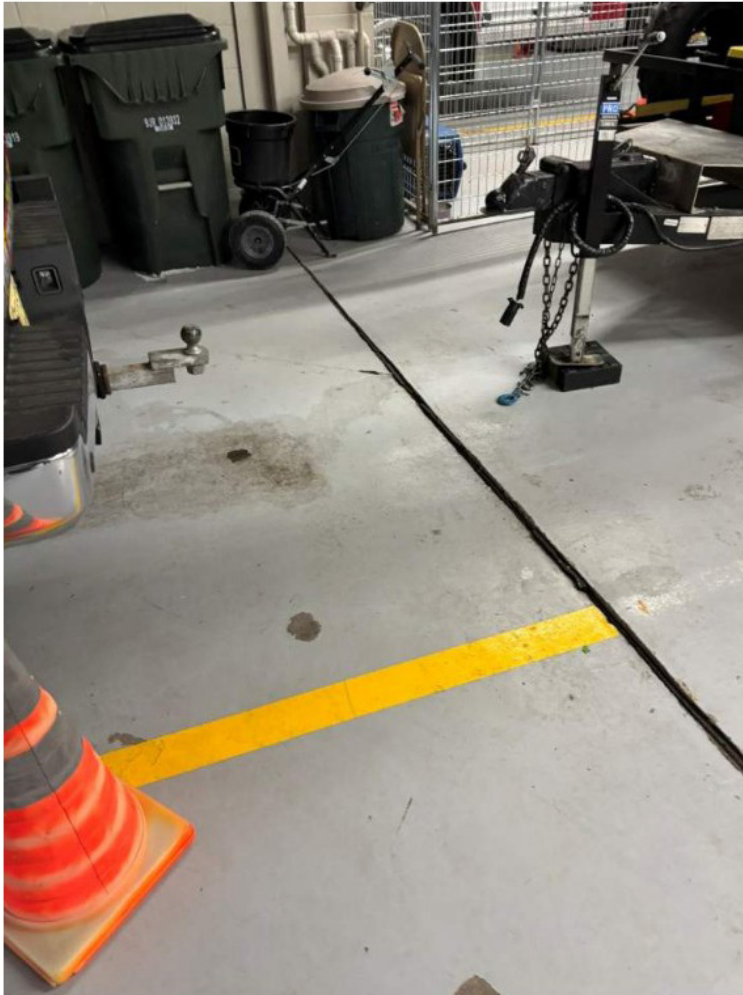
Photo 16: Transition at original floor (ground supported floor) to precast plank floor – The ground supported floor has settled due to lateral movement of the basement walls below. The floor should be leveled using foam injection, then properly sealed and coated to prevent moisture intrusion.

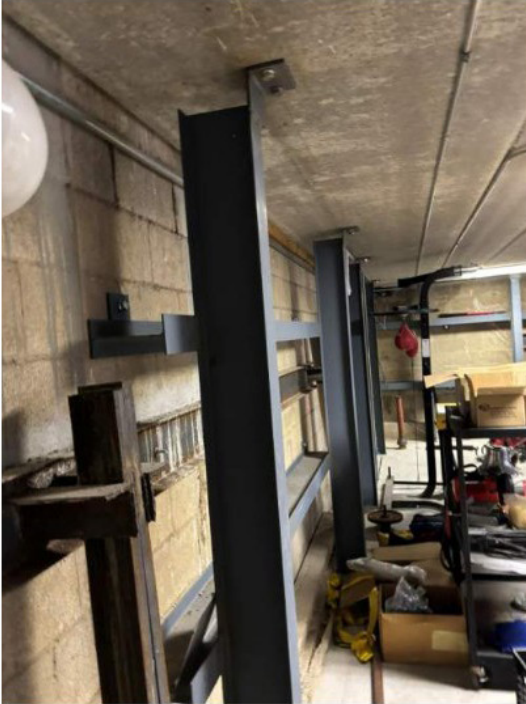
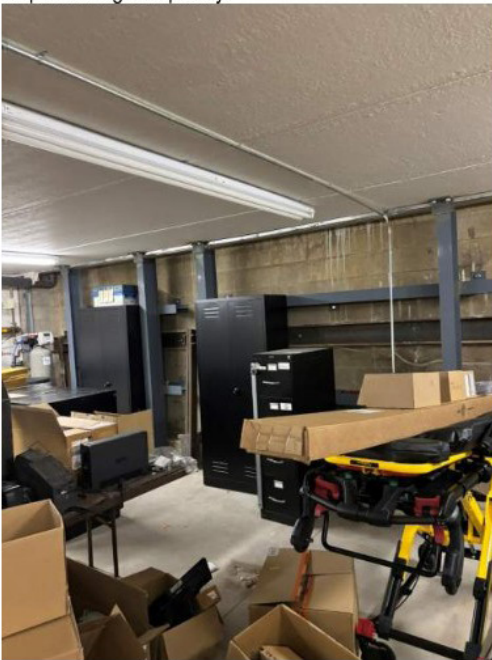
Photo 17 and 18: Heavy Steel reinforcing to prevent further movement of the original foundation systems. We did not review the adequacy of the design, but the owner stated it was designed by a professional engineer, and it does appear to be performing adequately.
