EXISTING CONDITIONS AND CONCEPT STUDY FOR THE VILLAGE OF
PALMYRA PUBLIC SAFETY DEPARTMENT

PALMYRA, WI

MARCH 2026

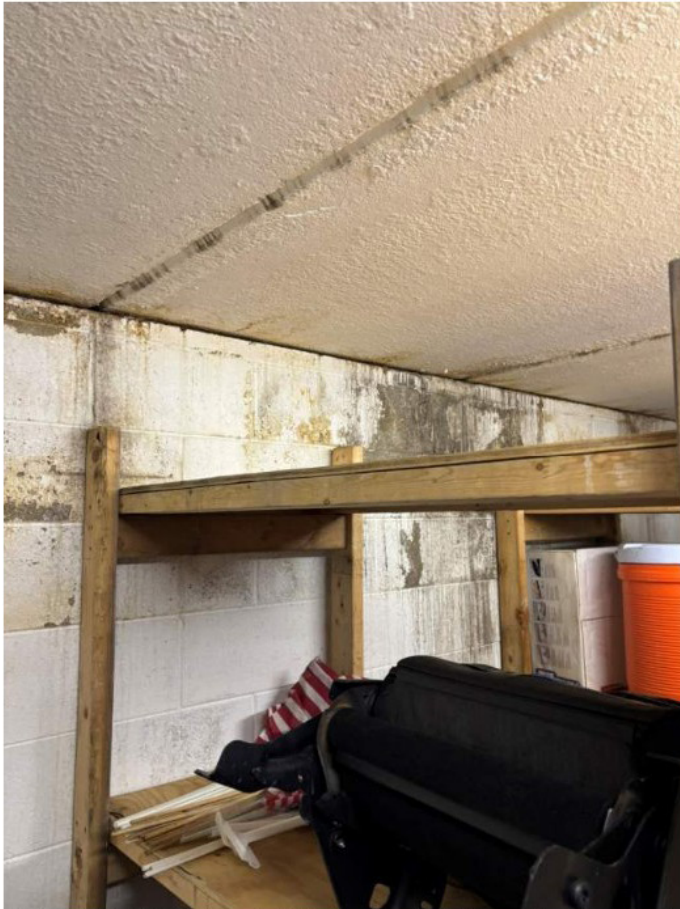
Photo 19: South Exterior wall. Evidence of water infiltration from the floor above and from outside water sources.

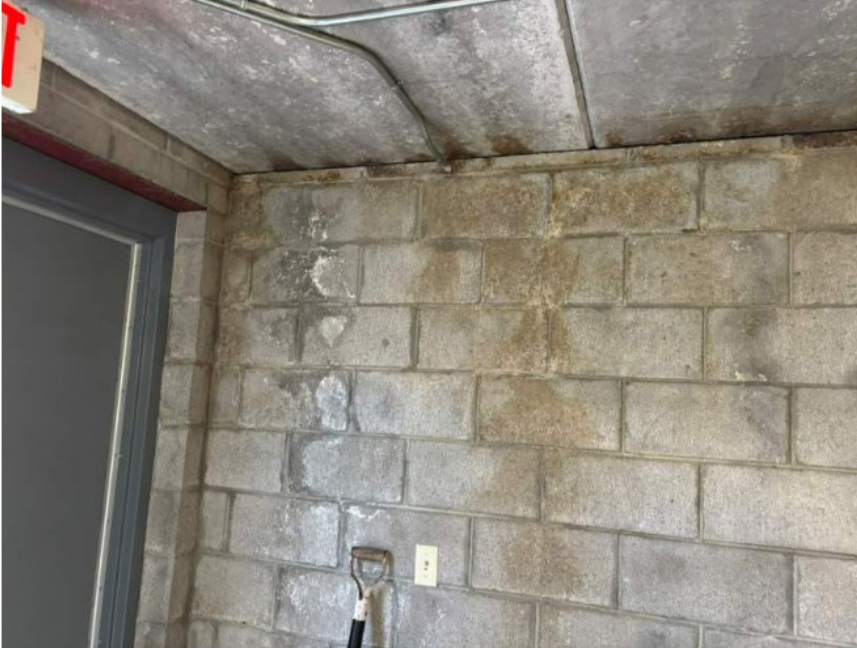
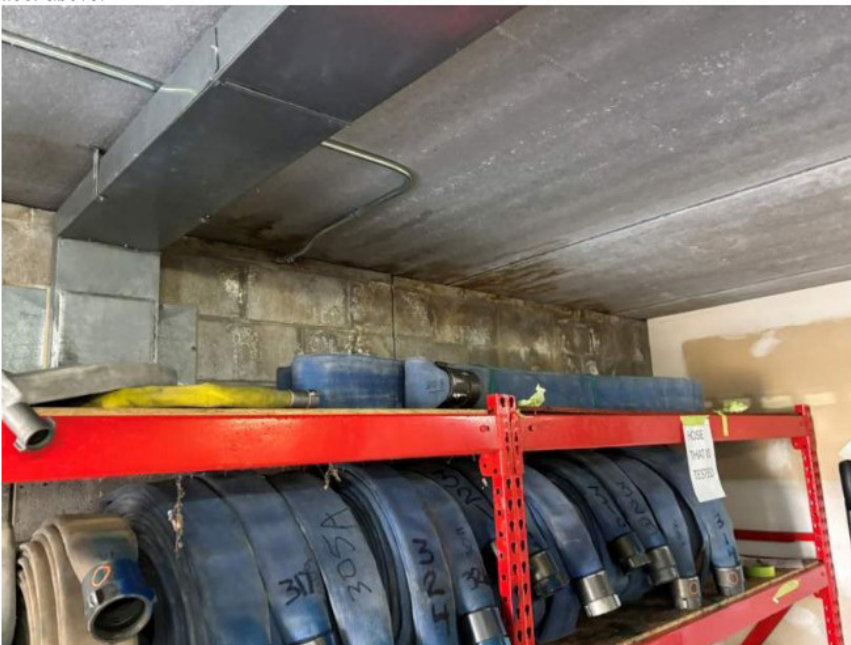
Photo 20 and 21: Northeast corner of the basement – note evidence of water infiltration from outside sources and from the floor above.

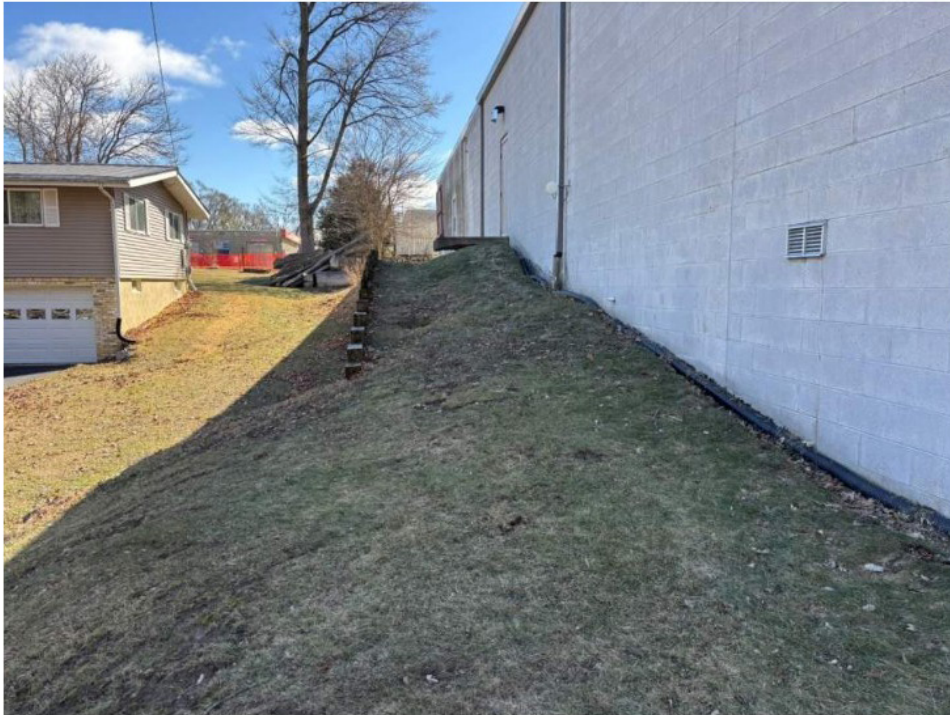
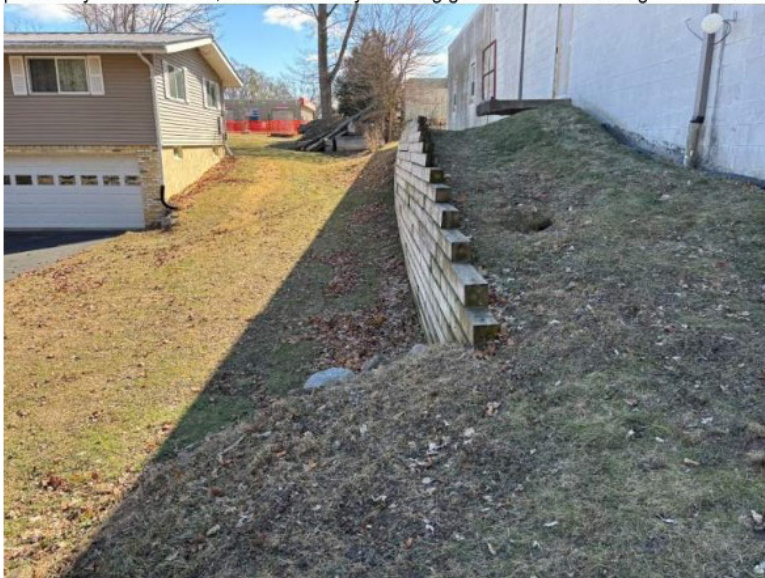
Photo 22 and 23: North exterior wall looking east: The existing wood retaining wall on the left is failing, causing settlement of the ground surface under the stoop slab. The slab is not supported and therefore not safe. It appears that the wall could potentially be eliminated, or minimized by lowering grade and constructing a steel stair for exiting.

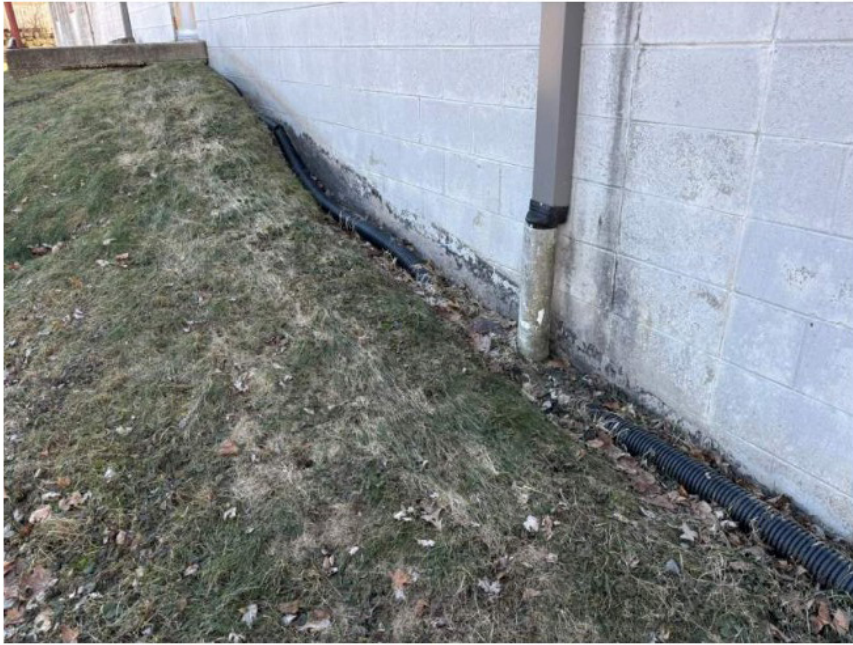
Photo 24: North exterior wall, note inadequate drainage, waterproofing system appears deteriorated, surface water would be directed to the wall surface.

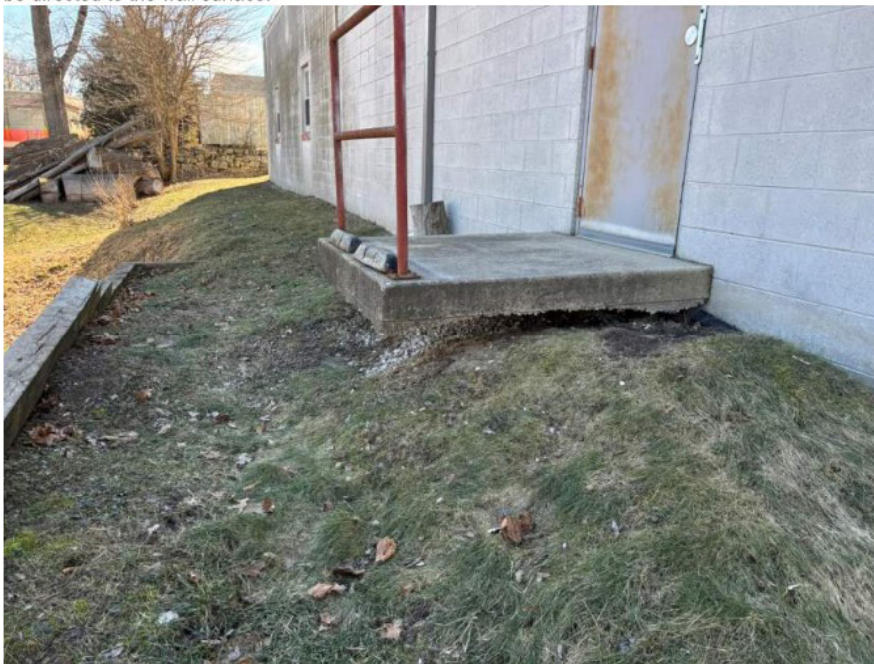
Photo 25: Stoop slab is not supported and therefore not safe as an exit. It should be closed off, until it can be repaired or replaced.

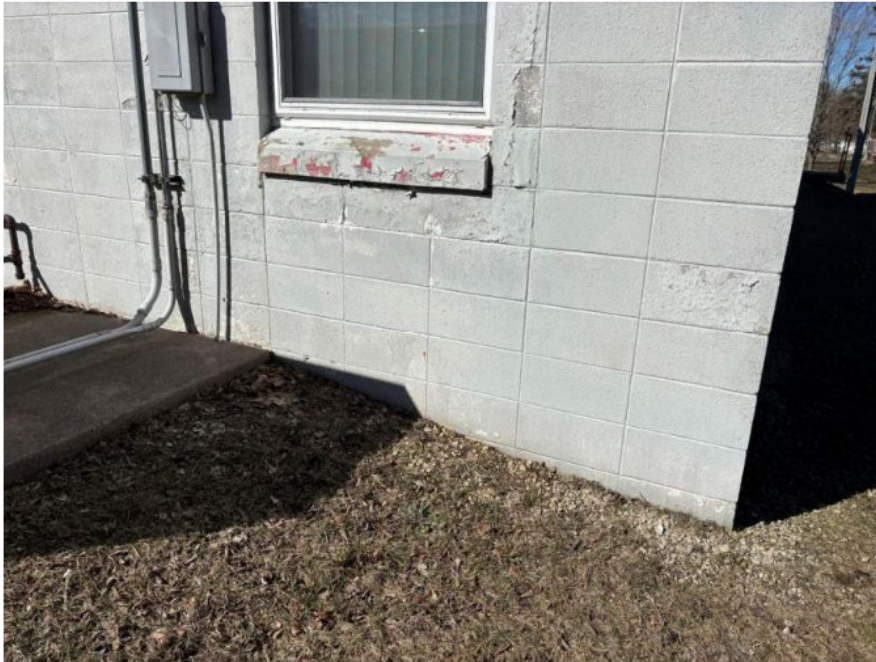
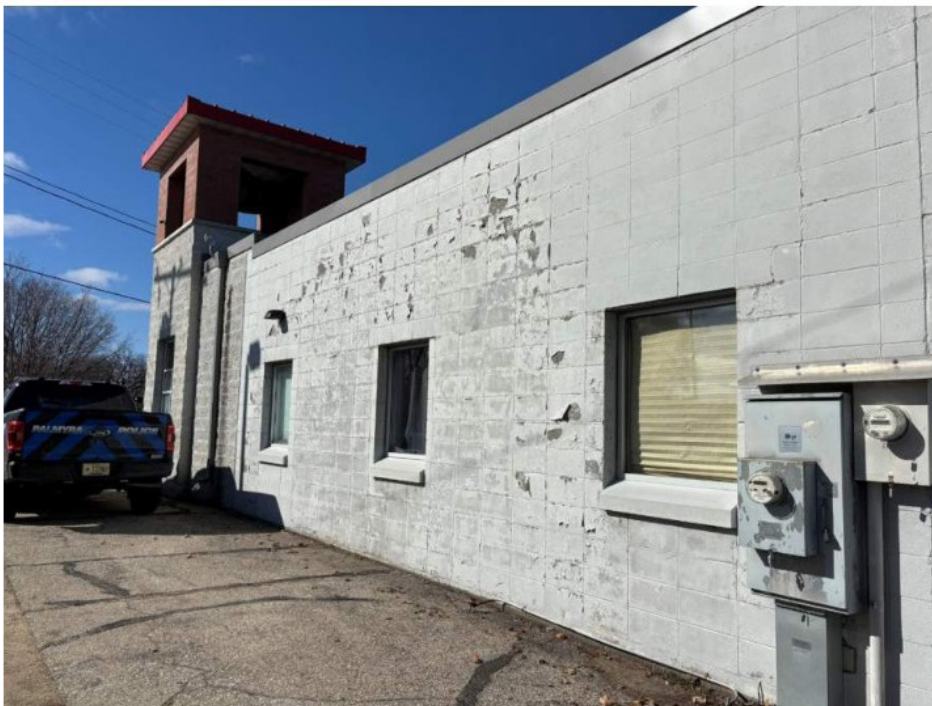
Photo 26 and 27: Exterior surface coatings are deteriorated.

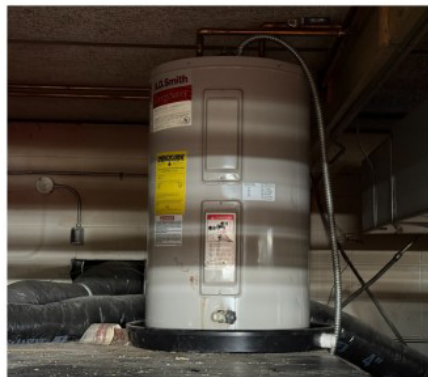
AO Smith electric domestic hot water tank

The domestic hot water for the building is an electric AO Smith unit located above the 1st floor bathrooms. This unit is installed in a crawl space and is difficult to access and service, relocation should be considered along with a recirculation system. This unit may have been installed approximately 12 years ago and is likely at the end of its useful life. There also appears to be no leak detection for this unit and the pressure relief valve and piping was not accessible.

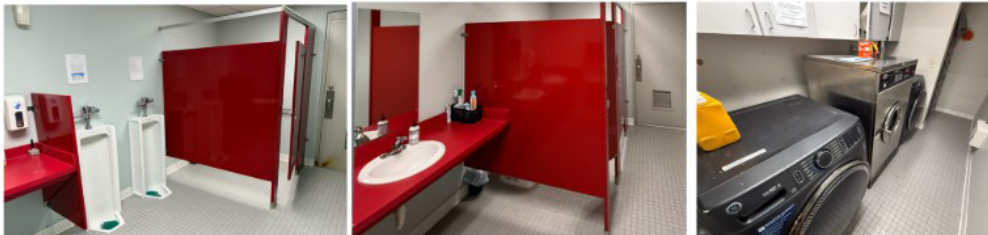
Men's / Woman's Rooms

The fixtures are in good condition, however based on the apparent age of these fixtures, it is unlikely the flow rates of these fixtures meet current energy code.
