# **PUBLIC WORKS COMMITTEE AGENDA**

VILLAGE OF SOMERSET

**Wednesday, January 14, 2026**

**To:** Robert Gunther  
**From:** Joshua R. Sweno, P.E.  
**Subject:** Main Street Bridge Inspection, Recommended Repairs  
**Date:** November 18, 2025

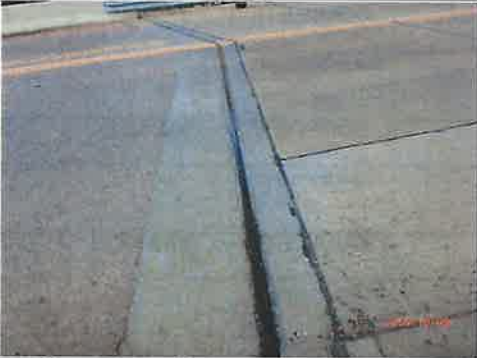
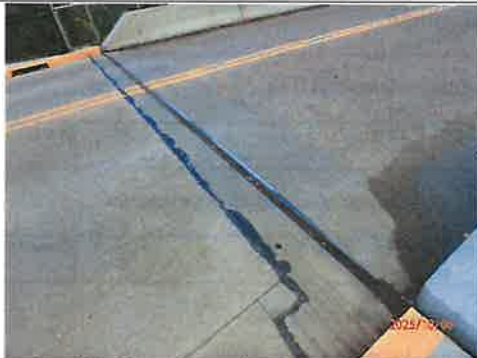
| Item | Priority | Recommended by | Status | Status change |
|---|---|---|---|---|
| Comment:<br>Expansion joints packed with debris and need to be cleaned to accommodate drainage and prevent damage. | | Status Comment: | | |

- Debris accumulation in the deck joints happens over time with the continuous use of the bridge by vehicles. It is recommended that the joints be cleaned on a yearly basis with a power washer to allow for proper movement and prevent future damage to the joints.
- Debris accumulation in the deck drains happens over time with the continuous use of the bridge by vehicles. It is recommended that the drains be cleaned on an annual basis to allow for proper drainage.

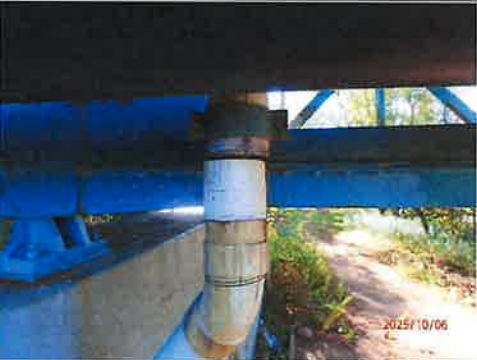
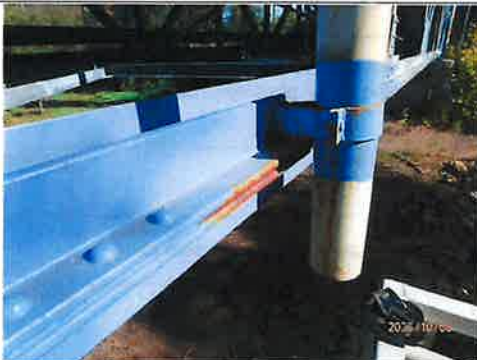
| Item | Priority | Recommended by | Status | Status change |
|---|---|---|---|---|
| Comment:<br>Section of north downspout adjacent to pier 3 replaced by contractor in 2023. New section is disconnected adjacent to truss. Repair downspout connection.<br><br>Evidence of leakage from other downspouts based on adjacent truss corrosion. Repair downspout seals. | | Status Comment: | | |

- The north downspout adjacent to pier 3 was repaired by the contractor in 2023. The new section has disconnected adjacent to the truss which will lead to water splashing on the adjacent truss member. This drain connection should be repaired in the next 2 years. As an alternative the deck drain systems throughout the deck appear to be continuing to leak onto the adjacent truss members based on the presence of corrosion on previously painted areas. Consideration should be given to fully replacing the deck drain systems.

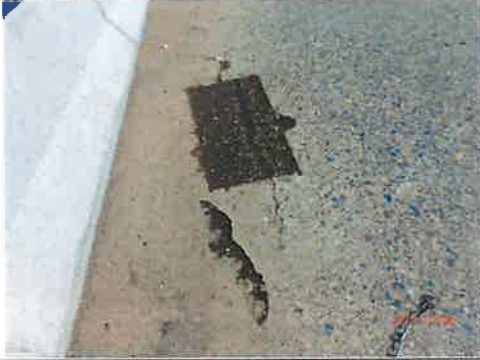
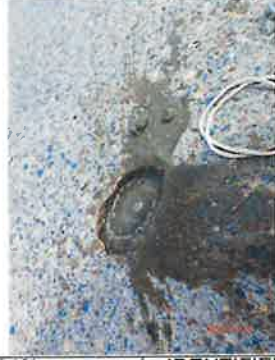
| Comment:<br>Past wearing surface deck patches are showing signs of deterioration. Recommend replacing the deck patches and conduct deck repairs for DELAM and open spalls.<br><br>Consider concrete overlay of entire deck. | | Status Comment: | | |

- There are concrete patches in the wearing surface of the concrete deck that were completed in the past. These patches are beginning to show signs of deterioration. There are also areas of small open spalls in the deck wearing surface. It is recommended that the patched areas be replaced, the open spalls be patched, and the areas of delamination be repaired and patched within the next 2 years.

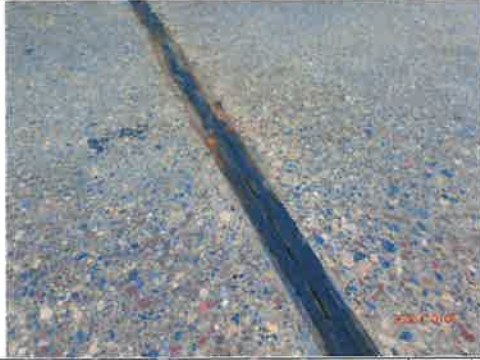
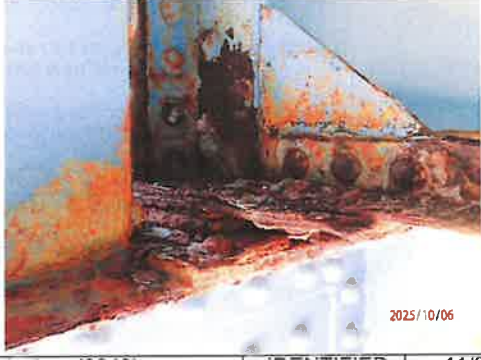
| Comment:<br>Pier joints are continuing to leak causing corrosion and pack rust on the steel members and bearings below them. Recommend replacing all pier joints. | | Status Comment: | | |

- There is damage to the joint material and leaking at the ends of the compression joints at pier 1 and pier 3. The leaking has been occurring for numerous years and is causing significant corrosion to the girder bearings below. It is recommended that the pier 1 and pier 3 compression joints be replaced within the next 2 years.

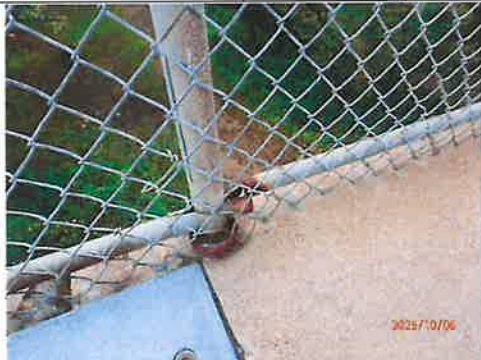
| Comment:<br>Repair or replace chain link fence. There are several locations where the bottom horizontal members have rusted through. | | Status Comment: | | |

- The outer chain link fence railing along the sidewalk on both sides of the bridge has several locations where the bottom horizontal members have rusted through. It is recommended that the chain link fence railing be repaired or replaced within the next 2 years.

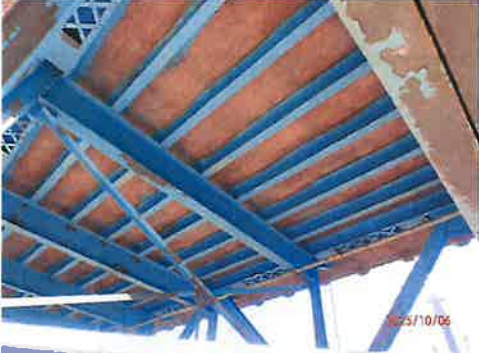
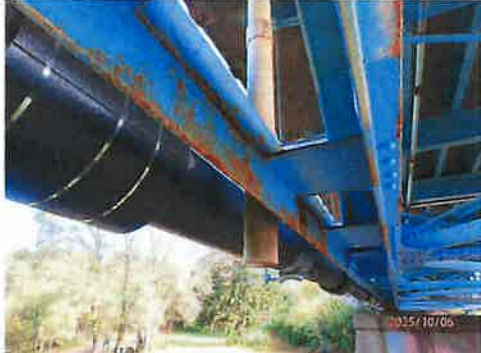
| <b>Paint - Spot Paint</b> | Low | Sweno, Joshua (9640) | IDENTIFIED | 11/08/25 |

| Comment:<br>Continue to perform spot painting on areas of corrosion or consider full repaint of steel elements. | | Status Comment: | | |

- The paint system throughout the steel truss and girders is deteriorating. It is recommended that spot painting be completed on an as-needed basis, likely every 5 to 10 years. The frequency will depend on the exposure of the steel superstructure members to the elements (water, snow, and salt).

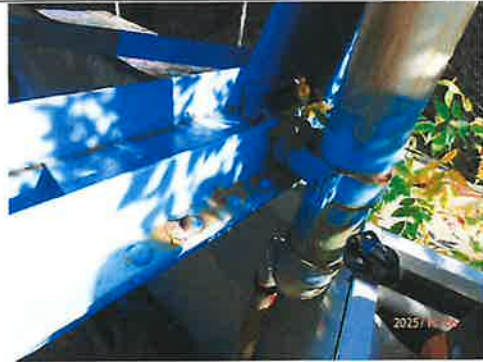
**NSTM Item 1**

Corrosion of truss bottom chord at pier 3.

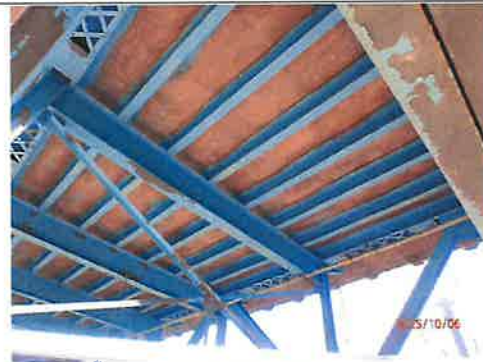
**NSTM Item 2**

Typical truss, floor beam, and stringer paint condition.

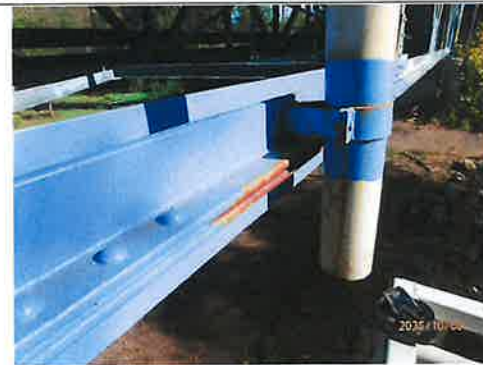
**NSTM Item 3**

Corrosion forming in previously painted areas around drains.

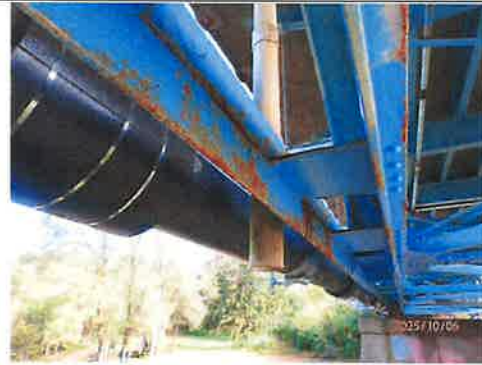
**NSTM Item 4**

Corrosion forming in previously painted areas around drains.

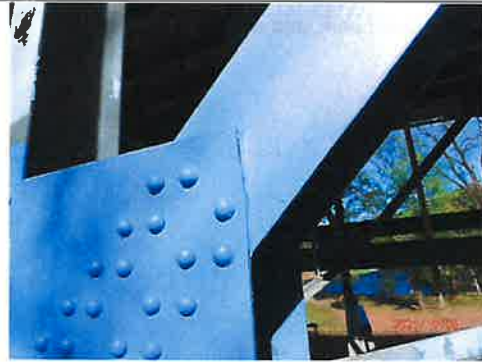
**NSTM Item 5**

Representative photo of past gusset plate distortion.

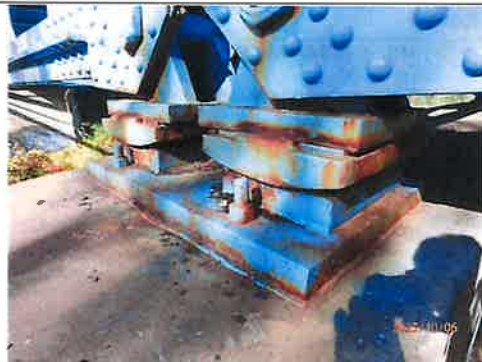
**NSTM Item 6**

Representative photo of surface rust on pier 2 bearings.

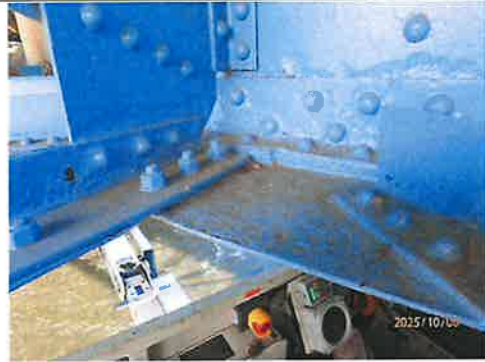
**NSTM Item 7**

Representative photo of past section loss in the truss span steel diaphragms and gusset plates.

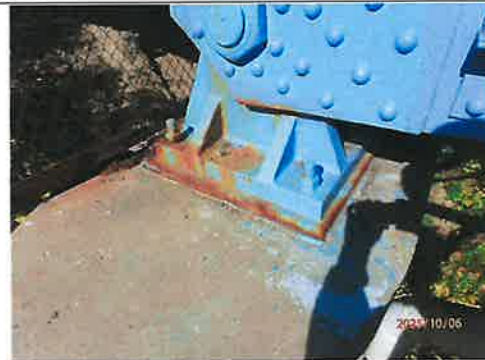
**NSTM Item 8**

Corrosion in truss bearings at pier 1.

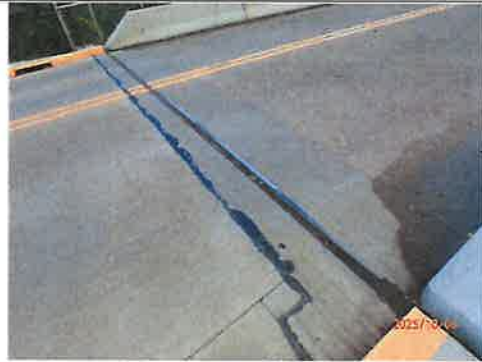
**Routine Item 3**

West abutment expansion joint filled with debris.

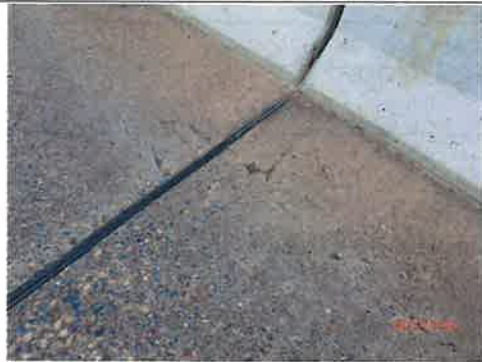
**Routine Item 4**

DELAM/spall along compression joint at pier 3. Compression joint leaking at ends with parapet.

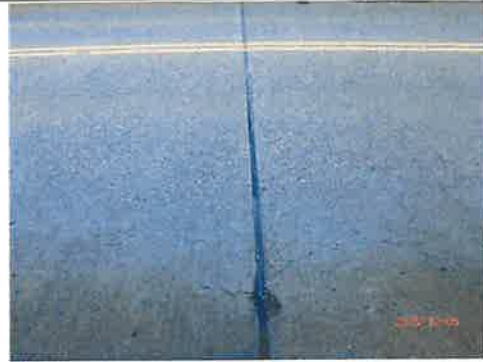
**Routine Item 5**

Representative photo of compression joint at Pier 1 and Pier 3.

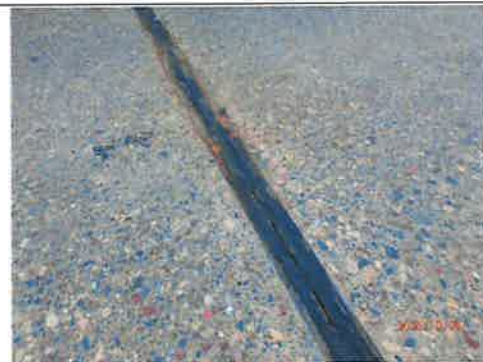
**Routine Item 6**

Tears and leakage in pier 2 strip seal expansion joint.

- The expansion joint at pier 2 was repaired in 2024 with a sealer to close tears in the joint gland material. The sealer is wearing away allowing water to continue to leak onto the lateral bracing and pier 2 bearings. Additional repairs to the pier 2 joint will likely have the same result. It is for this reason that it is recommended that the pier 2 expansion joint be replaced within the next 2 years.

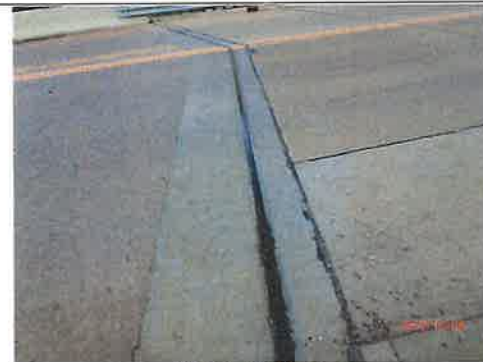
**Routine Item 7**

East abutment expansion joint filled with debris.

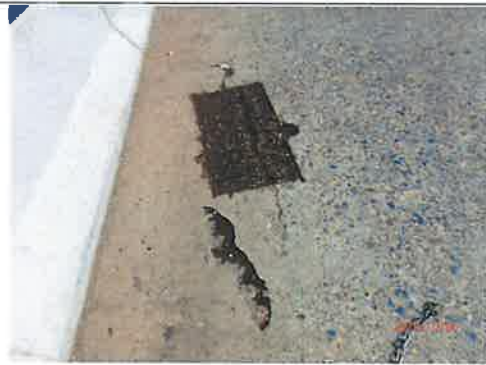
**Routine Item 9**

Deterioration in deck patches and spalling around DELAM.

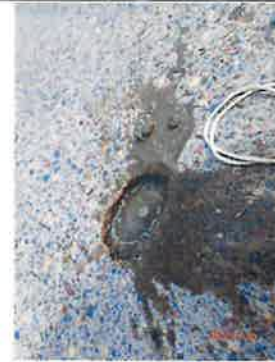
**Routine Item 10**

6"x6" spall in span 4.

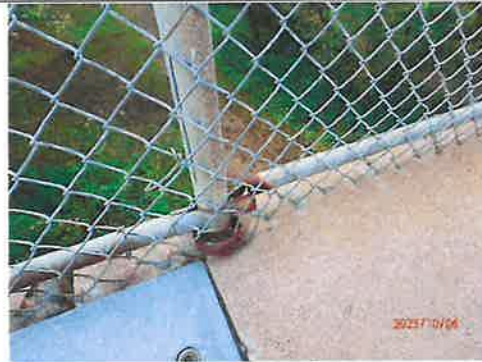
**Routine Item 11**

Several locations where bottom horizontal members have rusted through on chain link fence.

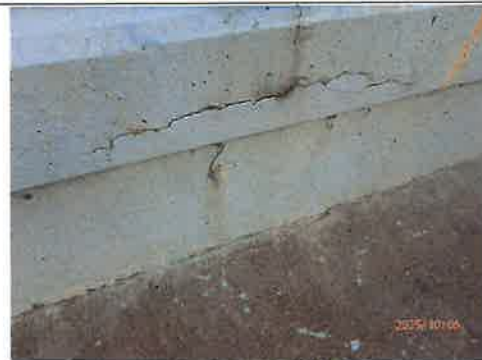
**Routine Item 12**

Representative photo of MOD CRKS and DELAM in the concrete parapet.

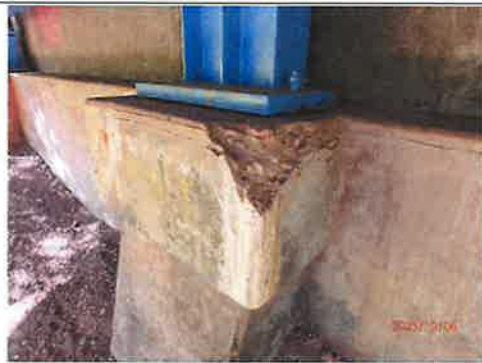
Spall in corner of patch at west abutment.

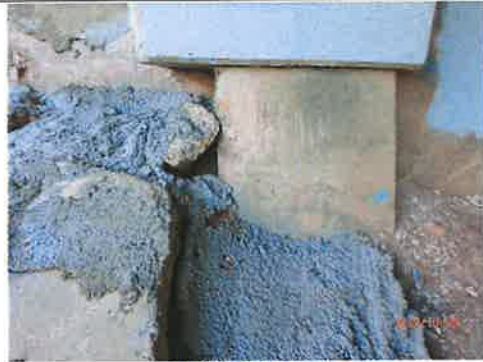
**Routine Item 17**

Spall at north end of east abutment.

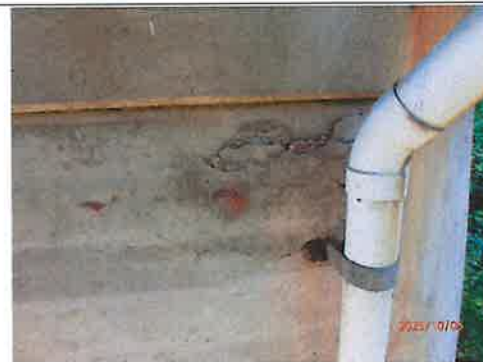
**Routine Item 19**

Spall at drain anchorage in pier 1.

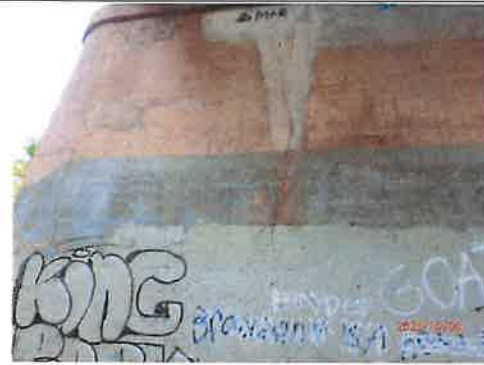
**Routine Item 21**

Wide CRK in pier 2.

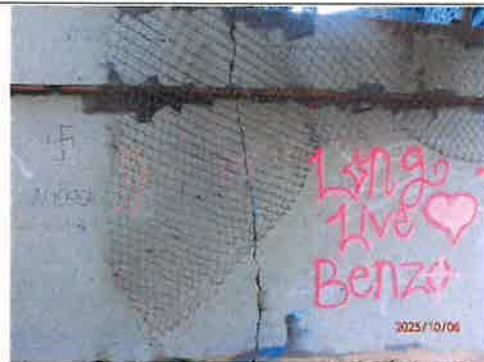
**Routine Item 23**

Wide CRK in pier 3.

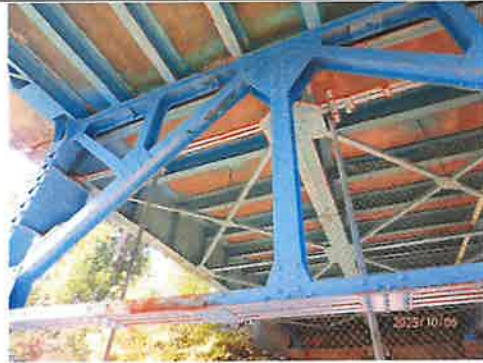
**Routine Item 25**

Representative photo of pack rust and corrosion at connections.  
Worst at pier 1 joint.

- Past minor leaking at the pier deck joints is leading to corrosion of the lateral bracing and bearings. It is recommended that the pier lateral bracing and bearings be cleaned and painted within the next 2 years.

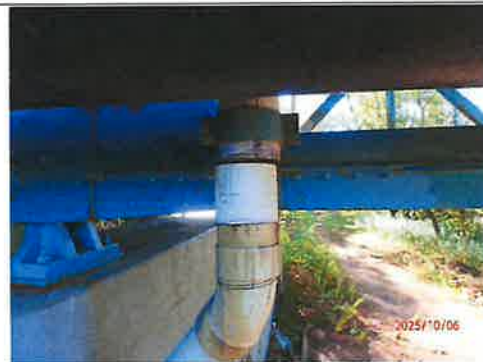
**Routine Item 26**

Disconnected down spout in Span 3 at NE drain.

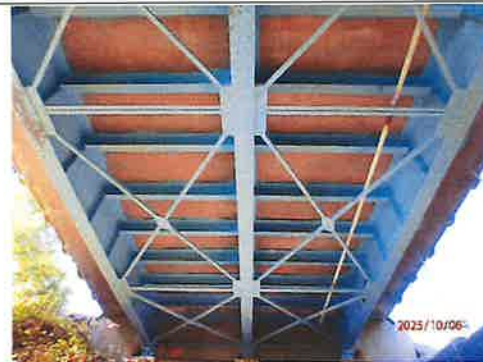
**Routine Item 27**

Representative photo of spalls in the bottom of sidewalk at some  
chain-link fence base plate locations.

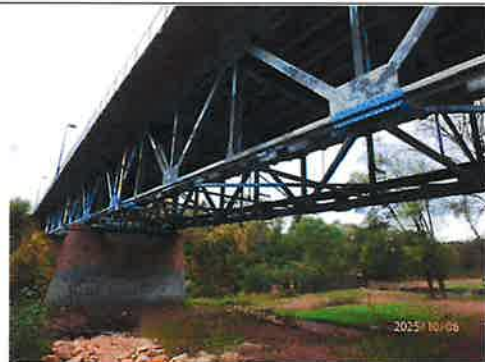
**Routine Item 30**

Span 3 south truss face. Representative photo of paint effectiveness in Span 2 and 3.
