**Alta Town Council Meeting Packet**  
**Strategic Planning Retreat**  
**September 4, 2025**

# Town of Alta Capital Projects Planning and Funding

# Town of Alta

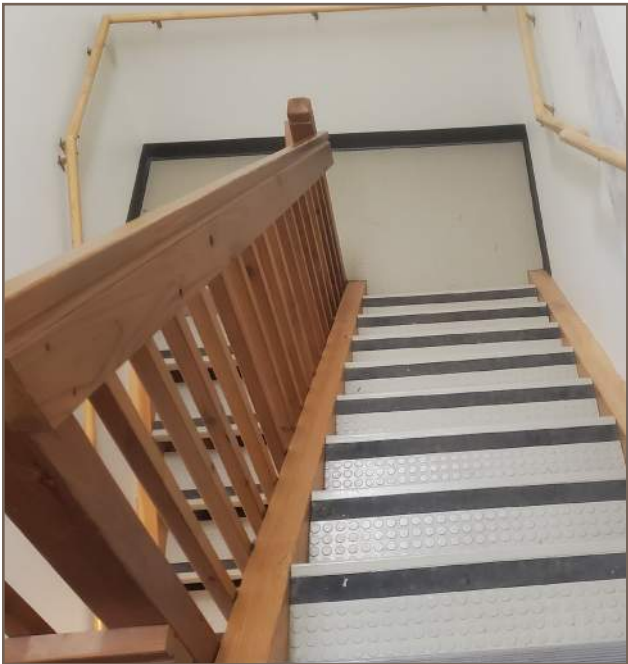
The handrail and guardrail in the interior stair are wood. The outside of the stair has a code compliant unfinished wood handrail, while the interior is a "bread loaf" railing that is not compliant with the current building code. The rail does not continue around the intermediate landing newel post un-interrupted, nor does the rail extend the required distance at the top and bottom of the stair.

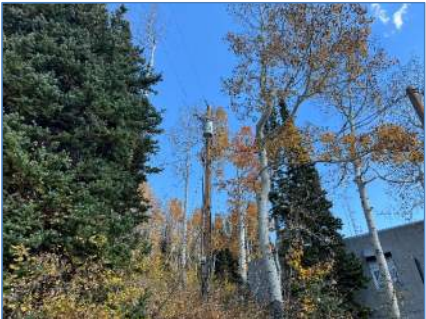
Exhibit 1 – Utility transformer (assumed) for Town Office and Marshall Building electrical service

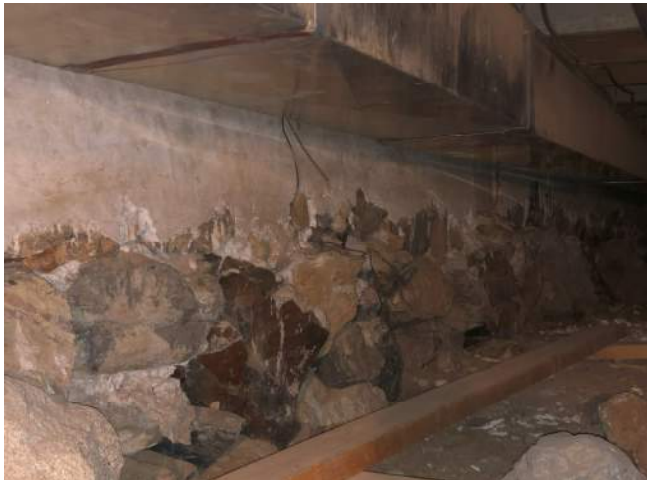
Photo #1 – Stone Rubble & Concrete Foundation

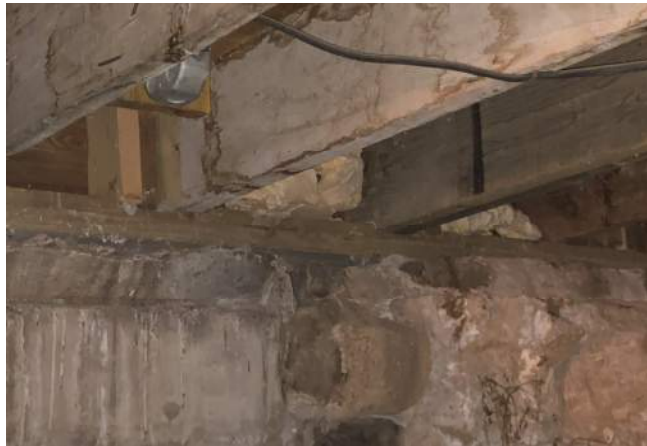
Photo #2 – Floor Joists Resting on Foundation
