## **Peru Board of Health meeting minutes**

Re: 13 Kreutzer Rd Title 5 inspection

# Title 5 Official Inspection Form

13 Kreutzer Road

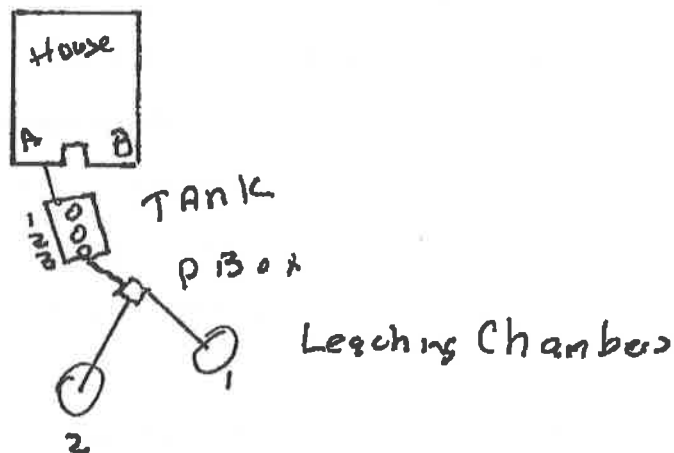
- ☒ hand-sketch in the area below  
☐ drawing attached separately

AT1 19'9"  
BT1 23'  
AT2 23'  
BT2 24'  
AT3 26'  
BT3 24' 9"  
A DB 32'3"  
B DB 26'6"  
ALC1 44'  
BLC1 22'  
ALC2 53'  
BLC2 51'

TANK 39" Below Grade  
DBOX 48" Below Grade  
LC1 28" Below Grade  
LC2 42" Below Grade
