TOWN HALL 3 EAST MAIN ROAD PERU, MA 01235

**Joint Meeting Selectboard and Building Assessment Needs Committee: July 14, 2025 @ 6:00 P.M.**

## **Town of Peru, Massachusetts Municipal Building**

In January 2025 Austin Design Cooperative was hired to conduct a feasibility study to determine the scope of work and associated costs required to renovate the existing building located at 3 East Main Road, Peru, MA.

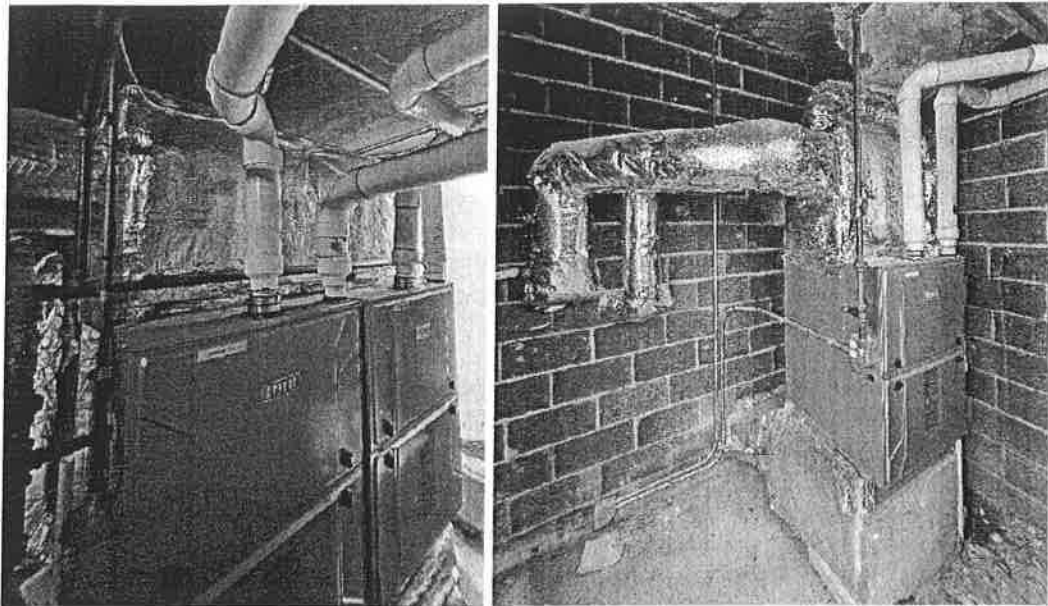
**Photo 1** - Furnaces (1 and 2, left; 3, right)

A single condensing, propane-fired furnace (manufactured by Bryant @ 2011) provides heated air to the office area via supply air ducts. The return air is routed from floor grilles and ducts in the basement back to the furnace. Most of the return air grilles appear to be blocked by shelving creating a significant deficit of return air back to the furnace. The furnace itself was observed to be in good condition. Median life expectancy of commercial grade furnaces is within the range of 15-20 years (depending upon frequency of maintenance). Based upon the age and observed condition of the furnace it is anticipated to have approximately five (5) years of remaining service life. The ductwork outside of the conditioned space is insulated. Some of the insulation near the furnace is damaged and should be repaired. The return duct routed through the crawl space is not insulated and increases heat losses.

UNIT NO.	Heat Input	Heat Output	HP	Max. Airflow	E.S.P.	Serving
Furnace #1	120MBH	117MBH	1	2055cfm	0.2in.w.c	Gym Area
Furnace #2	120MBH	117MBH	1	2055cfm	0.2in.w.c	Gym Area
Furnace #3	120MBH	117MBH	1	2055cfm	0.2in.w.c	Offices

We recommend new HVAC systems for the following three areas. All systems are different from the current design, but similar in type to one another. Each area will be conditioned by a variable refrigerant flow system (VRF). Ventilation air will be supplied and exhausted by an energy recovery ventilator (ERV). Ventilation air will be routed via ductwork to the spaces or the VRF cassettes within the ceiling space. Incoming outdoor ventilation air will be dehumidified by duct mounted dehumidifiers (DH).

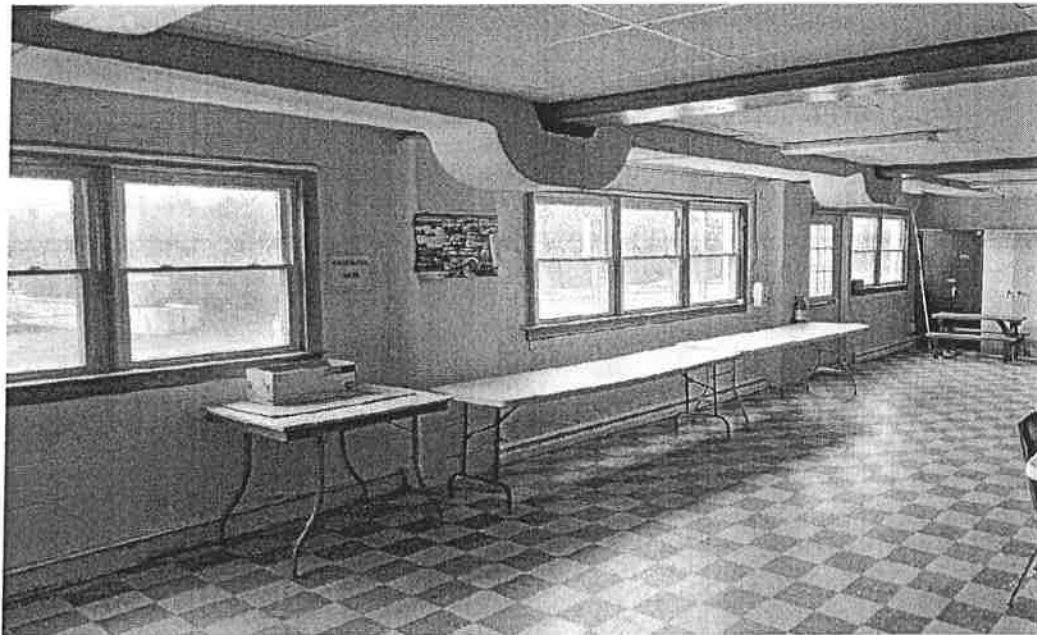
**Photo 2** - Ceiling ductwork serving upstairs gym; baseboard type air supply for basement common space

The building HVAC system is divided into three areas: office area, gym area, and the basement. All spaces are conditioned via the use of hot air furnaces. There is no central cooling nor outdoor air ventilation being provided to any of the areas. Fresh air enters the building by 'natural' means (through windows or uncontrolled infiltration). Such air is not filtered, tempered or humidity controlled.

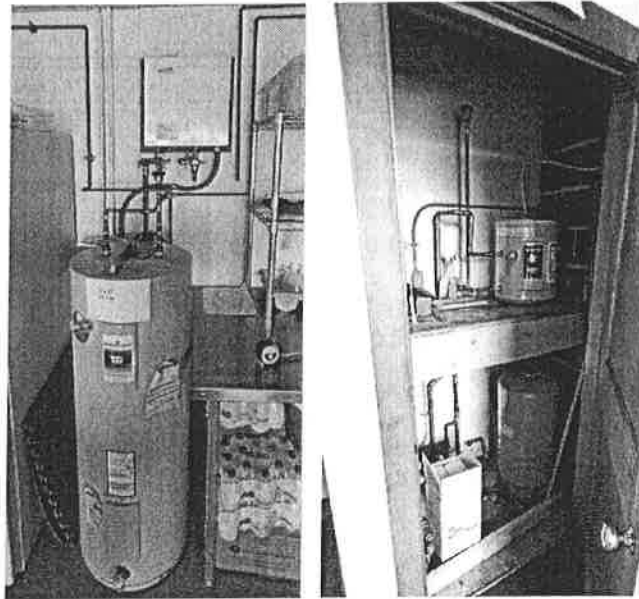
Domestic cold water is supplied by a well water system. The pump and pressure tank, located in an office closet, were manufactured in 2015. External corrosion is visible at the pipe connections. Internal conditions of the devices were not accessible for observation.

The building contains three electric water heaters. Two located in the basement and one in an upstairs closet. A 1994 Bradford White tank style water heater, with 40-gallon storage volume and 4500-watt of heat input, located in the kitchen provides hot water for the basement's restroom and the kitchen. According to the police chief, the newer Power Star tankless water heater was never connected to the plumbing since the building's electrical system could not support its operation. The 1994 water heater is well past the expected service life and should be replaced.

The upstairs restrooms are connected to a 2015 Bradford White water heater (model RE1606) with 6-gallon storage volume and 1500-watt of heat input. Tighe & Bond exercised the water heater by turning on the hot water in the sink. We observed that the water produced was not hot after xx minute of the running faucet. We recommend a Plumbing contractor being engaged to service the equipment to determine if simply adjustment will remedy the issue or if wholesale replacement is required.

**Photo 4 (left)** - Basement water heaters (tank type, and unconnected instantaneous type)

**Photo 5 (right)** - Upstairs water heater and well water system

1. Replacement of all fixtures and installation of additional ones (five lavatories, five toilets, one mop sink)
2. Replacement of water heaters with a mixture of
  - a. One centralized 50-gallon storage tank heat pump water heater
  - b. One 5-kilowatt instantaneous point-of-use water heaters

The domestic hot and cold water piping will be replaced throughout to meet the new design layout. The well pump system and pressure tank will be replaced as well.

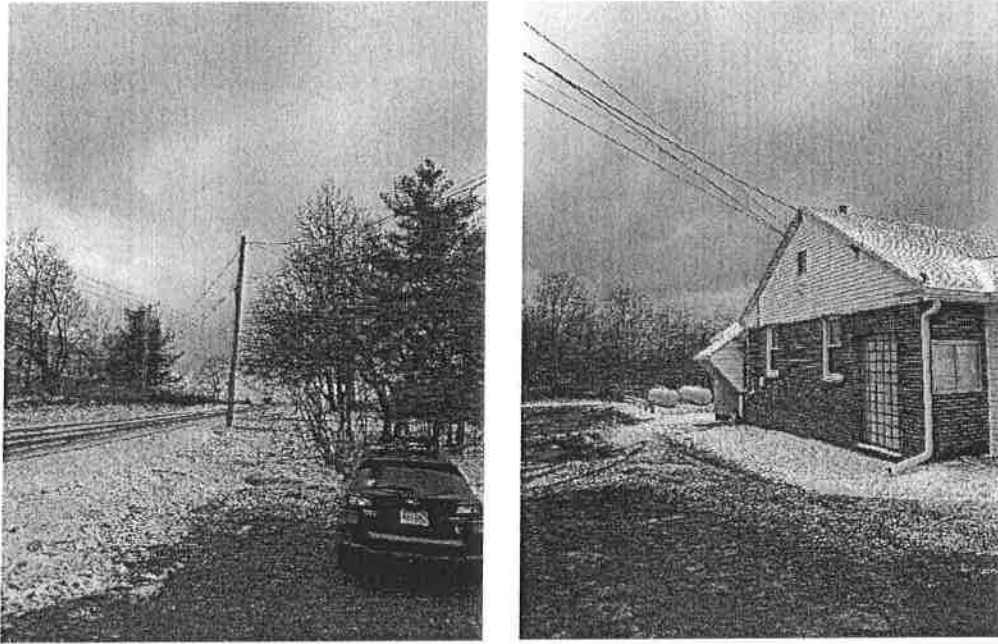
**Photos 1 & 2 – Utility Pole & Overhead Electric Lines To Building**

The building electrical service originates from existing utility pole #41-1 (along Main Road), with electrical lines running overhead from the utility pole over to a weatherhead (mounted on the side of the building).

- This level of electrical upgrade will require the local service utility company (Eversource) to get involved. A utility 3-Phase primary circuit will need to be extended over to a new 3-Phase transformer to serve the building. Note – all primary circuit provisions and utility transformer shall be provided by the utility company. A meeting with the utility company on site during the early stages of design is recommended to coordinate the new electrical service for the building.

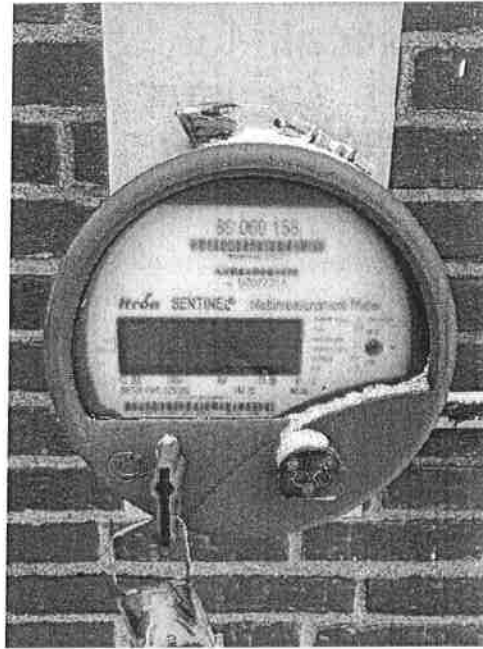
**Photo 3 – Utility KW Demand Meter**

The electrical lines transition down the side of a building (routed in RGS conduit) into the utility kW demand meter.

The utility meter is mounted within a NEMA-3R socket enclosure and is rated as follows: CL200, 240V, 3W, 60Hz. The meter number is 89-069-158. The building is equipped with a separately metered electrical service and the electrical infrastructure is arranged for a single-tenant occupancy.

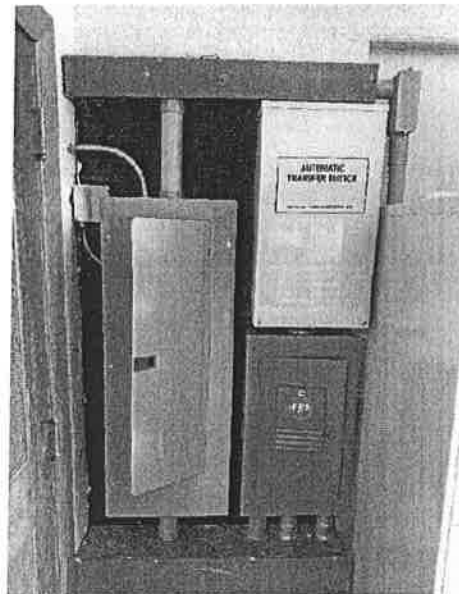
**Photo 4 – 1<sup>st</sup> Floor Main Electric Distribution Equipment**

The main electrical distribution equipment is established in the 1<sup>st</sup> floor office space. Electrical equipment in this office includes the following:

- Main Service Fuse Switch: Rated 200A, 120/240V, 1-Phase, 3-Wire – manufactured by Federal Pacific Equipment (FPE)
- Main Power Panel: Rated 200A, 120V/240V, 1-Phase, 3-Wire, 42-Poles – manufactured by Eaton BR Series
- Automatic Transfer Switch (with integral 200A Disconnect)

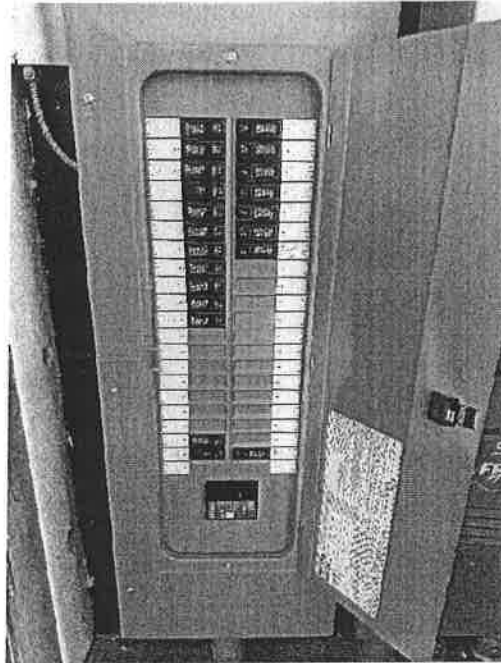
**Photo 5 – 1<sup>st</sup> Floor Main Power Panel**

The main power panel is equipped with branch circuits serving the following loads:

- Office general-purpose receptacles (fed via multiple 20A, 120V branch circuits)
- Cellar Exhaust Fan & Dehumidifier (fed via 20A, 120V branch circuit)
- Printer (fed via 15A, 120V branch circuit)
- Interior lighting (fed via 15A, 120V branch circuit)
- Well Pump (fed via 20A, 240V branch circuit)
- Hot Water Heater (fed via 30A, 240V branch circuit)
- Basement Level Sub-Panel (fed via 200A, 240V sub-feed breaker)

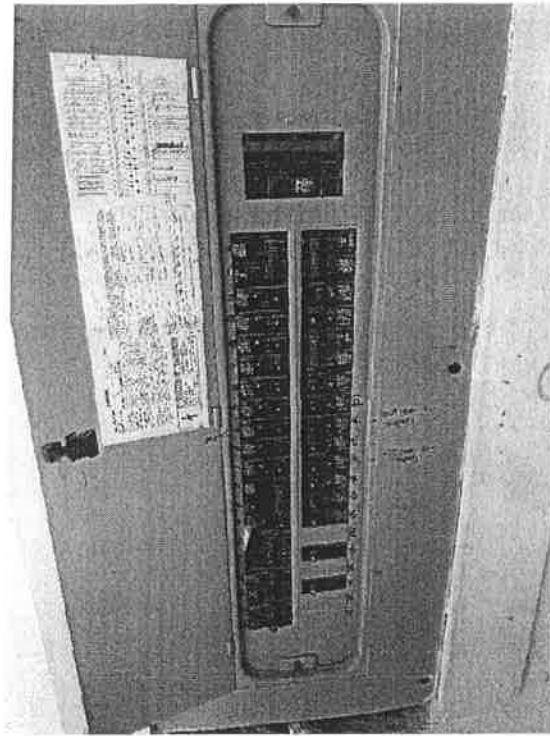
**Photo 6 – Basement Power Sub-Panel**

The basement level recessed mounted sub-panel (no label – fed via main power panel) is rated as follows: 200A, 120/240V, 1-Phase, 3-Wire, 40-Poles. The panel is equipped with a top-mounted 200A Main Circuit Breaker (MCB) and is manufactured by Siemens, catalog #G4040MB1200. The panel is equipped with branch circuits serving the following:

- Kitchen/Cafeteria receptacles (fed via multiple 20A, 120V branch circuits)
- Police Department receptacles (fed via multiple 20A, 120V branch circuits)
- Kitchen/Cafeteria lighting (fed via multiple 20A, 120V branch circuits)
- Exterior lighting (fed via multiple 20A, 120V branch circuits)
- Exit signs (fed via 20A, 120V branch circuit)
- Hot water heater (fed via 30A, 240V branch circuit)
- Kitchen Stove (fed via 50A, 240V branch circuit)
- Blowers (fed via 20A, 240V branch circuit)
- Police Garage (fed via 60A, 240V branch circuit)
- 2<sup>nd</sup> Floor Storage Panel (fed via 100A, 240V branch circuit)

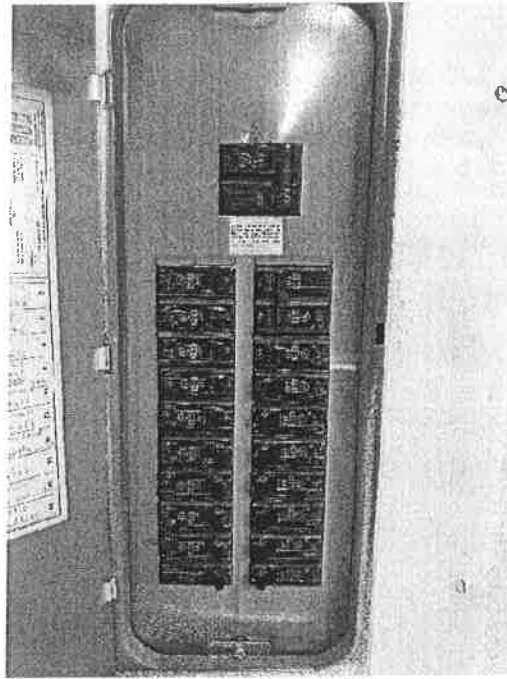
**Photo 7 – 2<sup>nd</sup> Level Sub-Panel**

The 2<sup>nd</sup> level surface mounted sub-panel (no label – fed via basement sub-panel) is rated 100A, 120/240V, 1-Phase, 3-Wire, 20-Poles. The panel is equipped with a top-mounted 100A MCB and is manufactured by GE PowerMark Gold Series. The panel is equipped with branch circuits serving the following:

- Gym lighting (fed via multiple 20A, 120V branch circuits)
- Event hall lighting (fed via 20A, 120V branch circuit)
- Exit signs & Emergency Lights (fed via 20A, 120V branch circuit)
- Computer room receptacles (fed via 20A, 120V branch circuit)
- North/West wall receptacles (fed via multiple 20A, 120V branch circuits)
- AC outlet (fed via 20A, 120V branch circuit)
- Police/Security receptacles (fed via multiple 20A, 120V branch circuits)

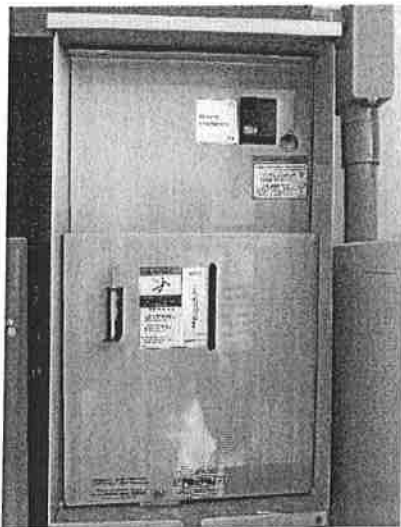
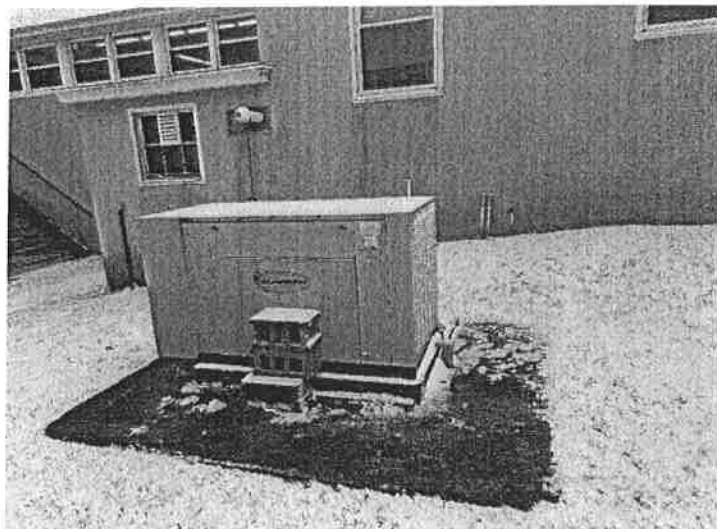
**Photos 8 & 9 – Natural Gas Generator & ATS**

The building is also equipped with a natural gas standby power generator (mounted outside) providing back up power for the entire building. Note – the generator did not have a nameplate placard listing the equipment’s electrical ratings (i.e. KW/KVA, Voltage, Phase, etc.). Based on the 200A breaker inside the automatic transfer switch (ATS), we can assume the intent of the generator system is to provide backup power for the entire 200A, 120/240V electric service.

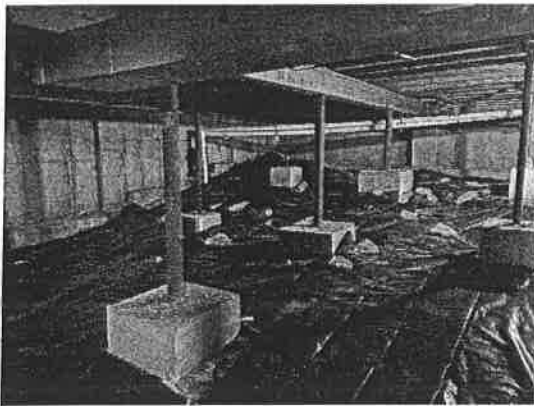
**Photo 9** – Foundations and Wood Framing

The Peru Town Hall is a two-story building with multiple structural systems utilized for support. The building sits on CMU and reinforced concrete foundations. The East portion of the building is single story with attic space. Floor construction is wood framing. Walls appear to be CMU with brick veneer. The roof system is wood trusses with wood plank decking.

All structural systems throughout the building appear to be in good serviceable condition. No signs of overstress were observed during our site walk. Doors and windows were operating properly, and roof lines appear to be straight. No signs of significant building movement or water damage were noted at the time of our site visit. No calculations were performed verifying the load carrying capacity of the existing structural members, therefore commentary regarding their adequacy is based solely on visual inspections and observations.

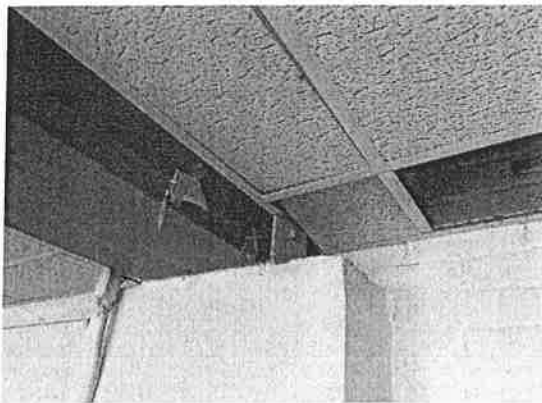
**Photo 11** – Glulam on Pilaster

The West portion of the building has two accessible levels, one walk in basement level and one main level above. Floor construction for the basement level is concrete slab on grade, and the floor construction for the upper level is large glue laminated beams with wood joists and a hardwood deck for flooring. The upper-level floor appears to be supported on CMU bearing walls, however, the roof system is constructed of multiple glue laminated frames which bear on pilasters located in the within the lower-level walls. Therefore, the CMU wall above the upper-level floor appears to be non-load bearing. Wood roof joists span to the glue laminated frames to support the roof deck which was not visible.

The use of the existing upper-level area is proposed to be split into office space and community assembly type space. Because assembly spaces require heavy load carrying capacity, it is recommended as part of the next phase that Tighe & Bond analyze the load carrying capacity of the existing construction for the upper-level floor. Alternatively, if original construction drawings with structural load rating information is available, Tighe & Bond can review the drawings and determine if proposed loading is acceptable for the existing construction.
