# Village of Somerset Facilities Condition Assessment + Space Needs Study Report

January 2024

# Public Works Facility Assessment

# Village Hall Facility Assessment

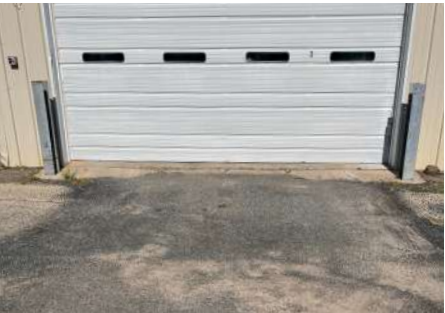
| Sub Category | Element/Location | Condition | Priority | Details | Recommendations | Estimated Cost |
|---|---|---|---|---|---|---|
| Drainage | Garage Entrance | Poor | 2 | Asphalt has settled and has required multiple patches. Water pools in front of the door with the negative drainage grade. | Replace asphalt and regrade. | \$2,300 |

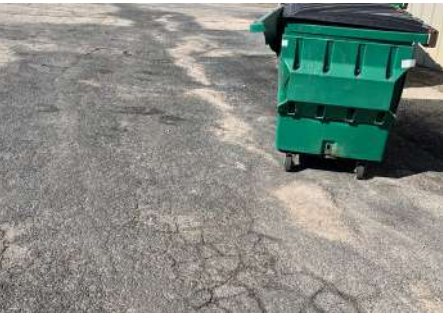
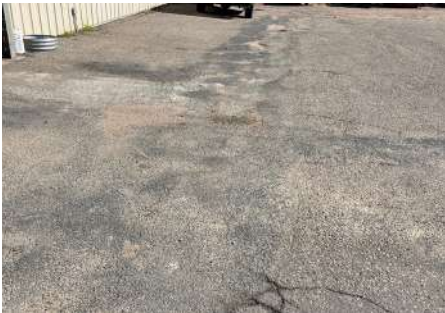
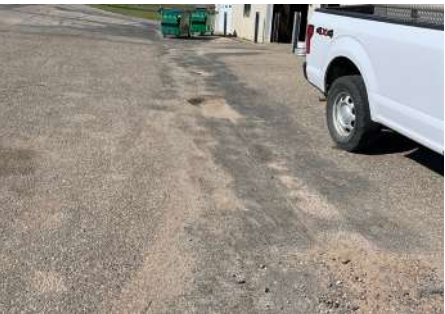
| Sub Category | Element/Location | Condition | Priority | Details | Recommendations | Estimated Cost |
|---|---|---|---|---|---|---|
| Drainage | Driveway | Poor | 2 | Drainage provided is the only surface drainage that carries water across the entire site, as well as the building front to the north. | Install storm sewer system to outlet on the north side of the property. | \$60,500 |

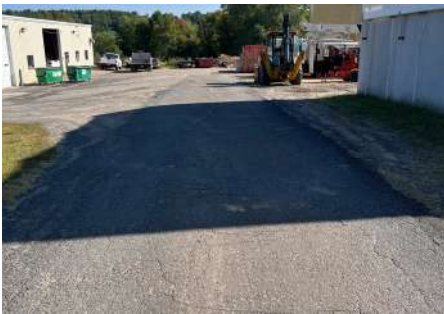
| Sub Category | Element/Location | Condition | Priority | Details | Recommendations | Estimated Cost |
|---|---|---|---|---|---|---|
| Vehicle Routes | Entry Driveway | Poor | 2 | Asphalt is spider cracking throughout the driveway and chunks are being removed on edges by unpaved routes. | Replace asphalt. | \$152,000 |

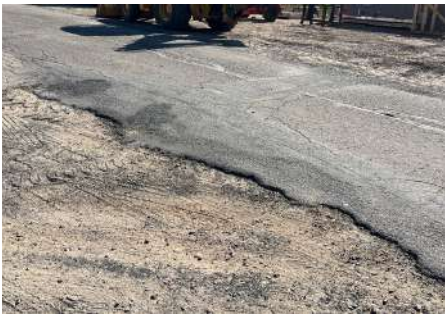
| Sub Category | Element/Location | Condition | Priority | Details | Recommendations | Estimated Cost |
|---|---|---|---|---|---|---|
| Vehicle Routes | Entry Driveway | Poor | 2 | Asphalt is spider cracking and chunks are being removed along the edges of the unpaved entry to the storage shed. | Replace asphalt. | \$6,900 |

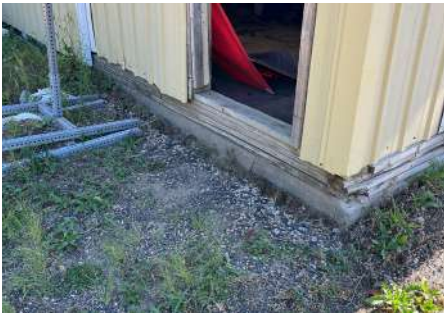
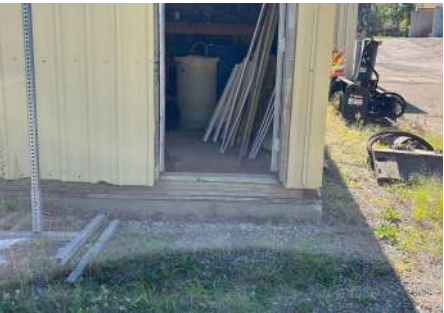
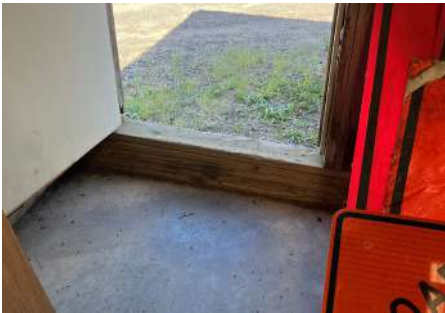
| Sub Category | Element/Location | Condition | Priority | Details | Recommendations | Estimated Cost |
|---|---|---|---|---|---|---|
| Pedestrian Routes | Entry Landing | Poor | 1 | No ADA landing is present into entry door and bump through doorway exceeds ADA maximum of one-quarter inch. | Create landing outside and inside of doorway and a ramp inside the doorway. | \$4,600 |

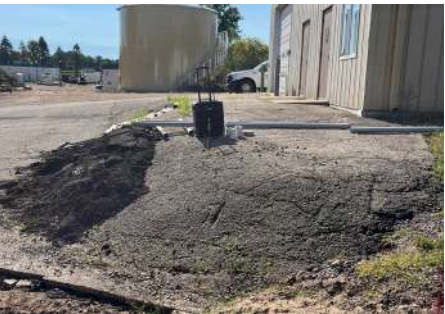
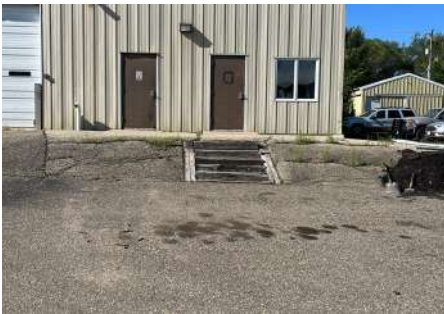
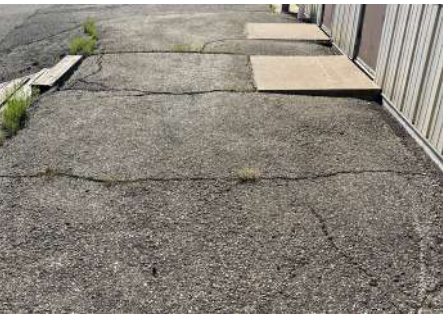
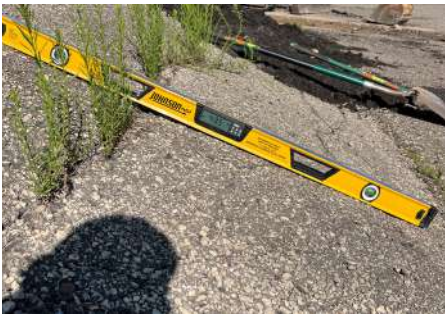
| Sub Category | Element/Location | Condition | Priority | Details | Recommendations | Estimated Cost |
|---|---|---|---|---|---|---|
| Pedestrian Routes | Handrail | Poor | 1 | There is no handrail along a steep slope (43.5%) of walking area on the north side of the building. | Install handrail. | \$3,100 |

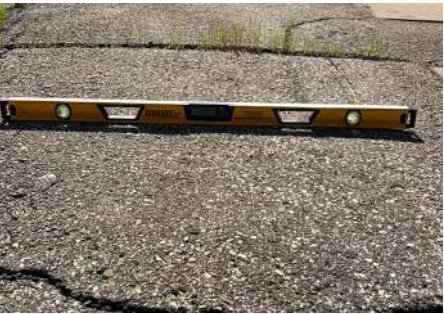
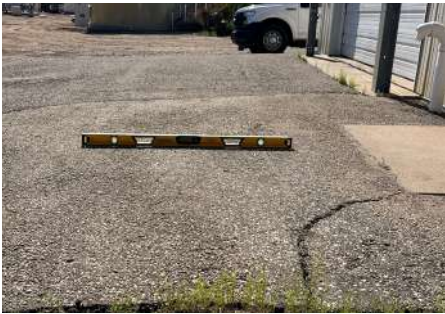
| Sub Category | Element/Location | Condition | Priority | Details | Recommendations | Estimated Cost |
|---|---|---|---|---|---|---|
| Pedestrian Routes | Sidewalk | Poor | 1 | Sidewalk is cracking and crumbling asphalt. The cross slope of the walk exceeds ADA maximum of 2%. | Remove asphalt and install proper graded concrete sidewalk. | \$11,700 |

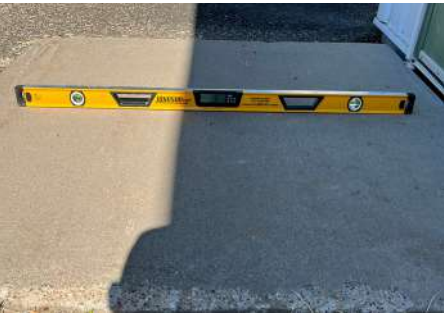
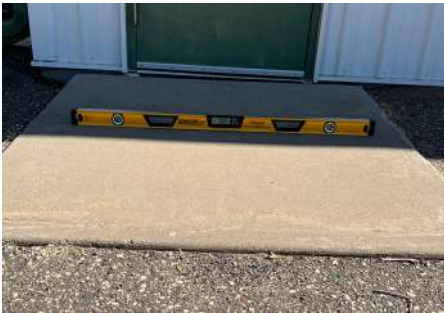
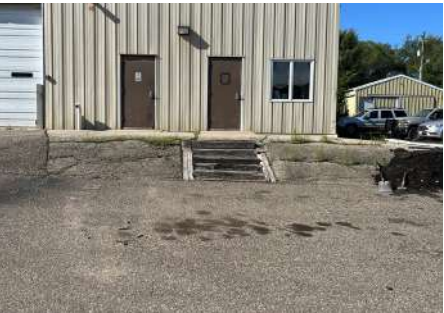
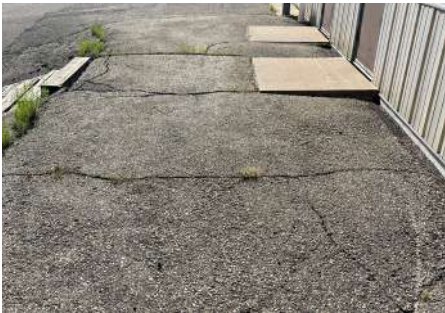
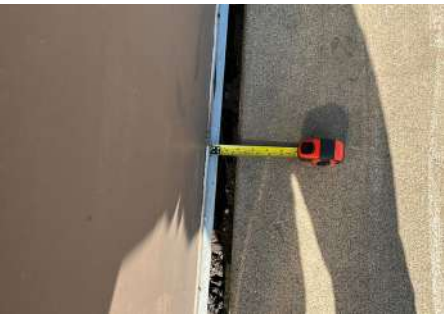
| Sub Category | Element/Location | Condition | Priority | Details | Recommendations | Estimated Cost |
|---|---|---|---|---|---|---|
| Pedestrian Routes | Entry Landing | Poor | 1 | Landing exceeds ADA required 2% maximum slope in any direction. Located at north storage building. | Replace concrete panels. | \$2,300 |
| Pedestrian Routes | Entry Landing | Poor | 1 | Landing exceeds ADA required 2% maximum slope in any direction. Located at north side of main building, west door. Large gap between walkway and door. | Replace concrete panels. | \$2,300 |
| Pedestrian Routes | Entry Landing | Poor | 1 | Landing exceeds ADA required 2% maximum slope in any direction. Located at north side of main building, east door. Large gap between walkway and door. | Replace concrete panels. | \$2,300 |
| Pedestrian Routes | Entry Landing | Poor | 1 | Landing exceeds ADA required 2% maximum slope in any direction. Located at south side of main building. | Replace concrete panels. | \$2,300 |

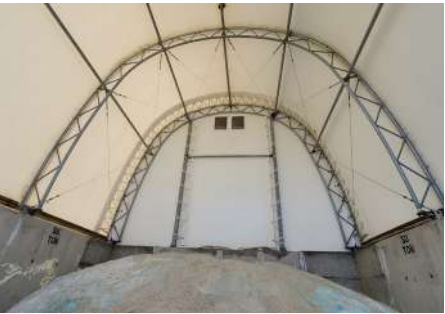
Hoop Structure/Salt Storage Roof

| Sub Category | Element/Location | Condition | Priority | Details | Recommendations | Estimated Cost |
|---|---|---|---|---|---|---|
| Exterior Roof | Hoop Structure/<br>Salt Storage Roof | Good | 3 | Steel roof hoop structure and canvas has normal wear. | Perform regular maintenance. | \$0 |

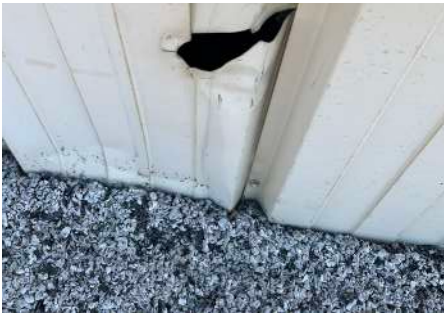
Damaged Panels

| Sub Category | Element/Location | Condition | Priority | Details | Recommendations | Estimated Cost |
|---|---|---|---|---|---|---|
| Exterior Walls | Panels | Fair | 2 | Select damaged panels. | Repair or replace panels to enclose the envelope. | \$8,000 |

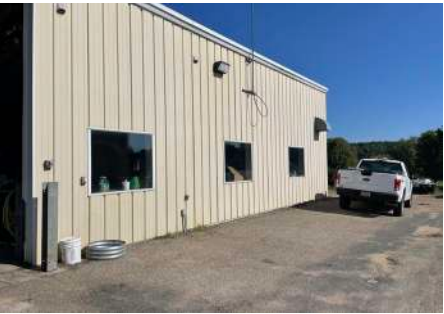
| Sub Category | Element/Location | Condition | Priority | Details | Recommendations | Estimated Cost |
|---|---|---|---|---|---|---|
| Exterior Walls | Panels/Northeast Corner | Fair | 2 | Select damaged panels. | Would benefit from an additional bollard to protect corner. Repair or replace panels. | \$2,200 |

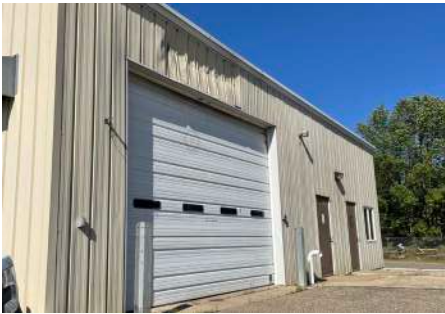
Metal Panel/Northern East Wall

| Sub Category | Element/Location | Condition | Priority | Details | Recommendations | Estimated Cost |
|---|---|---|---|---|---|---|
| Exterior Walls | Metal Panel/<br>Northern East Wall | Fair | 3 | Metal panel exterior material shows normal wear. | Perform regular maintenance. | \$0 |

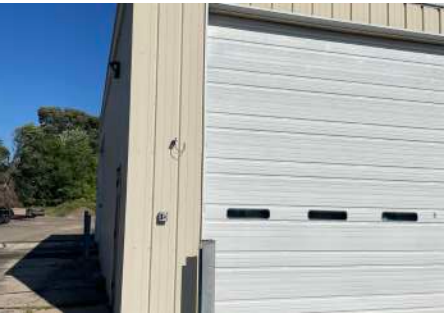
Metal Panel/South Corner

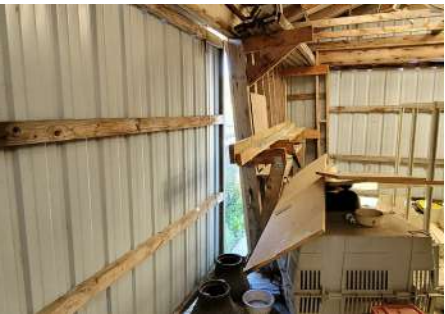
| Sub Category | Element/Location | Condition | Priority | Details | Recommendations | Estimated Cost |
|---|---|---|---|---|---|---|
| Exterior Walls | Wall/Animal Shelter | Poor | 1 | A portion of the exterior wall has been pushed out of plane. | Repair wall. | \$5,300 |

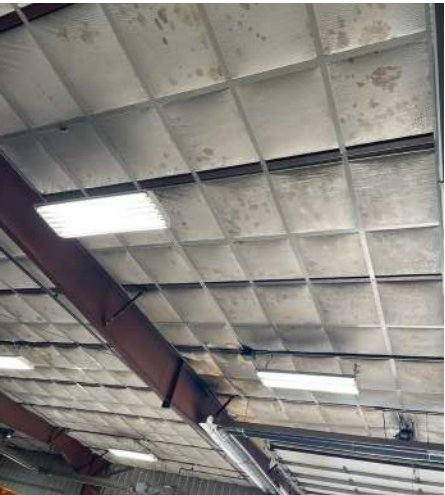
| Sub Category | Element/Location | Condition | Priority | Details | Recommendations | Estimated Cost |
|---|---|---|---|---|---|---|
| Interior Ceiling | Ceiling | Good | 3 | The ceiling condition shows normal wear. | Perform regular maintenance. | \$0 |

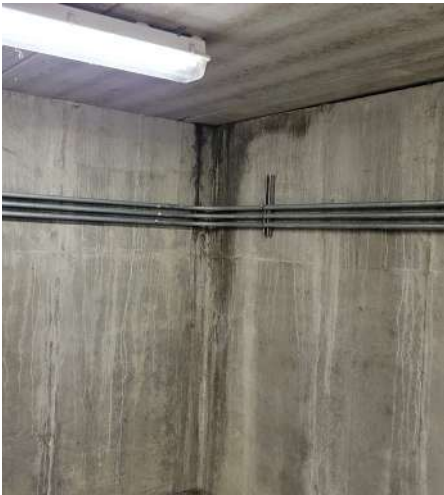
| Sub Category | Element/Location | Condition | Priority | Details | Recommendations | Estimated Cost |
|---|---|---|---|---|---|---|
| Interior Walls | UV/Storage Building | Fair | 2 | There are signs of water intrusion into the lower level of the building. | Find and repair area of water intrusion. | \$3,800 |

UV/Storage Building

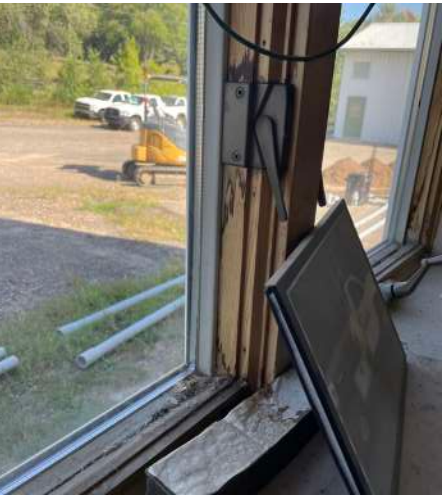
| Sub Category | Element/Location | Condition | Priority | Details | Recommendations | Estimated Cost |
|---|---|---|---|---|---|---|
| Interior Windows | Office Window | Fair | 2 | The window interior frame/jamb shows signs of moisture. | Replace windows. | \$3,700 |

Office Window

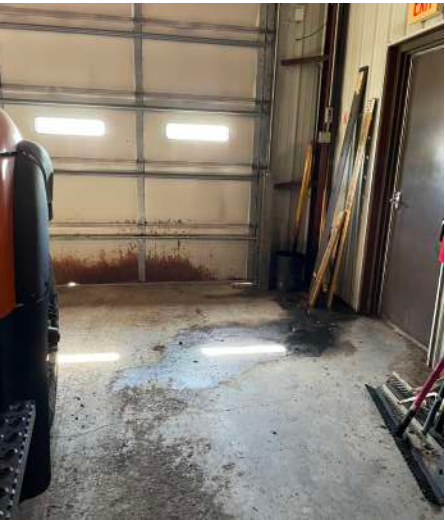
| Sub Category | Element/Location | Condition | Priority | Details | Recommendations | Estimated Cost |
|---|---|---|---|---|---|---|
| Interior Doors | Swing Door | Fair | 2 | Moisture and salt have resulted in rust damage at base of swing doors. | Replace doors and frames. | \$18,800 |
| Interior Doors | Overhead Door | Fair | 2 | Moisture and salt have resulted in rust damage at base of overhead doors. | Replace overhead doors. | \$45,400 |

Overhead + Swing Door

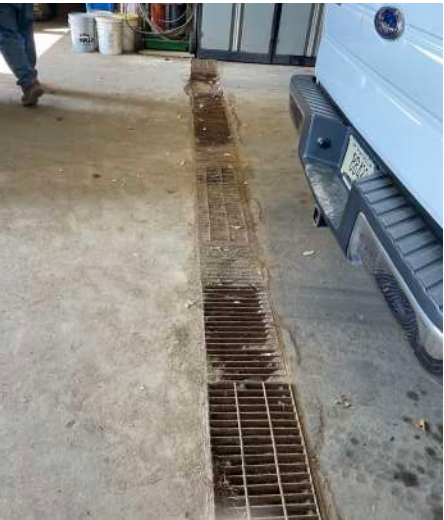
| Sub Category | Element/Location | Condition | Priority | Details | Recommendations | Estimated Cost |
|---|---|---|---|---|---|---|
| Interior Floors | Trench Drain | Fair | 2 | There is evidence of trench failure. Some sections were sunken and other sections were clogged. | Remove and replace with new trench. | \$9,100 |

Trench Drain

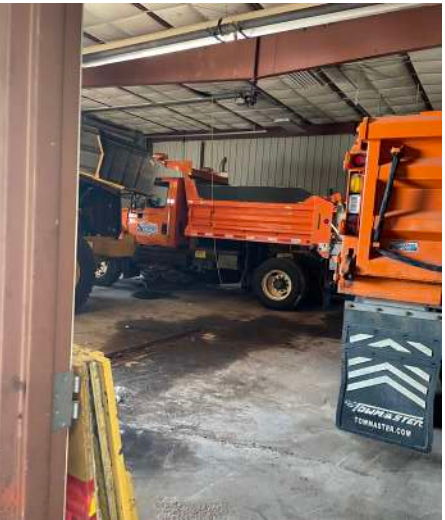
| Sub Category | Element/Location | Condition | Priority | Details | Recommendations | Estimated Cost |
|---|---|---|---|---|---|---|
| Interior Floors | Exiting Path | Poor | 1 | Exit routes are impeded due to parked vehicles and the piles of storage. | Adjust location of parked vehicles and storage. Mark routes with paint to denote path to remain clear. | \$750 |

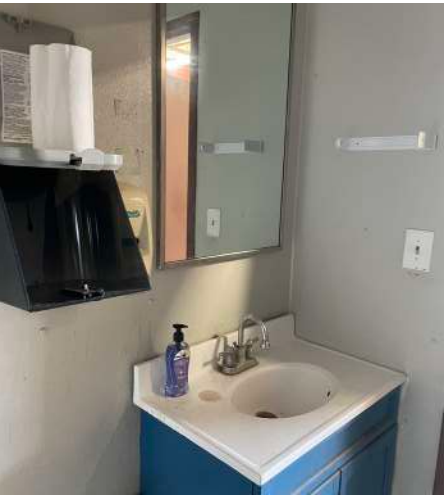
| Sub Category | Element/Location | Condition | Priority | Details | Recommendations | Estimated Cost |
|---|---|---|---|---|---|---|
| Interior Casework | Restroom Vanity | Poor | 1 | Vanity does not allow for front approach or side approach. Faucet does not have approved levers for accessibility and the mirror is placed too high for accessibility. | Replace vanity with wall mounted lavatory or removable base. Update single lever faucet. Lower mirror or angle. | \$8,400 |

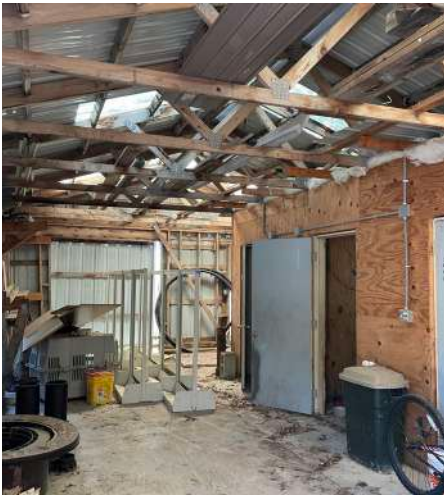
| Sub Category | Element/Location | Condition | Priority | Details | Recommendations | Estimated Cost |
|---|---|---|---|---|---|---|
| Interior Other | Interior Cold Storage Garage | Poor | 3 | This building is no longer serving its intended purpose, is damaged, and the cost of repair would exceed its value. | Demolish building. | \$9,100 |

Interior Cold Storage Garage

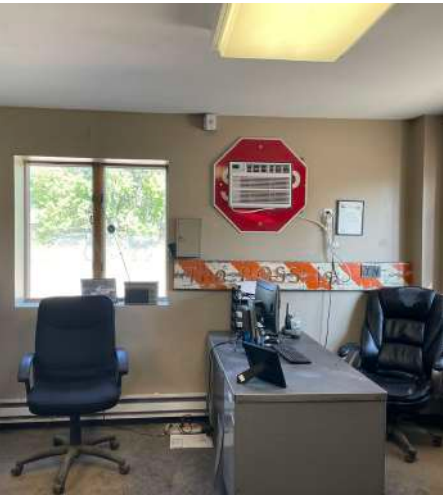
| Sub Category | Element/Location | Condition | Priority | Details | Recommendations | Estimated Cost |
|---|---|---|---|---|---|---|
| Interior Other | Shared Office | Fair | 2 | The office is shared by three staff with a wall AC unit. The space lacks adequate air exchange resulting in reduced air quality and indications of moisture damage at wood fames. | Replace wall unit with a P-Tac unit or similar. | \$11,800 |

Shared Office

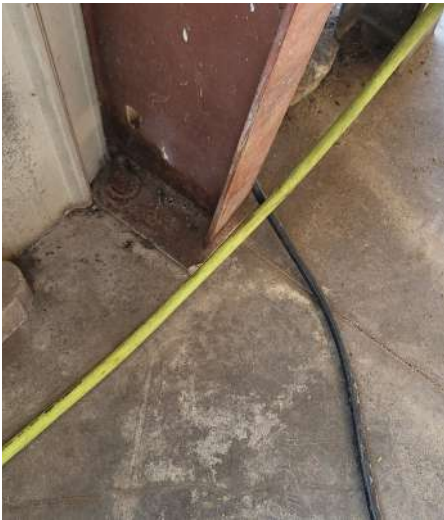
| Sub Category | Element/Location | Condition | Priority | Details | Recommendations | Estimated Cost |
|---|---|---|---|---|---|---|
| Interior Other | 808 Building PEMB Frames | Good | 3 | Building frames of the 808 building are in good condition and show normal wear. | Perform regular maintenance. | \$0 |

808 Building PEMB Frames

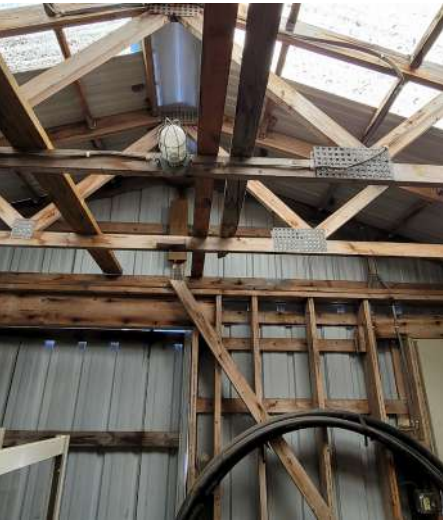
| Sub Category | Element/Location | Condition | Priority | Details | Recommendations | Estimated Cost |
|---|---|---|---|---|---|---|
| Interior Other | Animal Shelter Roof Trusses | Fair | 2 | The roof trusses are aged but show normal wear. | Perform regular maintenance. | \$0 |

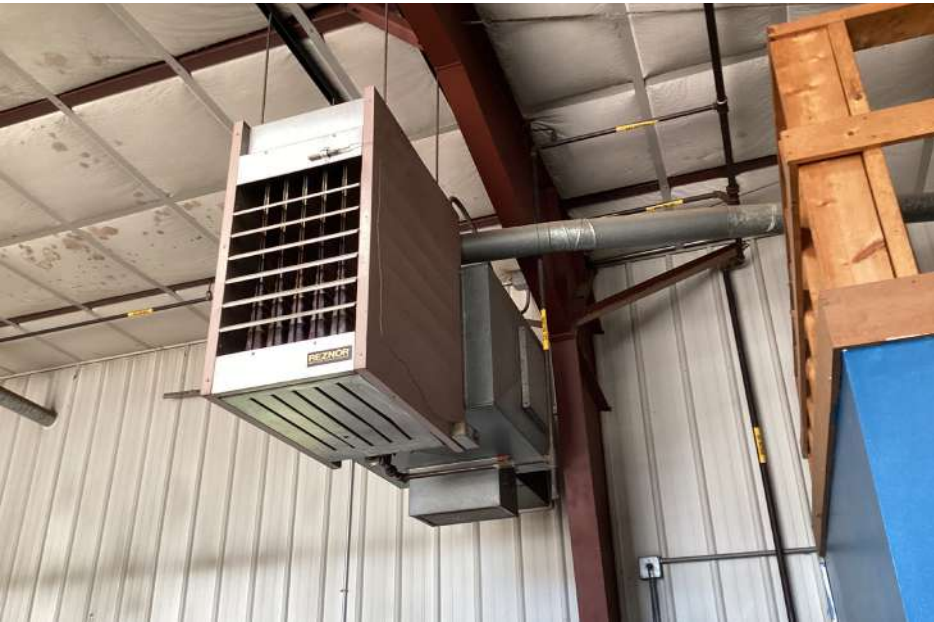
Unit Heaters/Shop

| Sub Category | Element/Location | Condition | Priority | Details | Recommendations | Estimated Cost |
|---|---|---|---|---|---|---|
| Heating Cooling | Heaters/Shop | Fair | 2 | There is a natural gas-fired heater that provides heating to the shop. Ceiling mounted infrared tube heaters provide additional heating. The infrared tube heaters appear to have varying ages. The average useful service life of this equipment is 15 years. | Replace heating equipment. | \$182,000 |

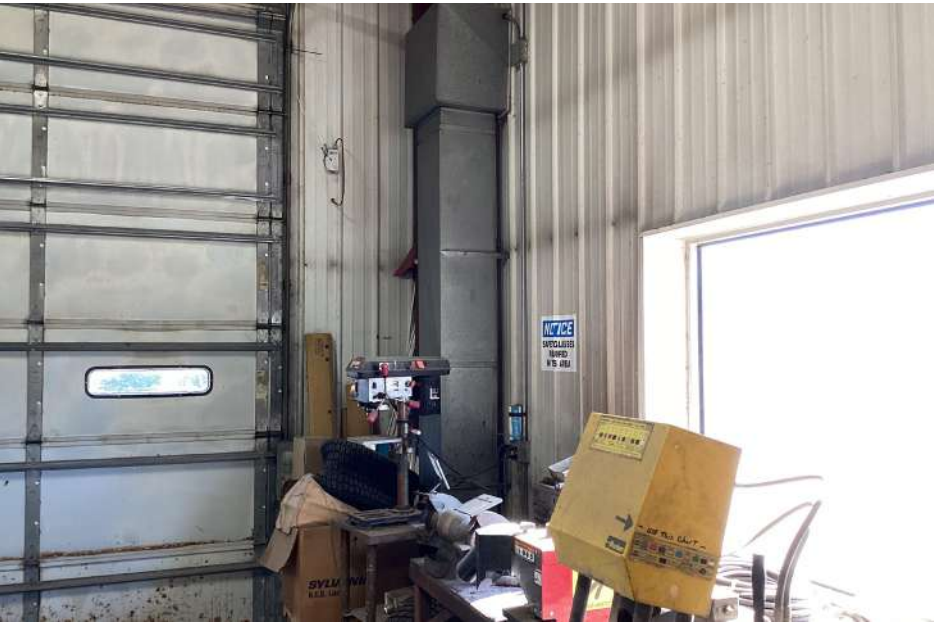
| Sub Category | Element/Location | Condition | Priority | Details | Recommendations | Estimated Cost |
|---|---|---|---|---|---|---|
| Piping Heating Cooling | Ventilation/Shop | Poor | 1 | General exhaust is provided in the shop area. Make-up air unit is mounted on the north wall, with the exhaust mounted on the southeast wall. This system uses manual controls. | Install CO/NO2 sensors that are interlocked with ventilation system. | \$36,300 |

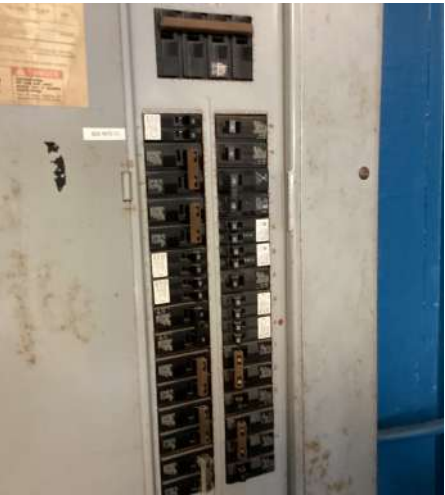
| Sub Category | Element/Location | Condition | Priority | Details | Recommendations | Estimated Cost |
|---|---|---|---|---|---|---|
| Power Supply | Electrical Panel | Poor | 1 | The main electrical panel is original to construction in 1991. The breakers are showing signs of corrosion. The average useful service life of this equipment is 30 years. | Replace the electrical panel. | \$18,900 |

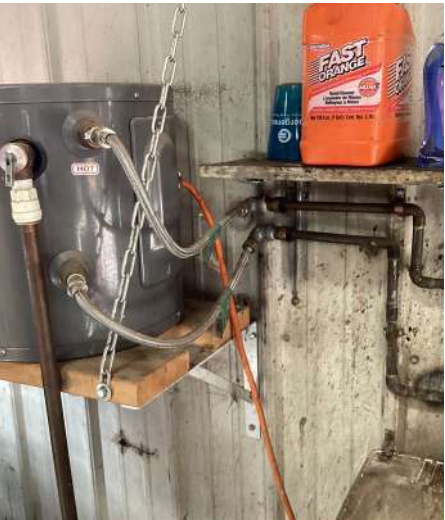
Water Heater/Shop

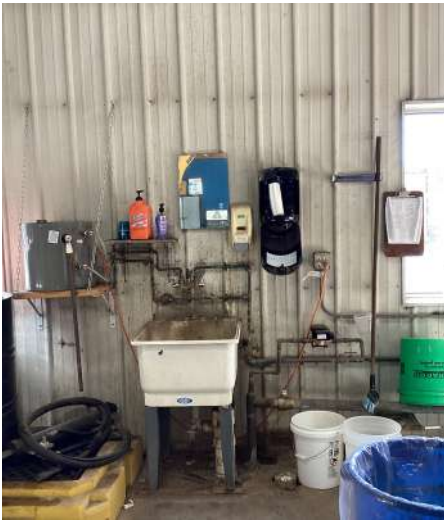
| Sub Category | Element/Location | Condition | Priority | Details | Recommendations | Estimated Cost |
|---|---|---|---|---|---|---|
| Power Supply | Receptacles/ Shop Sink Area | Poor | 1 | The receptacle that is located near the sink in the shop does not appear to be GFCI protected. | Replace with GFCI. | \$310 |

Receptacles/Shop Sink Area

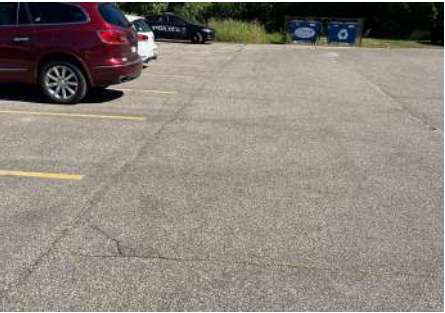
| Sub Category | Element/Location | Condition | Priority | Details | Recommendations | Estimated Cost |
|---|---|---|---|---|---|---|
| Vehicle Routes | Parking Lot | Poor | 1 | ADA parking stall loading area is above 2% cross slope from parking space to sidewalk. | Find and repair area of water intrusion. | \$6,900 |

Accessible Parking + Route

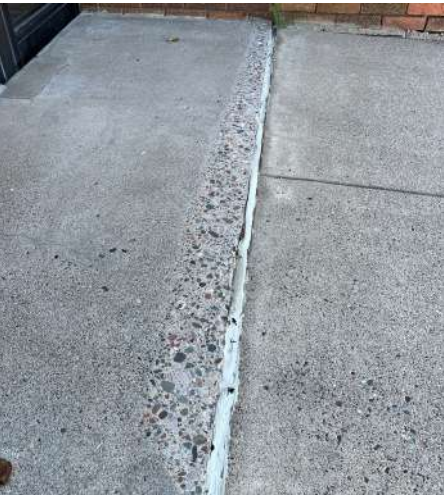
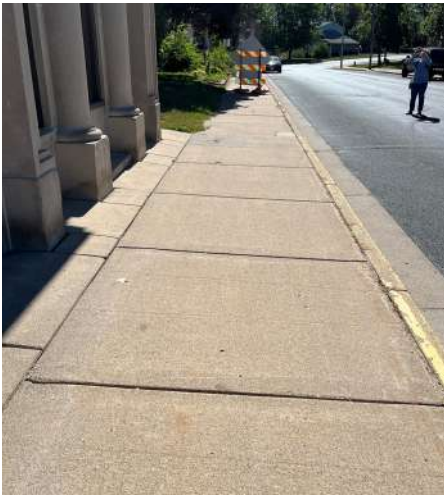
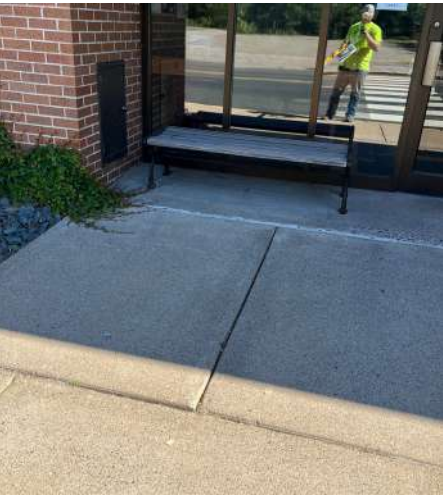
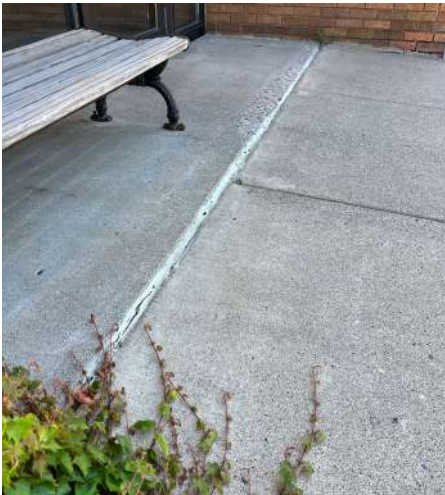
| Sub Category | Element/Location | Condition | Priority | Details | Recommendations | Estimated Cost |
|---|---|---|---|---|---|---|
| Pedestrian Routes | Entry Landing | Poor | 1 | Landing exceeds ADA required 2% maximum slope in any direction. | Replace concrete panels. | \$2,600 |

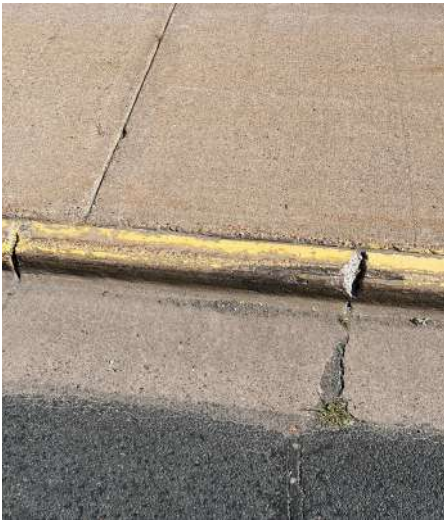
| Sub Category | Element/Location | Condition | Priority | Details | Recommendations | Estimated Cost |
|---|---|---|---|---|---|---|
| Pedestrian Routes | Curb + Gutter | Poor | 2 | Curb and gutter is cracked in multiple locations and lacks paint. | Perform regular maintenance. | \$0 |

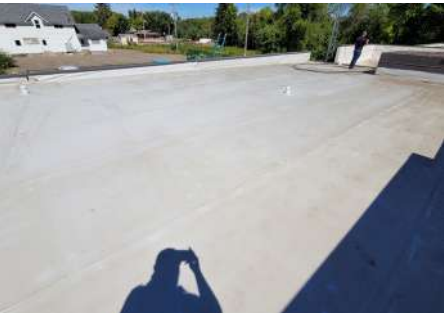
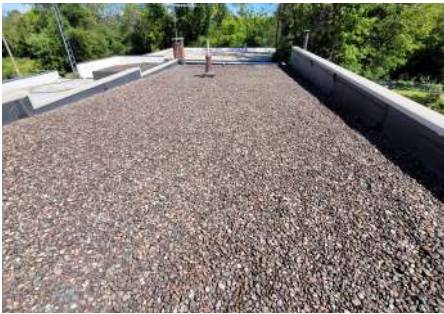
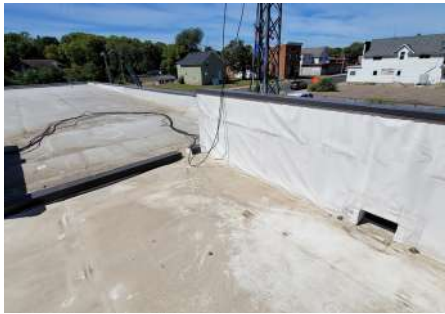
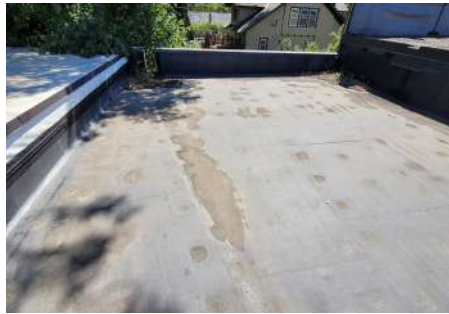
| Sub Category | Element/Location | Condition | Priority | Details | Recommendations | Estimated Cost |
|---|---|---|---|---|---|---|
| Exterior Roof | Roof | Fair | 2 | The roof is a combination of fully adhered EPDM, ballasted EPDM, and fully adhered TPO. The ballasted sections appear to have been installed in 2005. TPO sections were installed in 2012 with the addition of the police station. The average useful service life of the different roof membranes is 20–20 years. Debris is blocking scupper on the south wall. TPO material is loose on the higher parapet walls. | Replace ballasted sections. Repair TPO material on parapet walls. Clean debris from scupper. | \$68,100 |

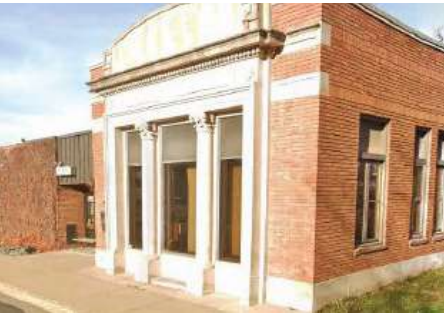
| Sub Category | Element/Location | Condition | Priority | Details | Recommendations | Estimated Cost |
|---|---|---|---|---|---|---|
| Exterior Walls | Exterior Facade Southeast Side | Fair | 3 | The facade shows normal wear. | Perform regular maintenance. | \$0 |

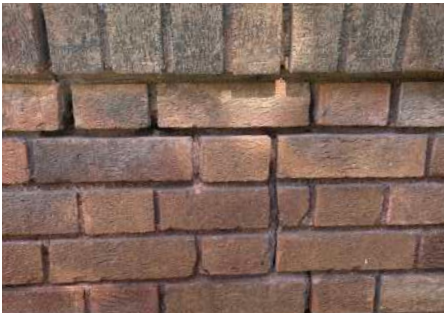
| Sub Category | Element/Location | Condition | Priority | Details | Recommendations | Estimated Cost |
|---|---|---|---|---|---|---|
| Exterior Walls | Brickwork | Fair | 2 | The brickwork shows normal wear. There were three locations where the mortar has some degradation. | Perform regular maintenance. Address tuck pointing at the conditions on the south wall below windows. | \$0 |

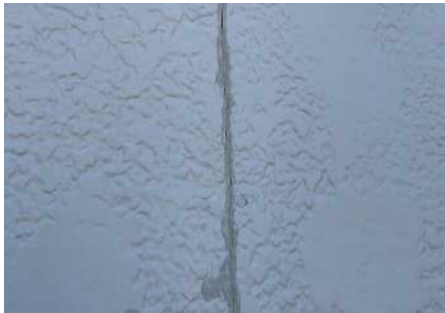
| Sub Category | Element/Location | Condition | Priority | Details | Recommendations | Estimated Cost |
|---|---|---|---|---|---|---|
| Exterior Walls | Composite Panels | Fair | 2 | Panels are in good condition, joint sealants are showing signs of disintegration. | Remove and replace per manufacture’s installation requirements. | \$2,200 |

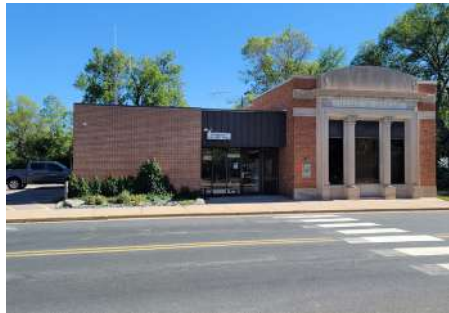
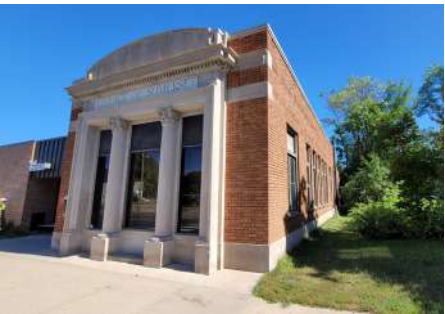
| Sub Category | Element/Location | Condition | Priority | Details | Recommendations | Estimated Cost |
|---|---|---|---|---|---|---|
| Exterior Walls | Exterior Walls | Good | 3 | Walls have normal wear. No signs of significant settlement. | Perform regular maintenance. | \$0 |

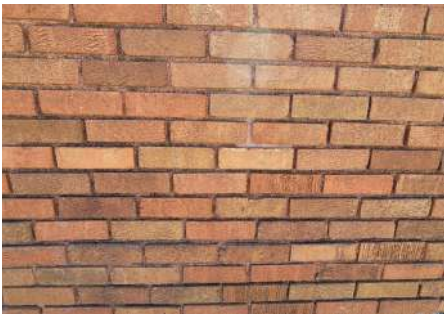
| Sub Category | Element/Location | Condition | Priority | Details | Recommendations | Estimated Cost |
|---|---|---|---|---|---|---|
| Exterior Walls | Brick Mortar | Poor | 1 | The brick mortar on the parapet of the original building is degraded. | Perform exterior masonry repairs including tuckpointing. | \$8,000 |

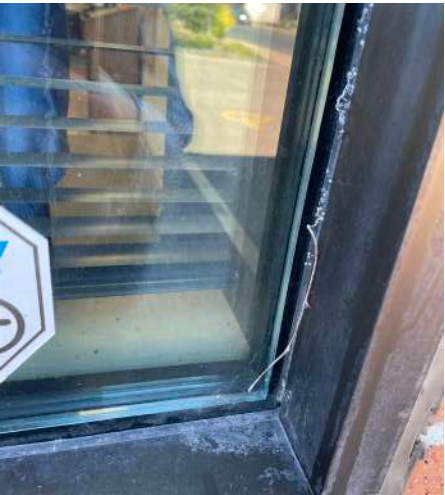
| Sub Category | Element/Location | Condition | Priority | Details | Recommendations | Estimated Cost |
|---|---|---|---|---|---|---|
| Exterior Windows | Seal at North Fixed Window | Fair | 2 | The window sealant is deteriorated. | Remove and replace with new sealant. | \$220 |

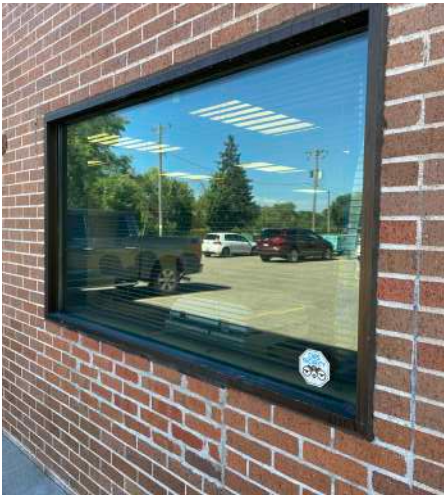
| Sub Category | Element/Location | Condition | Priority | Details | Recommendations | Estimated Cost |
|---|---|---|---|---|---|---|
| Exterior Windows | North Window | Fair | 3 | The fixed window shows normal wear. | Perform regular maintenance. | \$0 |

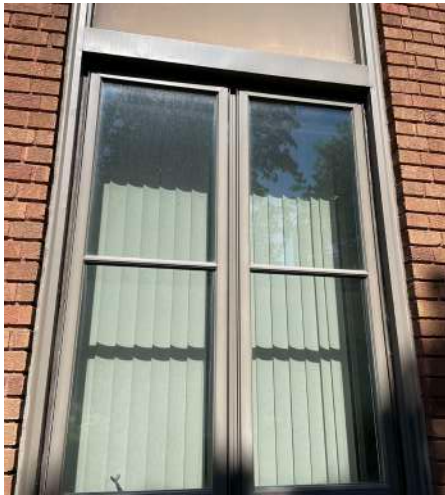
| Sub Category | Element/Location | Condition | Priority | Details | Recommendations | Estimated Cost |
|---|---|---|---|---|---|---|
| Exterior Windows | South Window | Fair | 2 | The original double hung windows are in poor condition and several are painted closed. Mapes panel infill at transom. | Replace with double pane, argon filled, tinted windows for energy performance at southern exposure. | \$33,300 |

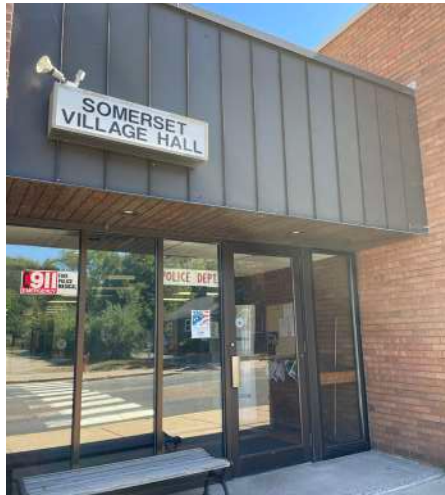
| Sub Category | Element/Location | Condition | Priority | Details | Recommendations | Estimated Cost |
|---|---|---|---|---|---|---|
| Exterior Doors | Storefront | Fair | 3 | The entry storefront shows normal wear. | Perform regular maintenance. | \$0 |

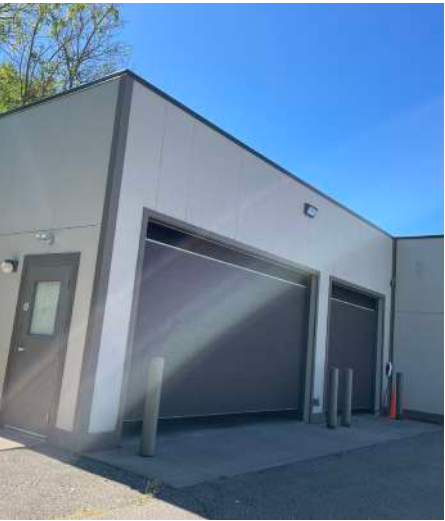
| Sub Category | Element/Location | Condition | Priority | Details | Recommendations | Estimated Cost |
|---|---|---|---|---|---|---|
| Exterior Doors | Hollow Metal Doors | Fair | 3 | The doors shows normal wear. | Perform regular maintenance. | \$0 |

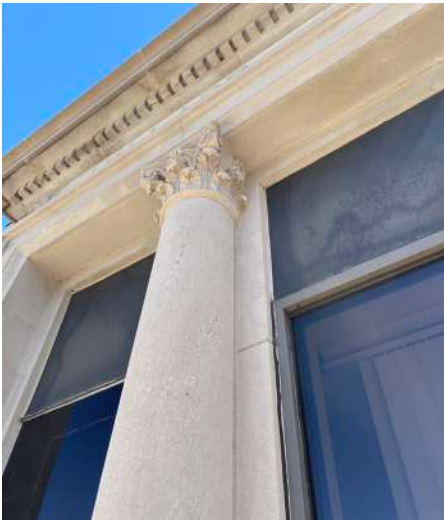
| Sub Category | Element/Location | Condition | Priority | Details | Recommendations | Estimated Cost |
|---|---|---|---|---|---|---|
| Exterior Other | Cornice Detail | Fair | 3 | The historical architectural detail shows normal wear. | Perform regular maintenance. | \$0 |

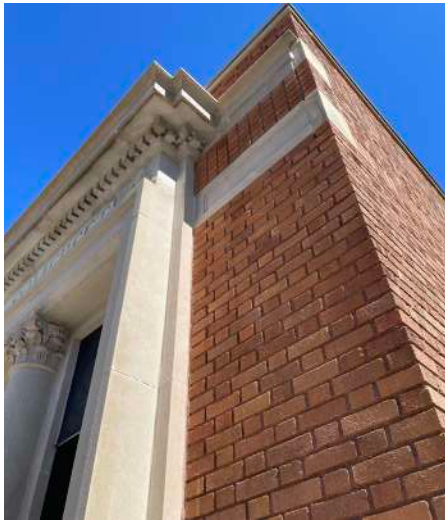
Dentil Detail

| Sub Category | Element/Location | Condition | Priority | Details | Recommendations | Estimated Cost |
|---|---|---|---|---|---|---|
| Exterior Other | Dentils Detail | Fair | 3 | The historical architectural detail shows normal wear. | Perform regular maintenance. | \$0 |

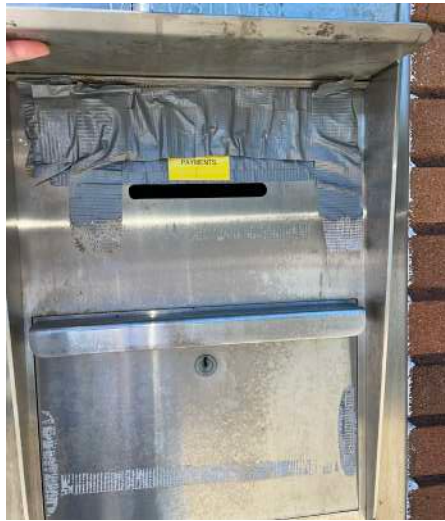
| Sub Category | Element/Location | Condition | Priority | Details | Recommendations | Estimated Cost |
|---|---|---|---|---|---|---|
| Exterior Other | Payment Drop | Poor | 2 | The payment drop insert has multiple gaps that result in envelopes getting lost. | Relocate to improve access and location or replace with updated drop box. | \$4,600 |

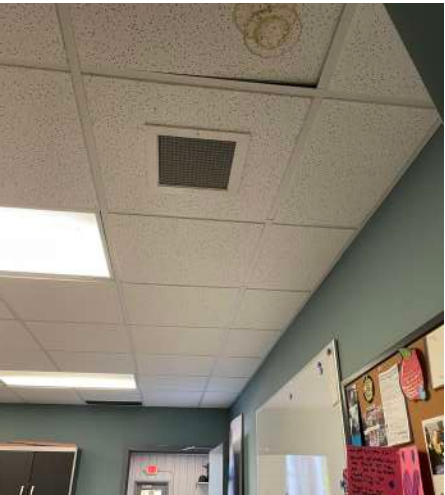
| Sub Category | Element/Location | Condition | Priority | Details | Recommendations | Estimated Cost |
|---|---|---|---|---|---|---|
| Interior Ceiling | Police Ceiling | Poor | 2 | Several damaged tiles remain that are the result of a roof leak that has been addressed. | Replace damaged tile. | \$690 |

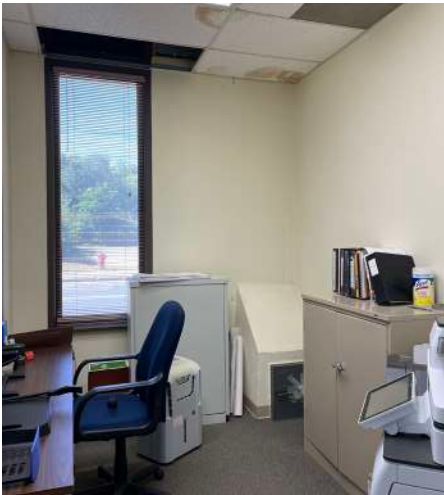
Village Hall Ceiling

| Sub Category | Element/Location | Condition | Priority | Details | Recommendations | Estimated Cost |
|---|---|---|---|---|---|---|
| Interior Ceiling | Village Hall ceiling | Poor | 2 | Several damaged tiles remain that are the result of a roof leak that has been addressed. | Replace damaged tile. | \$550 |

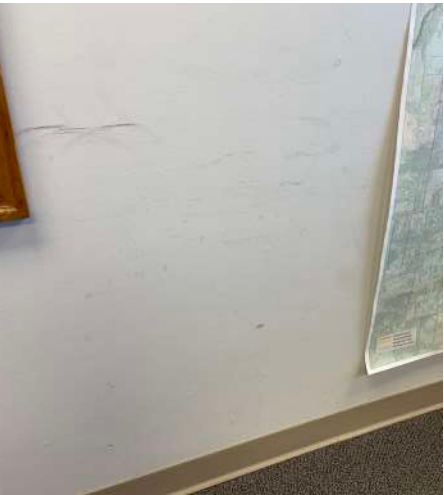
| Sub Category | Element/Location | Condition | Priority | Details | Recommendations | Estimated Cost |
|---|---|---|---|---|---|---|
| Interior Walls | Walls | Fair | 3 | Paint is marked, scraped, and damaged. | Perform regular maintenance. | \$0 |

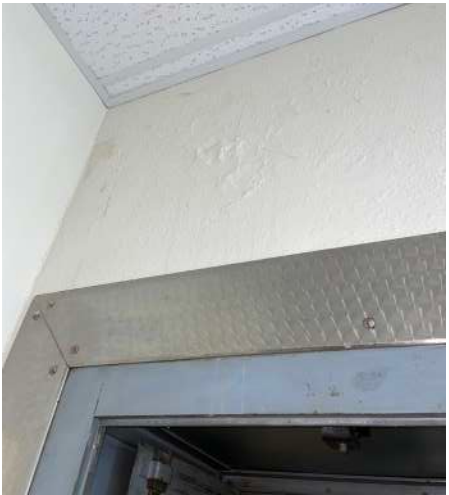
| Sub Category | Element/Location | Condition | Priority | Details | Recommendations | Estimated Cost |
|---|---|---|---|---|---|---|
| Interior Walls | Village Hall Plaster Walls | Fair | 3 | Finishes show normal wear. | Perform regular maintenance. | \$0 |

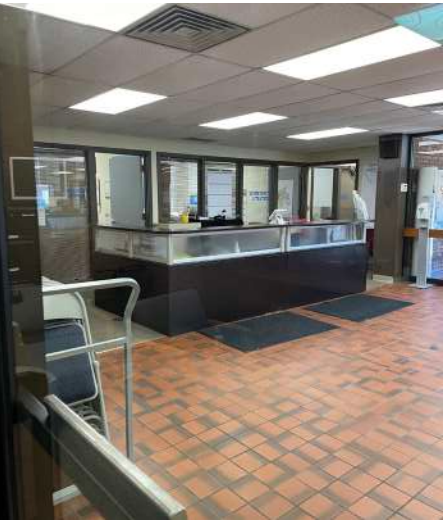
| Sub Category | Element/Location | Condition | Priority | Details | Recommendations | Estimated Cost |
|---|---|---|---|---|---|---|
| Interior Floors | Main Lobby Floor | Fair | 3 | The floor tile is dated but is in good condition. | Perform regular maintenance. Consider updating. | \$0 |

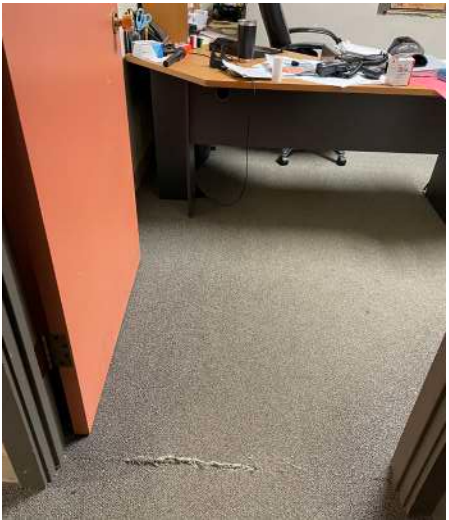
| Sub Category | Element/Location | Condition | Priority | Details | Recommendations | Estimated Cost |
|---|---|---|---|---|---|---|
| Interior Floors | Carpet/Police Area | Poor | 2 | Carpet flooring is worn, frayed, and has surpassed its useful service life. | Replace carpet flooring with an LVT that will have a longer life expectancy. | \$24,400 |

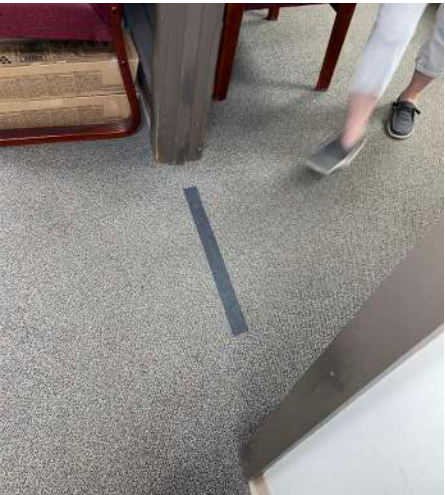
| Sub Category | Element/Location | Condition | Priority | Details | Recommendations | Estimated Cost |
|---|---|---|---|---|---|---|
| Interior Floors | Village Hall Carpet | Poor | 2 | Carpet flooring is worn, frayed, and has passed its average useful service life. | Replace carpet flooring with an LVT that will have a longer life expectancy. | \$24,400 |

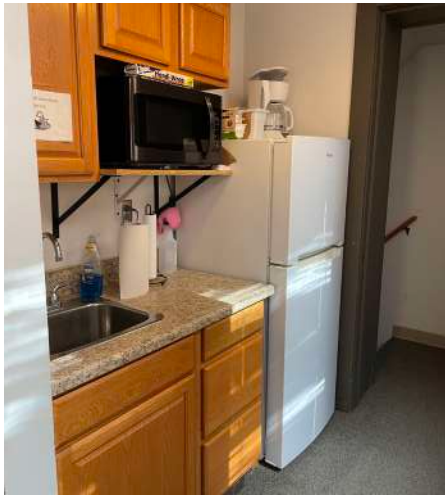
| Sub Category | Element/Location | Condition | Priority | Details | Recommendations | Estimated Cost |
|---|---|---|---|---|---|---|
| Interior Casework | Breakroom | Fair | 3 | Breakroom components are in good condition and show normal wear. | Perform regular maintenance. | \$0 |

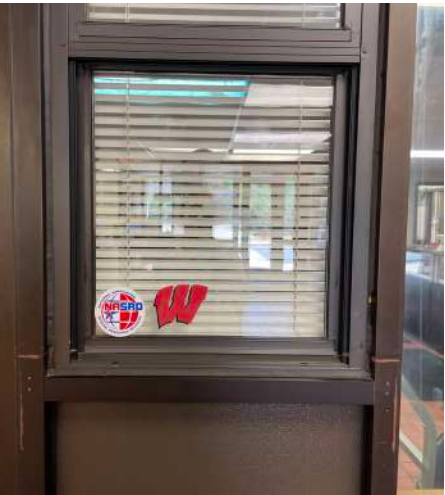
| Sub Category | Element/Location | Condition | Priority | Details | Recommendations | Estimated Cost |
|---|---|---|---|---|---|---|
| Interior Other | Interior Storefront System | Fair | 3 | Storefront system shows normal wear. | Perform regular maintenance. | \$0 |

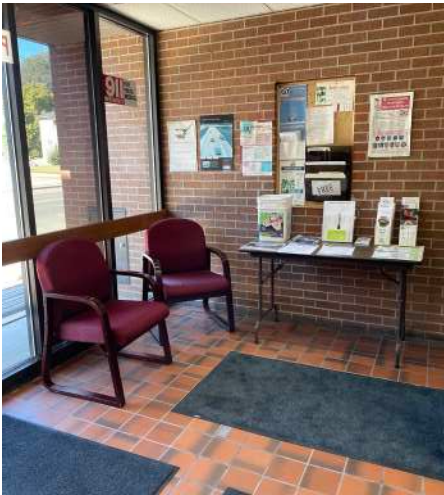
| Sub Category | Element/Location | Condition | Priority | Details | Recommendations | Estimated Cost |
|---|---|---|---|---|---|---|
| Interior Other | Entry Lobby | Fair | 3 | Finishes show normal wear. | Perform regular maintenance. | \$0 |

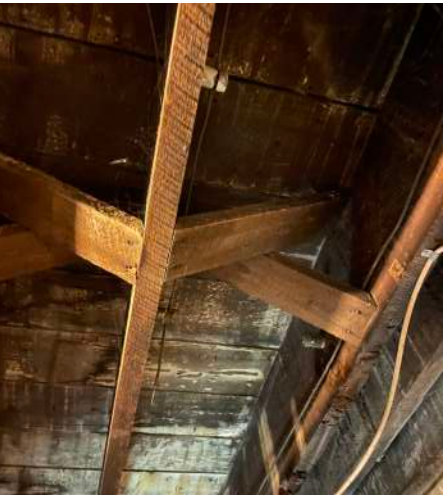
Subflooring Original Bank

| Sub Category | Element/Location | Condition | Priority | Details | Recommendations | Estimated Cost |
|---|---|---|---|---|---|---|
| Interior Other | Subflooring<br>Original Bank | Fair | 3 | This historical building has moisture exposure to exposed wood. Although this has no impact on structural integrity it does impact the indoor air quality. | Perform low impact blasting or install sealant to exposed wood joists and subflooring. | \$2,000 |

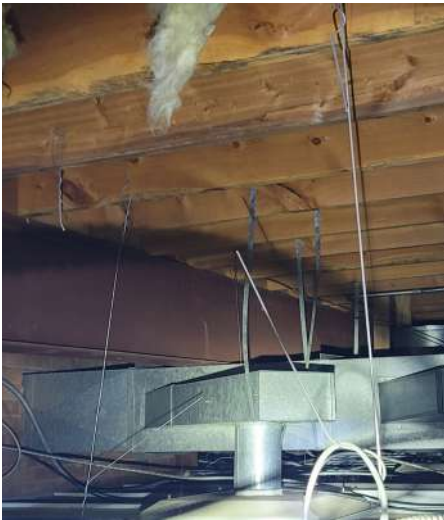
| Sub Category | Element/Location | Condition | Priority | Details | Recommendations | Estimated Cost |
|---|---|---|---|---|---|---|
| Interior Other | Roof Structural Support Members | Good | 3 | The viewable roof supports appeared to have normal wear. | Perform regular maintenance. | \$0 |

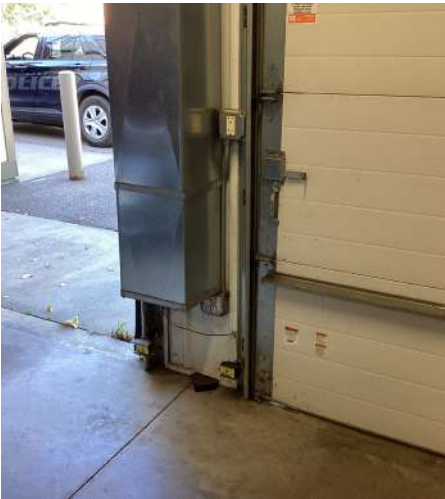
| Sub Category | Element/Location | Condition | Priority | Details | Recommendations | Estimated Cost |
|---|---|---|---|---|---|---|
| Other Mechanical | Exhaust/Garage | Good | 3 | Garage exhaust system is interlocked with outside air damper with carbon monoxide sensors. No issues are reported with the system. | Perform regular maintenance. | \$0 |

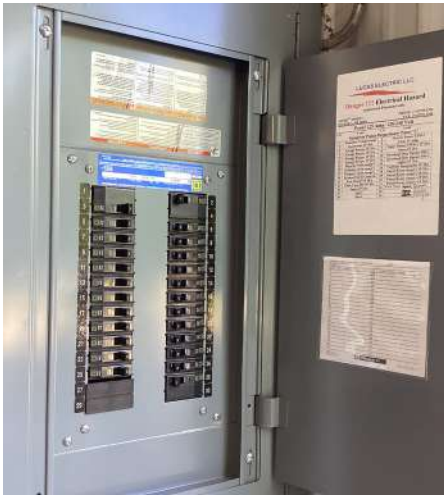
Branch Panel/Garage

| Sub Category | Element/Location | Condition | Priority | Details | Recommendations | Estimated Cost |
|---|---|---|---|---|---|---|
| Power Supply | Electrical Panels | Fair | 2 | The Cutler-Hammer panel board appears to be original to construction in 1977. Exposed bus bar was observed. There is an additional Siemens brand panel that was installed later. The age of this panel is unknown. Both panels have service disconnects. The average useful service life of this equipment is 30 years. | Replace original panel. | \$18,900 |

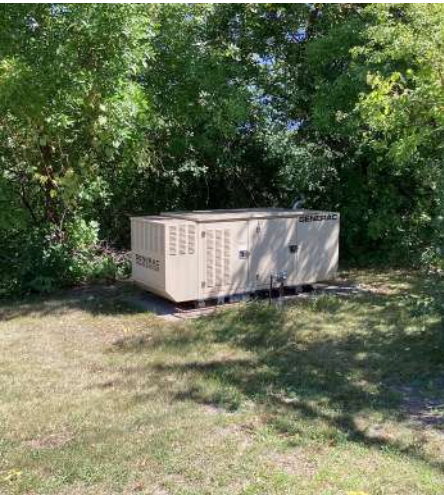
Emergency Generator

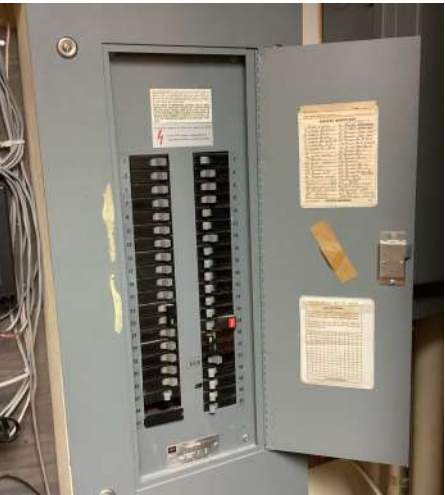
Electrical Panels

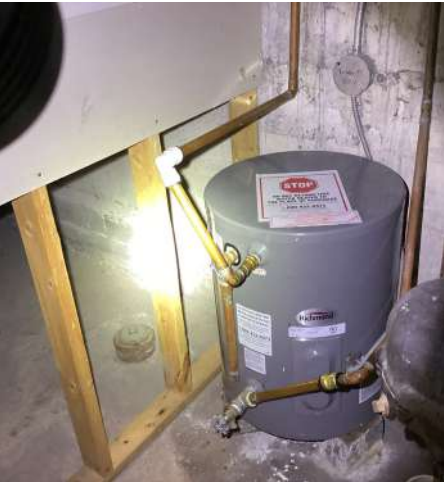
Water Heater/Basement  
Mechanical Room

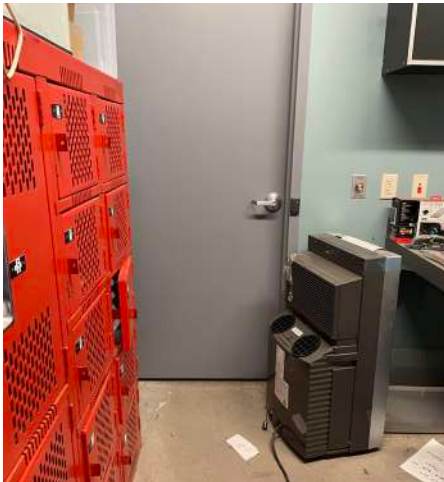
HVAC/Evidence Storage

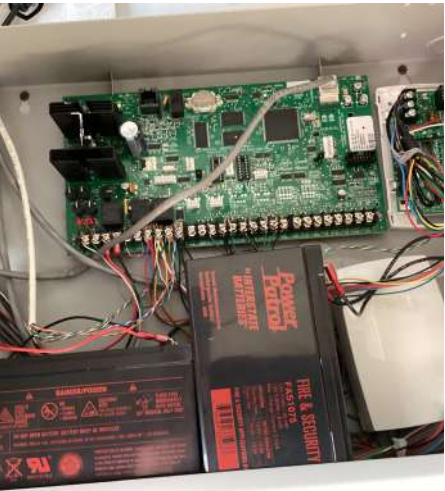
Fire Alarm/Throughout

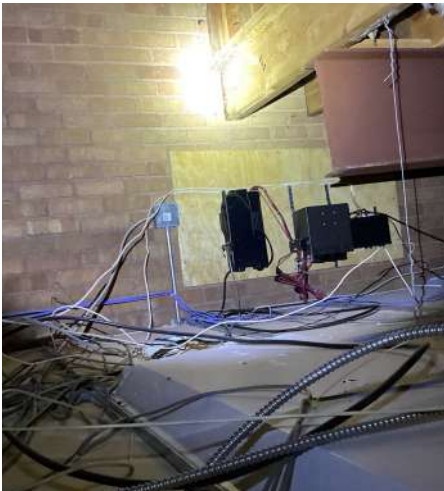
Wiring/Throughout
