# Village of Somerset Facilities Condition Assessment + Space Needs Study Report

January 2024

# Public Works Facility Assessment

# Village Hall Facility Assessment

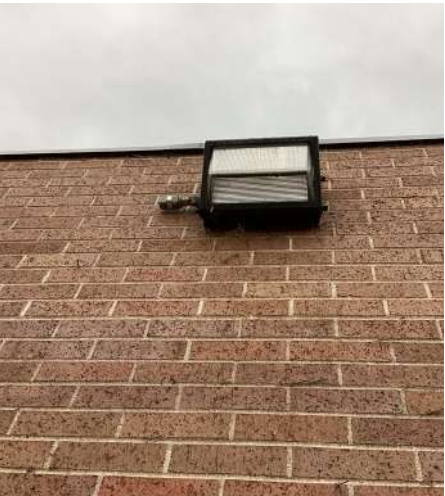
Exterior Lighting

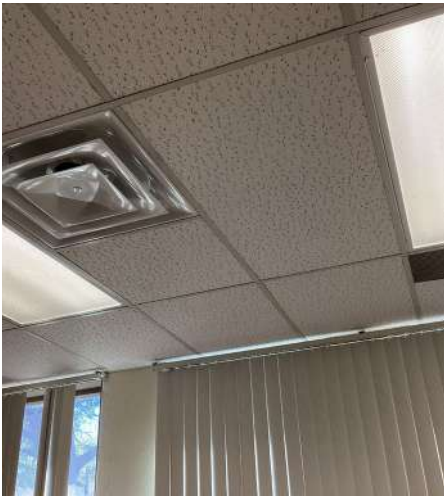
| Sub Category | Element/Location | Condition | Priority | Details | Recommendations | Estimated Cost |
|---|---|---|---|---|---|---|
| Interior Lighting | Throughout | Fair | 3 | Portions of the building have been updated with LED bulbs. Majority of the fixtures are fluorescent. | Replace light fixtures with LED and install occupancy sensing controls. | \$60,500 |

Interior Lighting

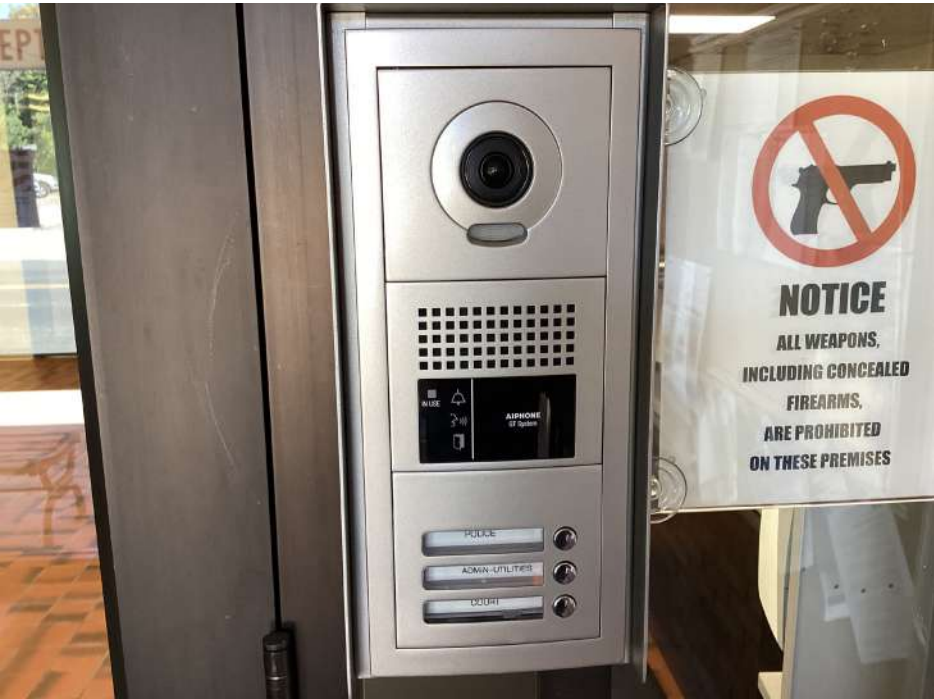
| Sub Category | Element/Location | Condition | Priority | Details | Recommendations | Estimated Cost |
|---|---|---|---|---|---|---|
| Security | Door Access | Good | 3 | The entrance doors feature an access system that calls corresponding departments. Staff report no issues with system. | Perform regular maintenance. | \$0 |

Door Access

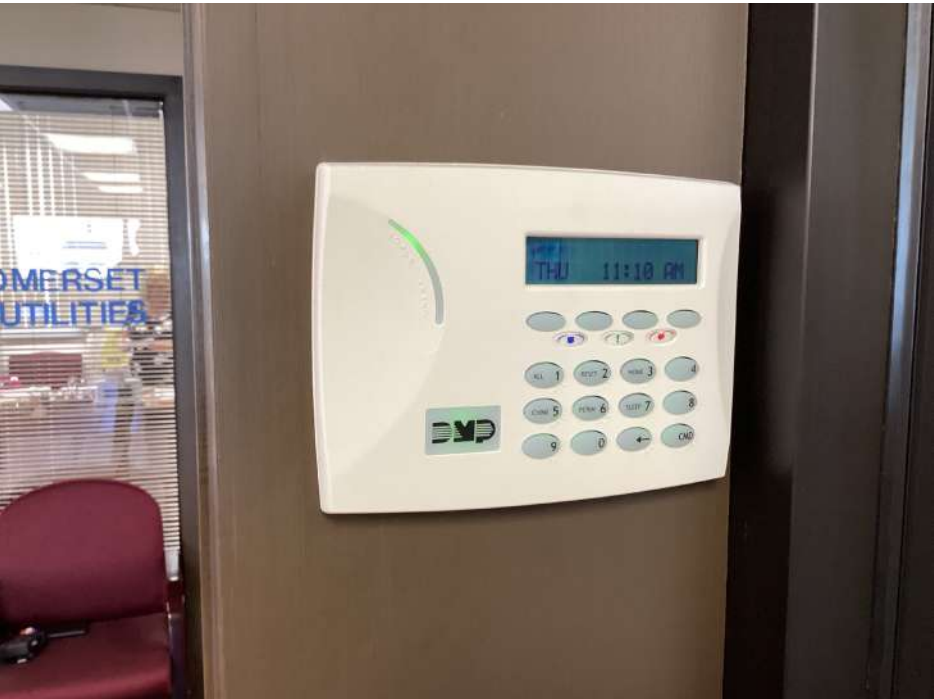
| Sub Category | Element/Location | Condition | Priority | Details | Recommendations | Estimated Cost |
|---|---|---|---|---|---|---|
| Security | Security System | Good | 3 | There are security cameras located throughout the interior and exterior of the building. The network video recorder is located in the network closet. System keypads are located at building entrances. Staff report no issues with system. Emergency call buttons are placed at work stations. The system was tested during site visit. | Perform regular maintenance. | \$0 |

Security System
