**Alta Town Council Meeting Packet**  
**Strategic Planning Retreat**  
**September 4, 2025**

# Town of Alta Capital Projects Planning and Funding

# Town of Alta

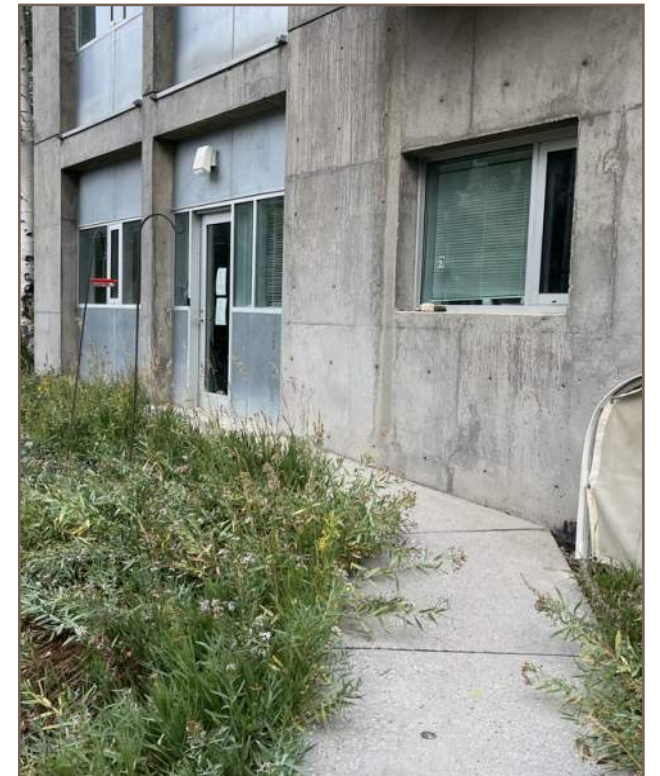
The west wall acts as a partial retaining wall as the slope of the hill progress from front (south) to rear (north). This wall has one punched opening filled with metal panel and a window, similar to the south wall.

The north wall is acting as a retaining wall and only the top of the wall is exposed to view. The hill slopes gently from east to west and the wall exposure increases from about four (4) feet to about seven (7) feet as the slope extends to the west.

**Good** – Periodic pressure wash cleaning and inspection of the foundation and retaining walls. Periodic inspection of the sealant at the metal panel to concrete interface.

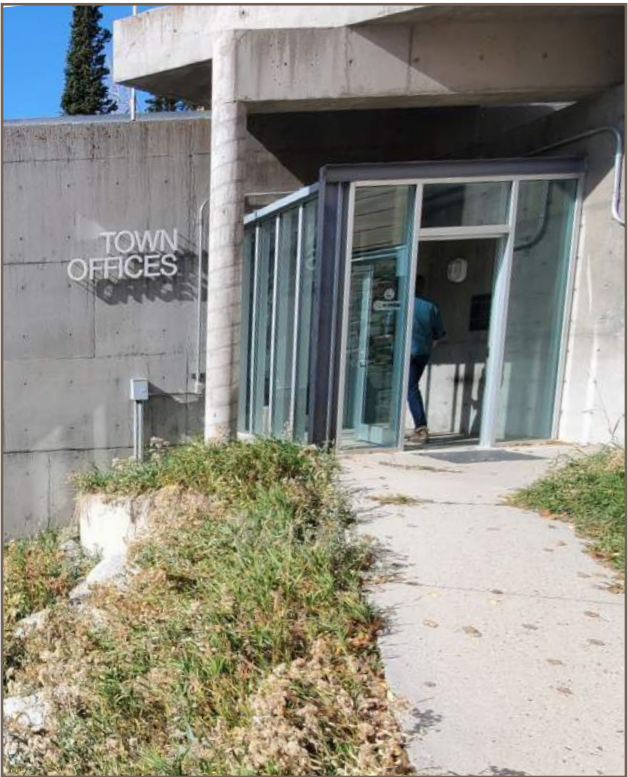
The storefront door systems are also anodized aluminum and match the window sightlines and detailing. Both door systems are mulled together with windows, the main entry also has a transom. It is also assumed that the IGU's have intact internal seals as no moisture was observed between panes of glass.

**Good** – Periodic cleaning and inspection of window seals. Any evidence of moisture between panes should be remedied by replacing the IGU. Adopt a periodic maintenance schedule with regular lubrication of operating hardware.

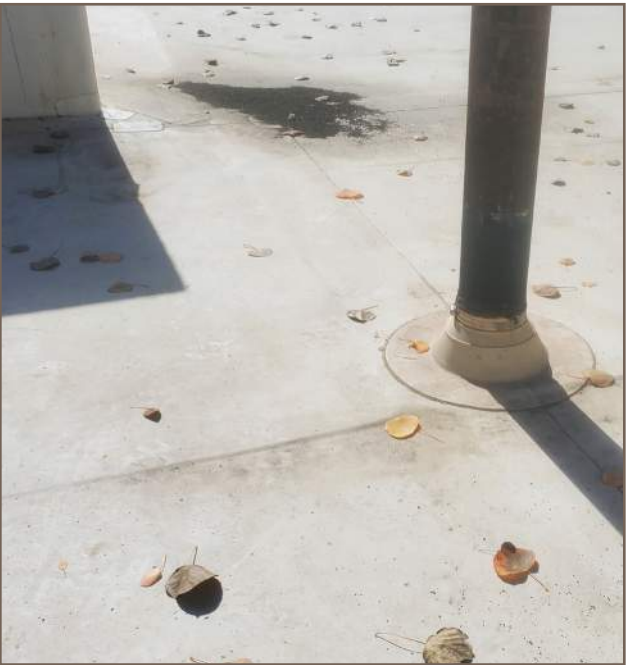
Only the main roof and the concrete canopy roofing were readily accessible for visual inspection. The roofing membrane appears to be a white TPO. The roofing may be PVC, but the typical dark colored line at the membrane seams is missing. The membrane installation is assumed to be a 20-year warranty system as vertical surface termination bar lacks the usual counter flashing required for a 30-year installation warranty. There is no obvious visual indication of exposed scrim, pinholes or seam separation and no obvious signs of roof leaks inside the building. The membrane appears to be in good condition, but based on the age of the building, this is likely the original roof membrane and plans should be made for replacement in the next five (5) years.

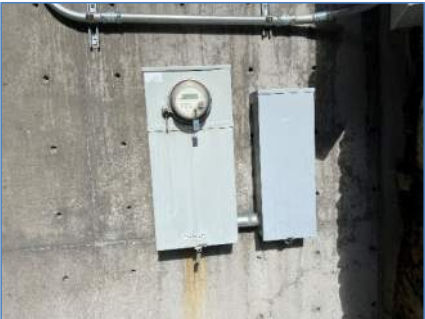
Exhibit 2 – Town Office and Marshall Building electrical service meter and service disconnect

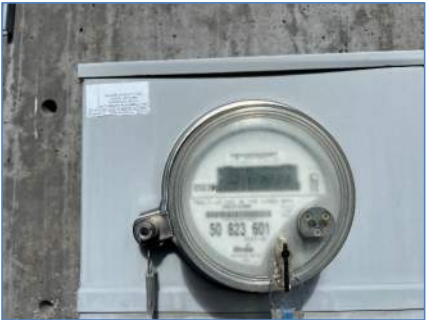
Exhibit 3 – Town Office and Marshall Building electrical service meter

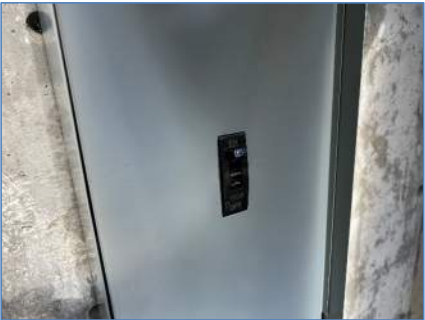
Exhibit 4 – Town Office and Marshall Building electrical service main service disconnect – 150A

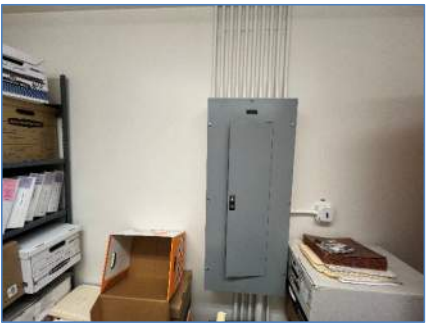
- f. The main service disconnect feeds panelboard A located at the lower level. The panelboard is installed in 1993, it has a few spare circuit breakers, and it appears to be in fair condition. The panelboard has another 10-15 years of useful life.

Exhibit 5 – Panelboard A

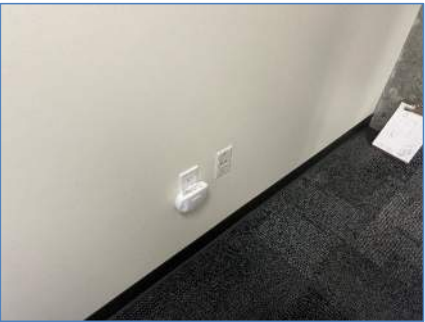
- i. A large mechanical duct is located above the boiler disconnect switch which not in compliance with NEC 110.26 (E). This should be fixed in by relocating the duct or the disconnect.
- j. The wiring devices (light switches, receptacles, etc.) appear to be in good conditions.
- k. The women's restroom receptacle outlet is not GFCI protected as required in NEC 210.8 (B)(1). It is unknown if the outlet is protected by an upstream GFCI outlet. This should be further investigated and a proper GFCI protection should be provided.

Exhibit 8 – Existing receptacle and data outlet

| System | Recommended Upgrade | Priority |
|---|---|---|
| GFCI outlets | <ul style="list-style-type: none"><li>Replace non-GFCI outlets with GFCI outlets in all locations specified in <i>NEC 210.8 (B)</i>.</li></ul> | 1 |

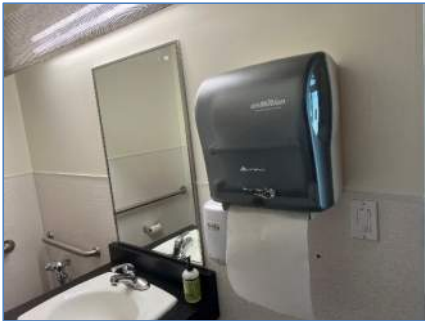
- a. Most of the building has florescent lights. Incandescent bulbs are still present at some locations (janitor closet, for example).
- b. The existing light sources are outdated and inefficient. All existing light fixtures and bulbs are recommended to be replaced with new LED lighting. Each space will need to be evaluated individually to determine the extent of the upgrade needed.

Exhibit 10 – Fluorescent light and occupancy sensor switch

| System | Recommended Upgrade | Priority |
|---|---|---|
| Lighting | <ul style="list-style-type: none"><li>Replace all lights with the outdated light sources (fluorescent and incandescent) with new LED lights.</li><li>Provide required egress lighting.</li></ul> | 1 |

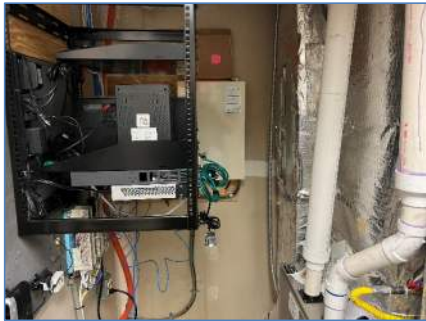
Exhibit 11 – Telecom rack

- a. The demarcation equipment and main telecom rack are located in the boiler room at the lower level.

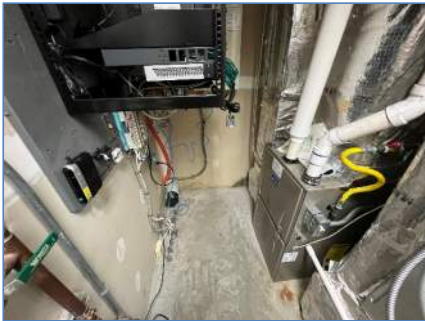
Exhibit 12 - Furnace, duct, and pipes in front of telecom rack

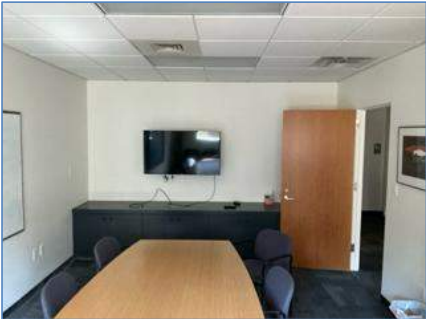
- a. Conference Room Video system consists solely of a wall mounted display. There are no provisions for Video Conferencing, nor connection of video inputs at the conference Table.
- b. Assuming display is used to show technical content, display is undersized.
- c. There are no provisions for in room voice lift. – The room is small enough that the Video Conferencing bar is appropriate
- d. There is no floor box below the conference table, limiting cable options.

Exhibit 13 – Conference Room AV System

| System | Recommended Upgrade | Priority |
|---|---|---|
| Audio/Video system 2 | <ul style="list-style-type: none"><li>Replace Display with 65" display</li></ul> | 2 |

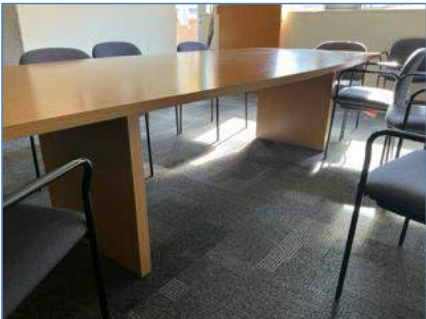
Exhibit 15 Conference Room Table – w/o floor box

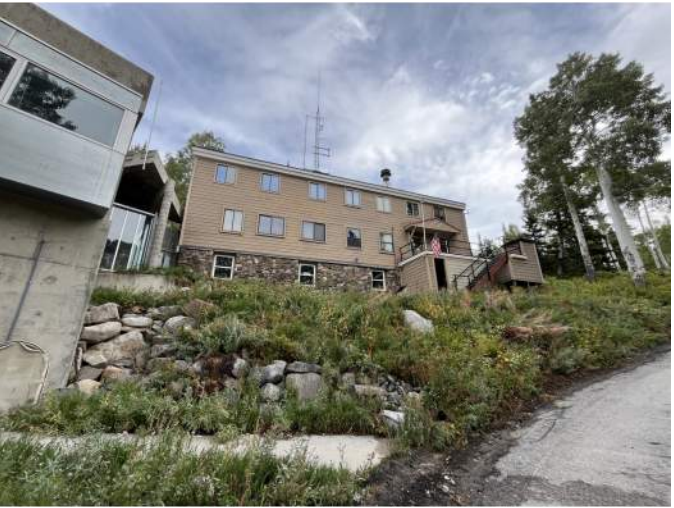
exposure and painted/stained wood trim. The wood siding appears to be well maintained. The paint/ stain is beginning to appear a bit thin, but only areas at grade or near snow accumulation exhibit peeling paint. A stone chimney matching the foundation protrudes on the east façade and extends above the low-pitched gabled roof. The top of the chimney is terminated with exposed clay flue liners projecting above the stone. The south tile is a chase for a gas-fired appliance flue. A rope acting as a guy wire is wrapped around the chimney and tied to the alarm tower on the roof and extends the full length of the roof to the access ladder on the west end of the building (see Roofing section).

Both building entrances are via deck topped with composite decking material. The east entrance to the main level is at grade with a single step onto the deck. The south entrance is via a short wood stair, a landing at the basement-level and a longer stair that runs along the generator addition to a large deck over the addition at the main-level entrance. The lower stair treads and stringers are wood and in need of repainting. The longer stair has wood stringers and perforated metal treads. The handrail at the stair and deck are metal and do not meet the current code requirements for railings. A projection extends above the main level decking on the southeast corner of the generator addition. The projection is wrapped in siding and capped with a formed sheet metal cap.

- Good** – Scrape and re-paint/stain the damaged wood siding, trim and stair finishes at grade.
- Better** – Scrape and re-paint/stain all the wood siding, trim and stairs.
- Best** – Replace the stair and deck railings with code guardrails that conform to the current accessibility standard.

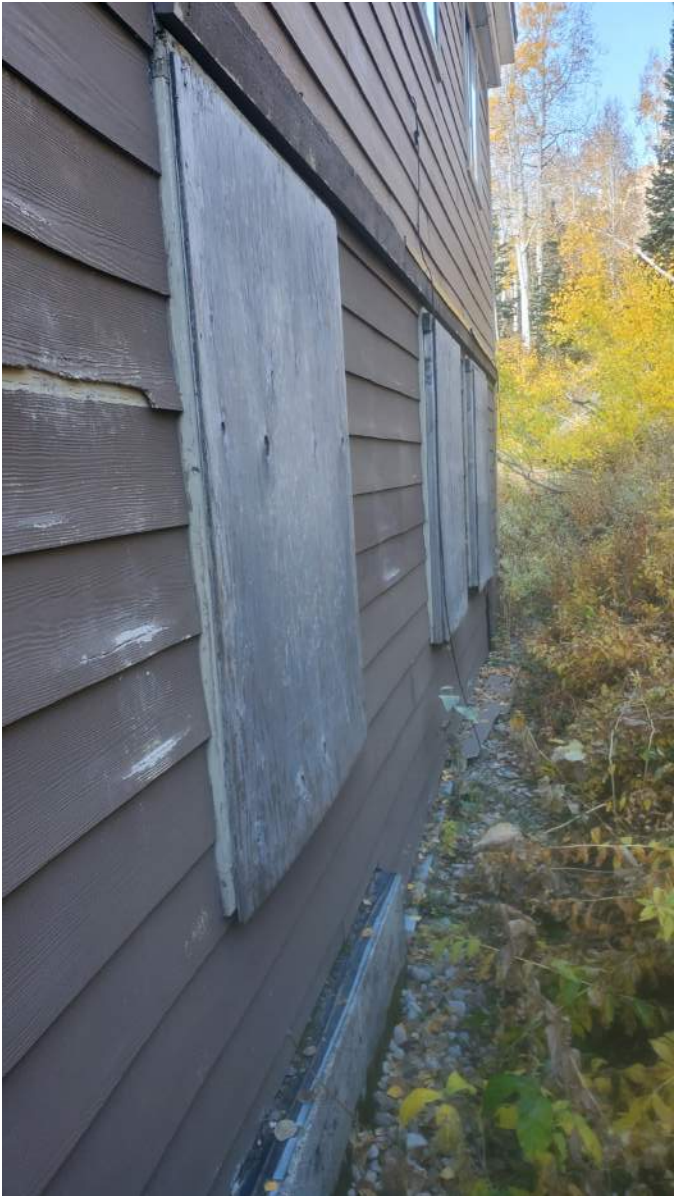
The exterior of the building is articulated with windows at regular intervals providing natural light into all rooms on the main and second floor as well as the main room on the basement south wall. The windows are a mixture of at least three types of windows and appear to all be double-pane insulated glass units. The windows in the basement are white vinyl single-hung windows, while the windows on the main and second floors are dark bronze aluminum windows, some are single-hung and the remaining are sliding. Many of the windows on the east, and south walls have been covered by plywood or sheet acrylic. It is assumed this is a measure to protect the window glass from damage due to snow drifting and ice dam curling from the roof. The result is a negative impact on the quality of the associated interior spaces. The plywood on the windows in the north wall may be as much of a solution for privacy and light control as it is for window glass protection as it seems to only affect windows into private sleeping rooms and a restroom.

The entrance doors, two into the basement, one at each main-level entrance and one at the west end of the interior hallway on each of the main and second-levels are insulated hollow metal doors. All appear to be in good condition and operate effectively, except the door at the west end of the second-floor, which is severely rusted. The door at the west end of the main level has a large step down to grade. The same door at the second-level has a small metal landing and stair to the roof.

**Good** – Verify gasketing at each exterior door. Replace the door at the west end of the second-floor hallway.

**Better** – Replace the plywood over the windows on the north elevation with acrylic sheet.

**Best** – Replace the glazing in the covered windows with laminated safety glazing and remove the coverings to improve the light penetration into the interior.

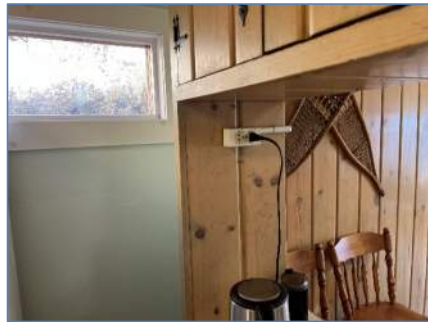
Exhibit 9 – Existing wiring devices and surface raceway

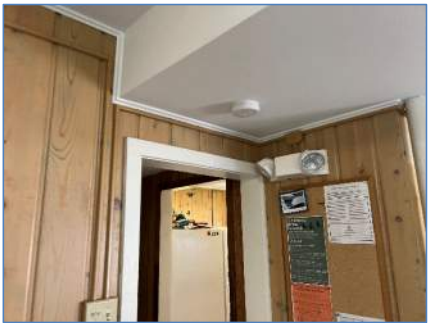
Exhibit 12 –Emergency bug eye and toggle switch

- c. Existing lighting controls consist solely of toggle switches.
- d. Significant upgrades to the interior and exterior lighting control systems are needed to meet the latest energy codes. There are opportunities for energy savings by installing lighting controls such as occupancy sensors and timed relay controls.

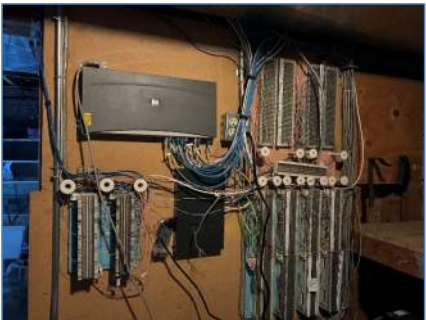
- a. The telecommunication equipment is located at the lower level and in one of the offices at the upper level (equipment rack with the radio equipment, etc.).
- b. A dedicated A/C system and telecommunication ground bus bars were not observed at these locations.
- c. Abandoned data and telephone wiring is scattered throughout the building.

Exhibit 13 – Lower-level telecom equipment

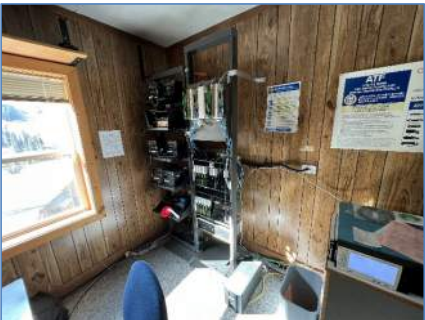
Exhibit 14 – Upper-level telecom equipment

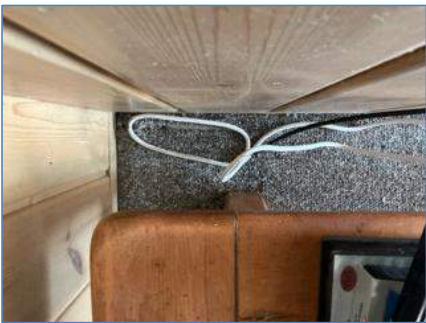
- a. Satellite Cable TV distribution system consists of coax cables run on the outside of the building, punched through external walls, and floors to TVs through the building. Some sleeping rooms do not have distribution.

Exhibit 15 – Coax cable punched through floor

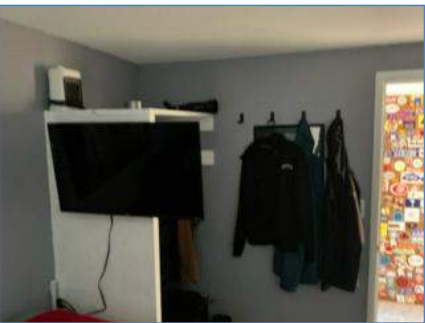
Exhibit 16 – Living quarters w/o Satellite Distribution

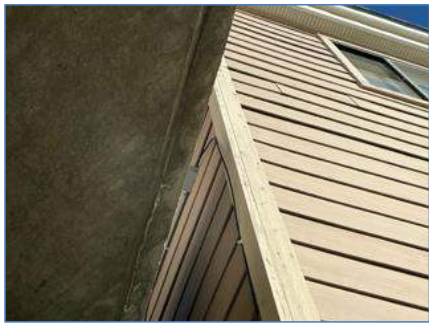
Exhibit 17 – External Coax cable routing

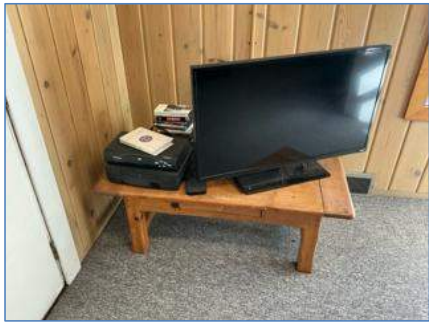
- b. Commons Area Display system consists of small 32” TV, a DVD Player, and Cable TV connection. While this may be adequate, it is small for current home and hospitality standards.

Exhibit 19 – Commons Area Display

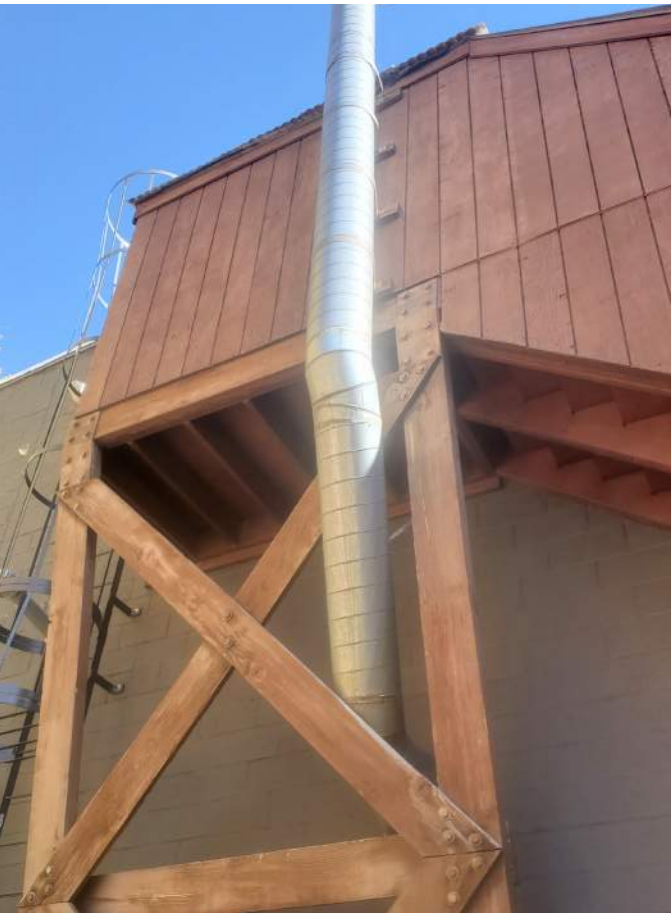
Post office and stair to the second floor addition is separating from the building and creating gaps in the building envelope which will allow energy leakage and water infiltration. The separation is particularly evident while climbing the east stair to the second floor. As one approaches eye-level with the top landing, daylight can be seen through a large gap between the wall and landing. The landing is obviously sloping from a high point on the west to a low point on the east. Building occupants have indicated that maintaining a comfortable temperature is difficult in the post office, which is below the area of the separation.

**Good** – Touch-up the peeling or flaking paint along the base of the west wall. Clear the large rocks away from the building to form a 3'-0" wide buffer zone along the building foundation on the north and west sides of the building. Repaint the northern portion of the east side of the second-floor addition.

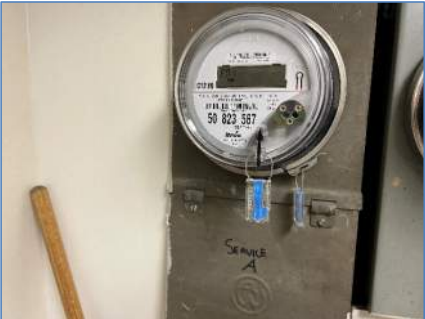
Exhibit 2 – Service A meter with error message E01

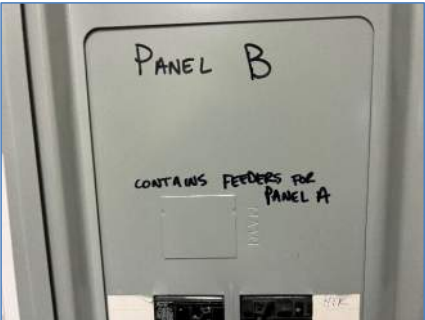
- c. There are two meters at the upper level: meter # 50 823 587 (service A) and meter # 50 823 586 (service B). It appears that service A feeds the lower level (panelboard A is in the high bay area at the lower level) and service B feeds the upper level (panelboard B is located next to the meter). There is also a note on panelboard B (*Exhibit 4*) that panel “contains feeders for panel A.” An E01 error (*Exhibit 2*) was displayed at the service A meter during the time of the site visit. This is typically an initialization error, meaning the meter has not been initialized. Also, we have only received the demand data for the service B meter. Considering all the above, ***we have assumed that the service B meter is active, the service A meter is inactive, and both panelboards (A and B), are fed from the service B.*** This assumption to be confirmed by the Owner.

Exhibit 4 – Panelboard B note for panel A feeder

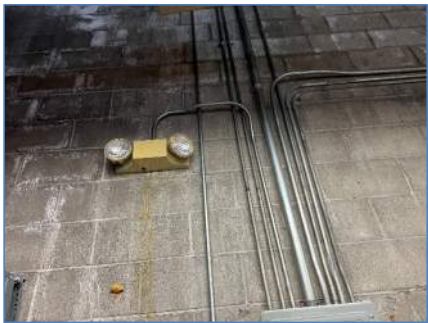
Exhibit 10 – Emergency bug-eye

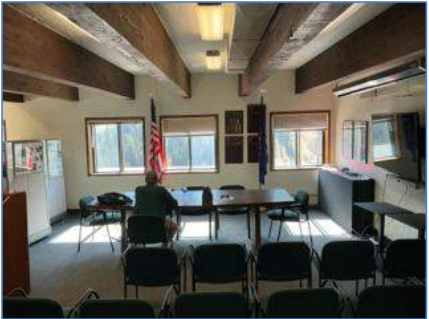
- b. The council chambers AV system consists of a wall mounted display, video conference bar, and connection cables connected to the back of the display.
  - 1) VC bar is inadequate for the space. Its current location limits the camera site lines for both council members, and public presenters, showing only profile views of presenters, and the council members.
  - 2) Requires the city manager to site next to the display to run the meeting.
  - 3) VC bar limits remote viewers to only see whomever is speaking the loudest.
- c. An old 4x3 projection screen hangs from the ceiling at the same location as the as the display.
- d. There is no in-room voice lift system, limiting speaker to their own voices.

Exhibit 13 – Council chambers.

| System | Recommended Upgrade | Priority |
|---|---|---|
| Audio/Video system | <ul style="list-style-type: none"><li>If accepted by the owner, we recommend the following:</li><li>Replacement of the presentation system with a new one consisting of dual screens, one for the public and one for council members to enhance viewing angles.</li><li>Two PTZ Cameras, one to show the Council Members, and one for the public presenters.</li></ul> | 2 |

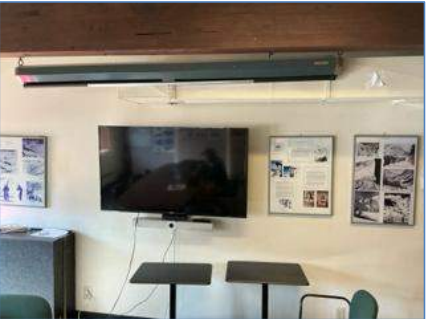
Exhibit 14 – Display, VC Bar, and projector screen.

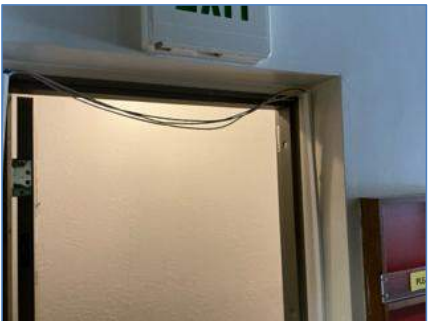
Exhibit 15 - Exposed cables above doorway.

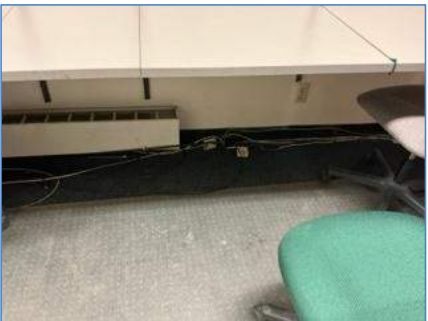
Exhibit 16 – Exposed cables below desks.
