EXISTING CONDITIONS AND CONCEPT STUDY FOR THE VILLAGE OF
PALMYRA PUBLIC SAFETY DEPARTMENT

PALMYRA, WI

MARCH 2026

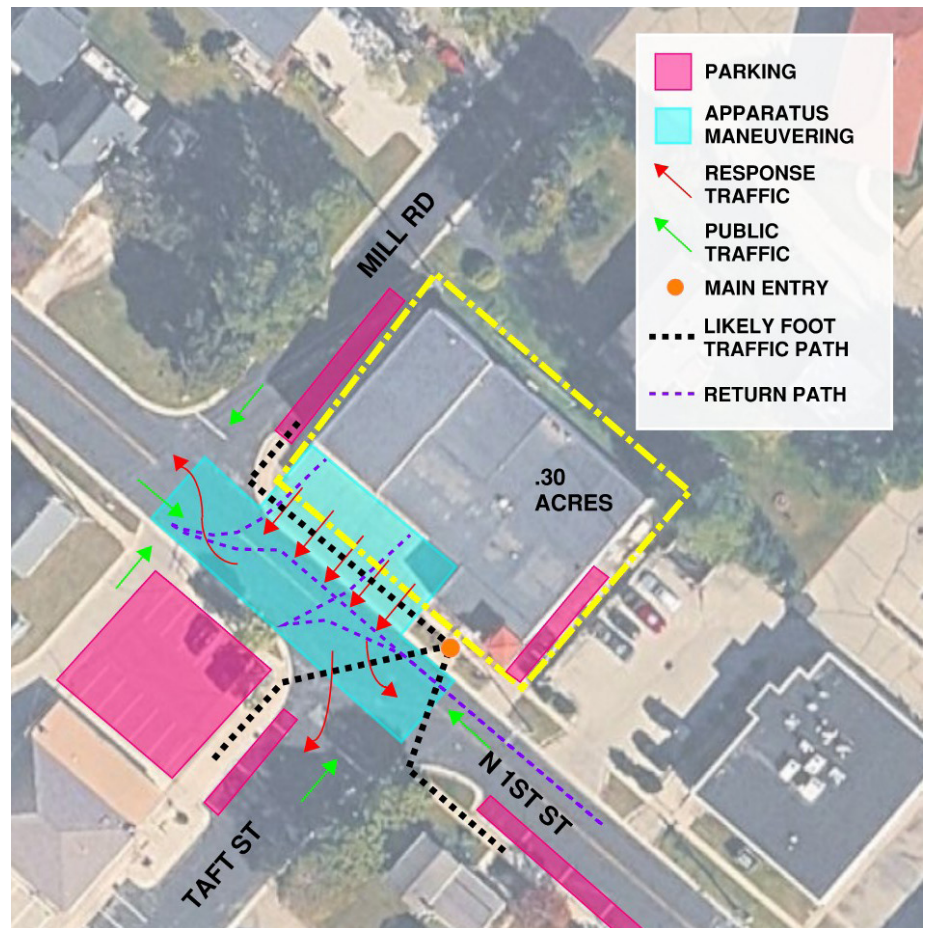
EXISTING STATION: SITE

The building is nestled between a residential neighborhood and a main commercial zone and is completely landlocked with no room for expansion.

At the north corner of the current building, along the northwest property line, is a steep grade change and a retaining wall. This grade change continues to slope downward along Mill Road towards the south and creates an awkward condition at the apparatus bay apron. Apparatus exiting the two west most bays must pull out far into the street and make wide turns to ensure they do not hit the retaining wall.

The response apron has additional challenges as well. It is too shallow and too steep with a slope of almost 10% at the steepest point. Many of the apparatus cannot be parked on the apron without sticking out into the street. When exiting the building, due to uneven pavement and awkward turns, vehicles have to move very slowly to prevent vehicle or building damage which can impact response times. Also, because the bays are back-in, the apparatus block traffic when

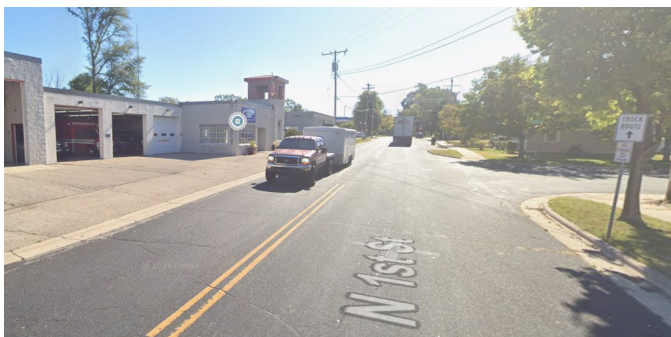
LOOKING SOUTHEAST ON N 1ST ST. - NO SIGNS, OR MARKINGS WARNING OF RESPONSE TRAFFIC

The remainder of the available parking spaces are across the street towards the southwest in the Village Hall parking lot or alongside the northwest side of the building on Mill Road. This requires visitors and staff to cross the path of responding vehicles if they are arriving at the building during an active call. There are also no pavement markings, arrows, signs or signals warning pedestrians or vehicle traffic of potential response traffic.

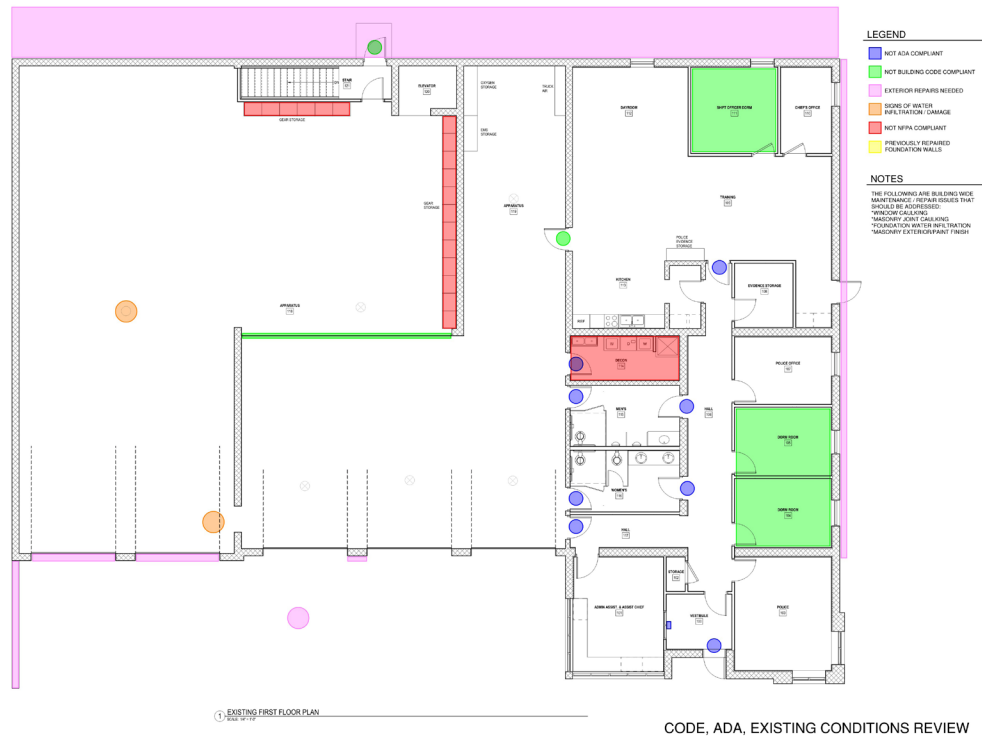
EXISTING STATION: FIRST FLOOR EXISTING CONDITIONS

In general, this facility does not meet current ADA guidelines and does not meet the current Wisconsin Building Code (IBC). It also has significantly deferred maintenance items. The above plan indicates areas that either do not meet the IBC or ADA guidelines or require maintenance or repair. These issues include, but are not limited to:

- Non-ADA compliant push/pull clearances at multiple doors
- Some non-ADA compliant door hardware
- Missing code required fire ratings at walls and doors separating living and sleeping spaces from other building areas
- Path of egress travel is not code nor ADA compliant
- Basement has significant evidence of continued water infiltration from floor above and from the exterior
- Elevator is not functional
- Kitchen is not ADA compliant
- Toilets are missing code required grab bars
- Shower is not ADA compliant
- An automatic sprinkler system is not installed in dwelling and sleeping areas

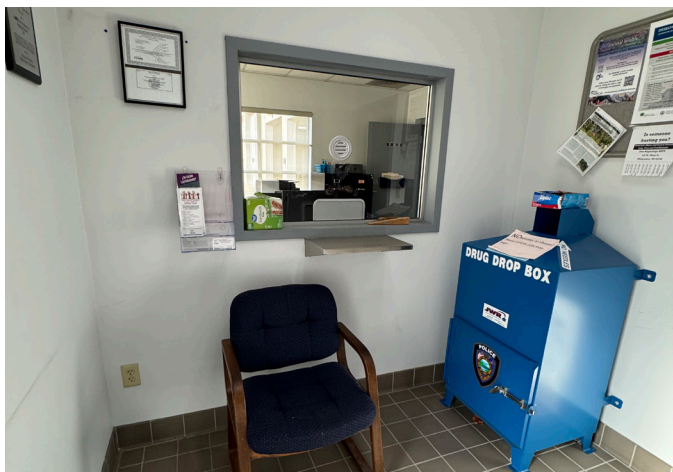
MAIN ENTRY VESTIBULE NON-ADA COMPLIANT TRANSACTION WINDOW

Directly off the building's vestibule is the shared assistant police chief / administrative assistant's office. This vestibule is secured so visitors do not have full access to the facility once they are buzzed into the vestibule from the outside. There is a pass-through / transaction window for visitors to be able to speak to someone from the department, and a second secure door that leads to the rest of the admin area. The main door into the building is not ADA compliant on the interior, nor is the transaction counter below the service window.

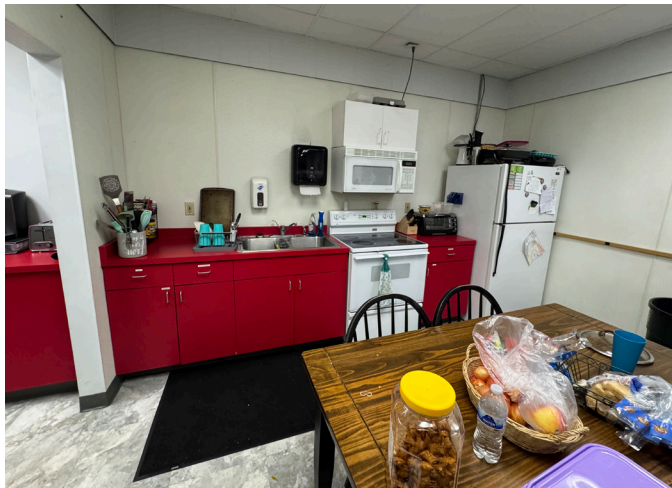
KITCHEN SHARED WITH PD IS NOT ADA COMPLIANT

The kitchen, dining and day room are adjacent to the open office / training area with no separation between them and the police department also uses these spaces. The kitchen is undersized both for function and for modern appliances and is not designed to serve a career department, especially because it also serves as a break room for the entire public safety department. The kitchen is also not ADA compliant, and with the layout and function of this facility, it is required by code to be ADA accessible.

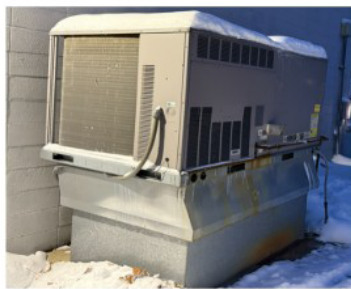
The building consists of several separate heating and cooling systems. These systems appear operational, however they are beyond their useful life, should be replaced and building ventilation rates verified.

Carrier WeatherMaker® packaged rooftop gas heat and electric cool unit – ground mounted

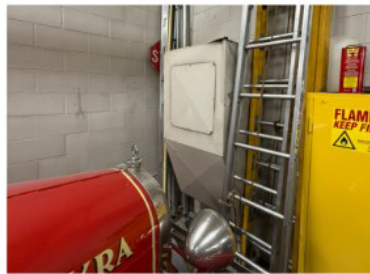
The back of the apparatus bay is equipped with one (1) wall mounted exhaust fan. This fan does not provide continuous ventilation and does not meet current code requirements. It is recommended that this area be evaluated for the installation of a continuous ventilation system, and a CO & NO2 detection system.

Existing Wall Exhaust Fan

A vehicle exhaust system is also a recommended best practice. There are various types of systems ranging from air scrubbers to direct connect capture systems.

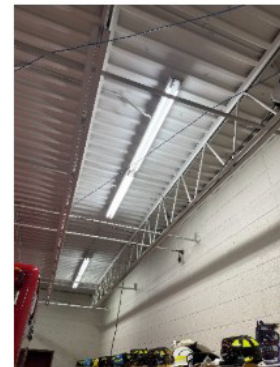
Data wiring not properly supported
